# Rehabilitation of historical ruined castles based on field study and laboratory analyses: The case of Bigalı Castle in Turkey

The castle structures, which were designed for defense purposes during the period they were built, as a result of the loss of their functions over time, some of them disappear completely, while some of them survive to the present day as a ruin. The rehabilitation of the structures requires a scientific approach and a knowledge of the cultural background to preserve historical identity of the structures. Utilizing these kinds of specific knowledge and the scientific method, the aesthetic and historical values of the structure can be provided. Rehabilitations require an interdisciplinary approach to gain a full understanding of the construction technique and member properties and, also its material characteristics of the structures based on historical documents. In order to restore such structures to their authentic form and prolong their service life, the historical research that started on the date they were built and continued to the present day should be researched, and the material characteristics of the original structural members should be identified

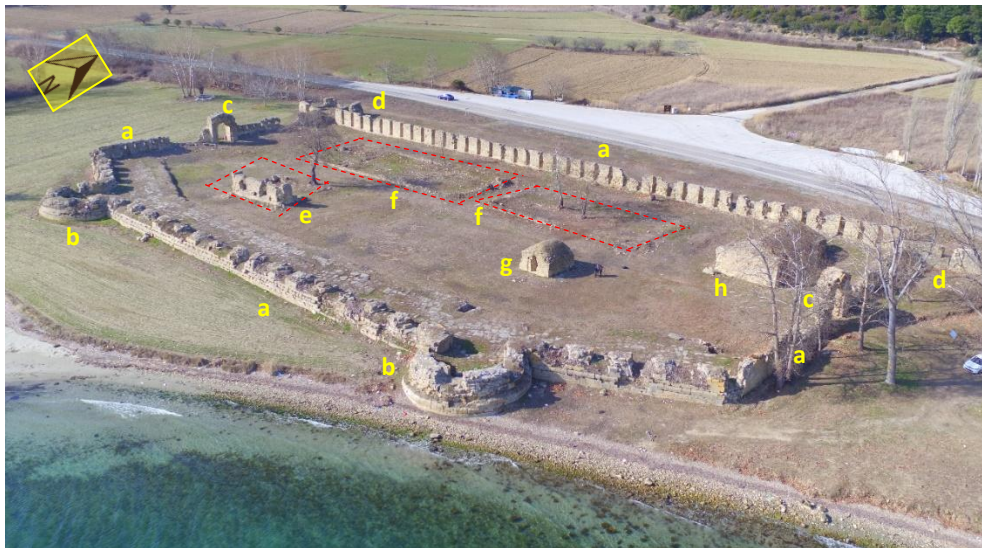
purpose of the castle was control and it was not the scene of wars. During the 1915 Çanakkale Wars, it was used as the 3rd Corps Weapon Repair Unit. It lost its function after the Çanakkale wars and turned into a ruin due to abandonment and environmental effects. While the castle examined in this study was in a good condition and had retained all of its components in the 1890s, it currently comprises a ruined mosque, a water fountain, an arsenal depot and two military headquarters, of which traces of the foundations are still visible (Figures 3 and 4).

**Figure 4.** The current view of the ruined castle: a. Facades, b. Circular towers, c. West- and East-entrance, d. Square towers, e. Mosque, f. Military headquarters, g. Water fountain, h. Arsenal depot. Source: Authors.

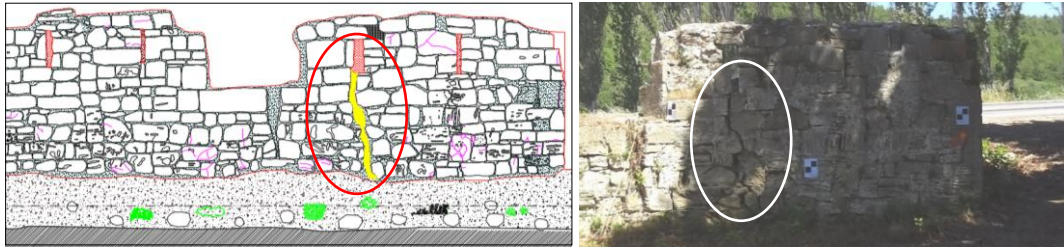
Material losses and defects were determined in many parts of the ruined castle (Figures 5 to 7). The physical and structural defects can be grouped as follows: *i.* Loss of components, *ii.* Partial collapse, *iii.* Surface erosion to the stone, *iv.* Structural cracks, *v.* Plaster flaking, *vi.* Joint losses, *vii.* Vegetations; and *viii.* Collapse-induced rubble.

Figure 5. Structural cracks in the south facade walls. Source: Acioğlu (2013).

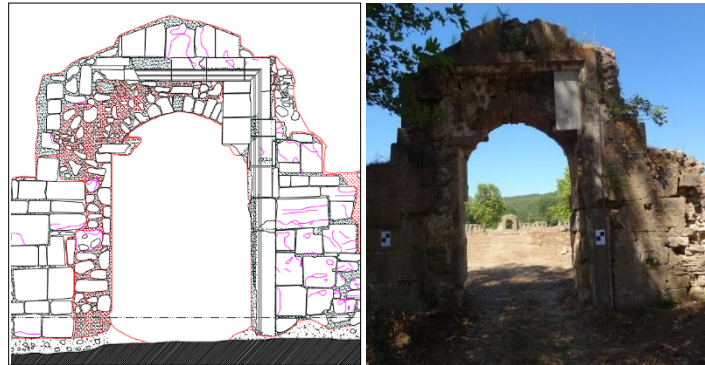
Figure 6. Material loss in the east entrance. Source: Acioğlu (2013).

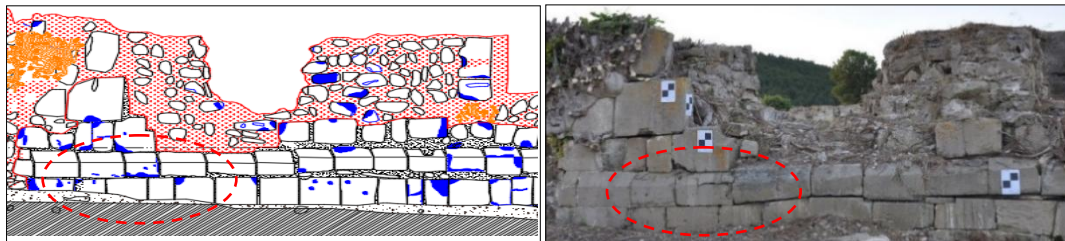
Figure 7. Time-dependent ground settlement in the east facade. Source: Acioğlu, 2013

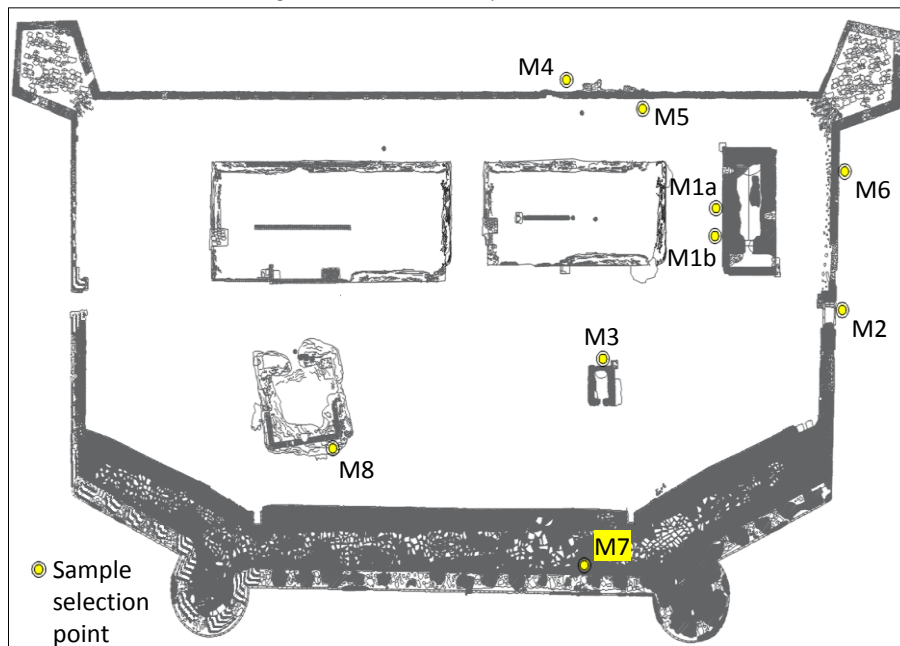
A detailed investigation was carried out during which representative samples—authentic materials— were taken from different locations, after first determining that they were part of the original structure, rather than later additions— having a different appearance and physical feature from the material used throughout the building—. The plaster and mortar samples were examined visually and subjected to chemical and mineralogical tests in accordance with the standards, and water-soluble salt contents of the samples were investigated through simple spot tests. The qualities, content and ratio of binders, aggregates and additives of the samples were identified, and calcination, petrographic analysis and acid loss tests, as well as a visual analysis of the aggregates that did not react with acids under a stereo microscope, were carried out. The codes and locations of the samples are given in Table 3 and Figure 8, with detailed visual descriptions given in Table 4.

**Figure 8.** Locations of the samples. Source: Authors.

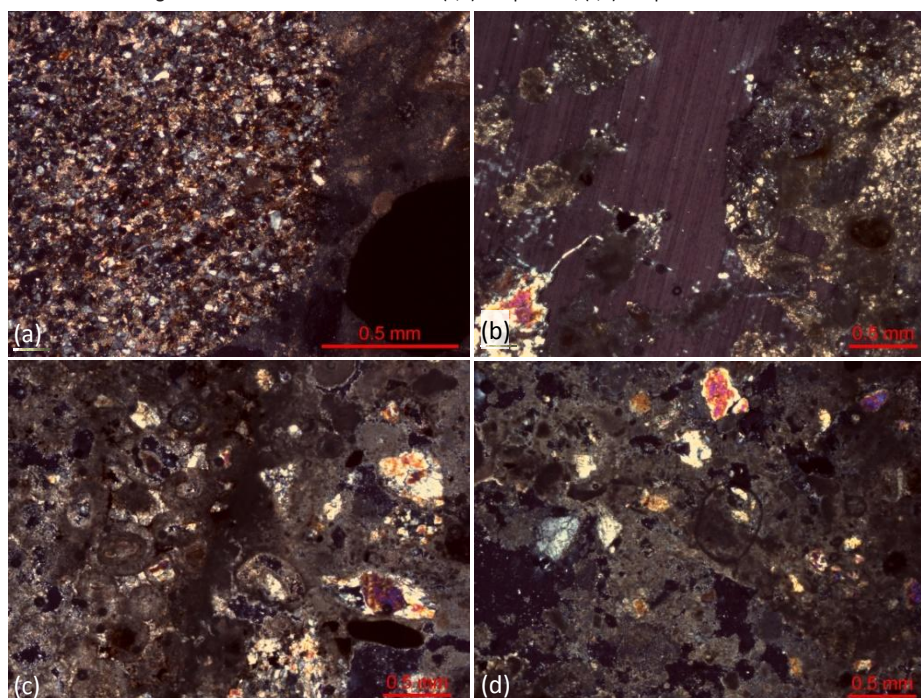
A total of seven samples were found to be suitable for mineralogical analyses (M1a, M1b, M2, M3, M5, M6 and M7). Each was submerged in epoxy, and thin sections were cut once the epoxy had set. The analyses revealed all the different types of aggregate and the minerals contained within the samples, as well as the binder-aggregate relationship and the porosity of the structure (Table 10). A detailed view of samples M1a and M3 are given in Figure 9. The analyses revealed that the aggregate, mineral composition and texture of mortar samples M1a, M1b, M2, M3, M5, M6 and M7 were similar, whereas the samples M3, M5 and M6 contained more coarse-grained aggregated than the other samples.

Figure 9. General view of thin sections: (a,b) Sample M1a, (c,d) Sample M3. Source: Authors.

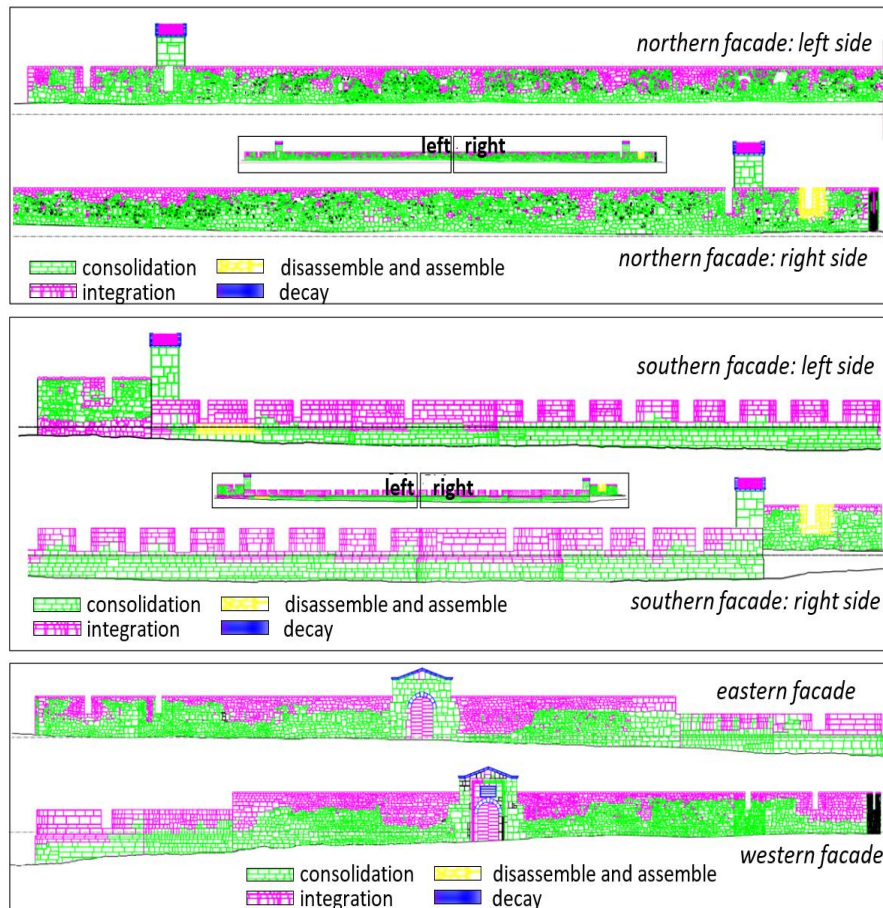
**Figure 10.** The illustrations of applications in the facades. Source: Authors.

The applications were carried out on the based on the material mixture proposals for the castle structure. In this context, the rehabilitation stages at the facades were carried out as consolidation, integration, reconstruction and preservation (Figure 10). The views the during- and after-the rehabilitation applications are given in Figures 11 to 14.

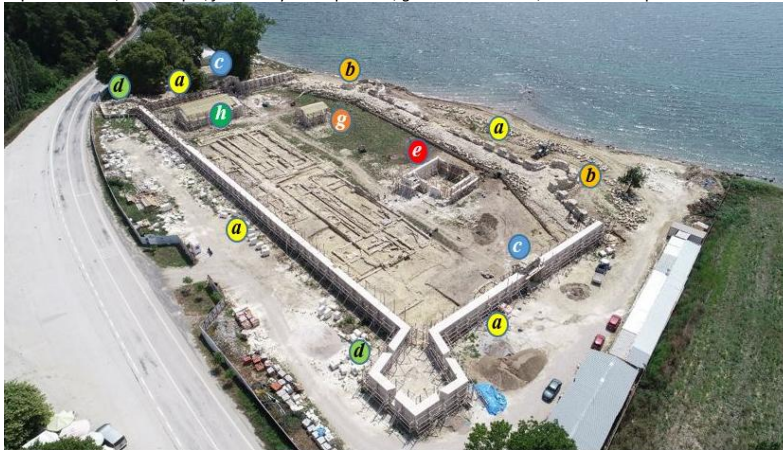
**Figure 11.** The overview of the castle in the rehabilitation applications: *a.* Facades, *b.* Circular towers, *c.* West-entrance, *d.* Square towers, *e.* Mosque, *f.* Military headquarters, *g.* Water fountain, *h.* Arsenal depot. Source: Authors.

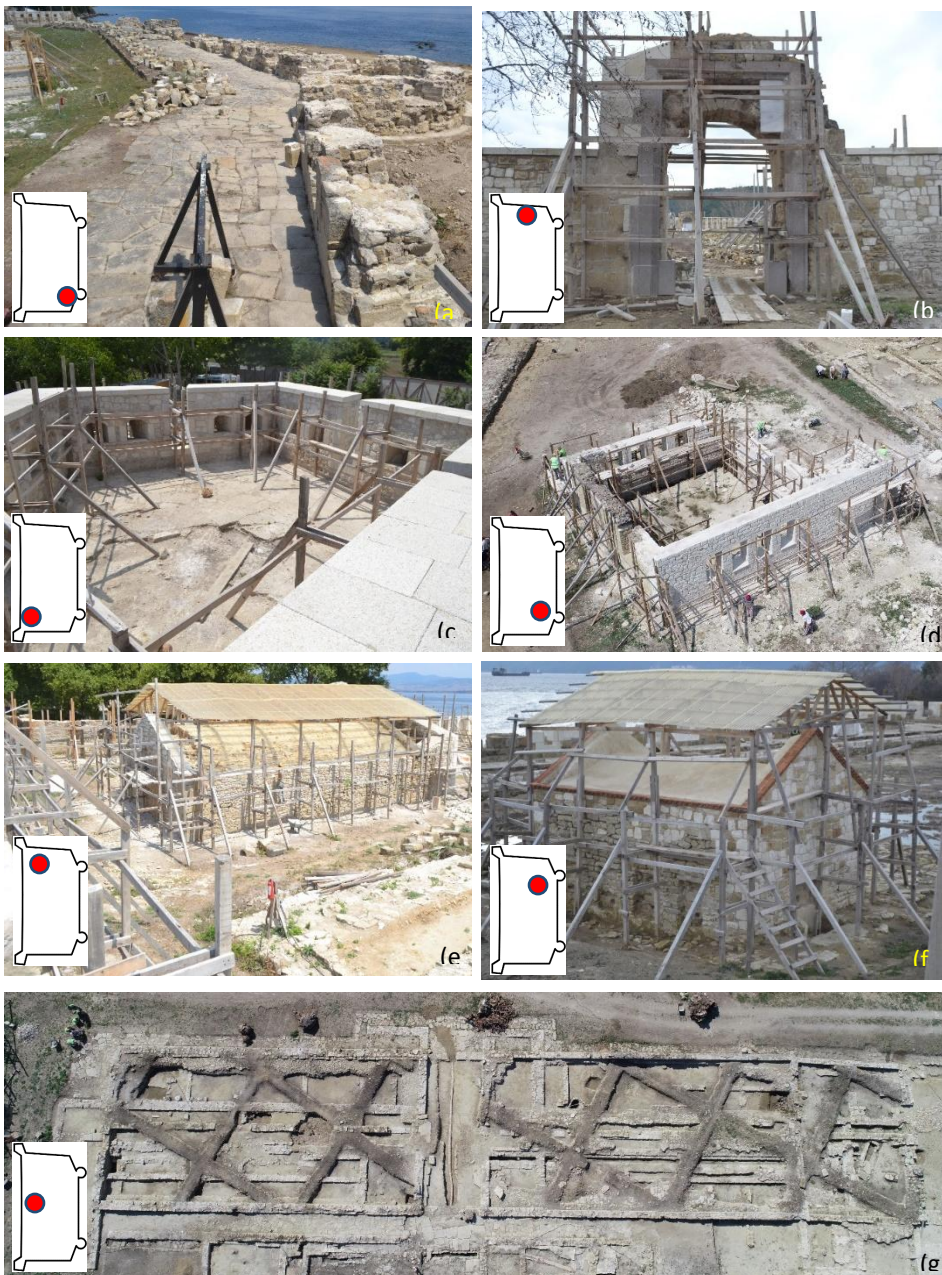
**Figure 12.** The rehabilitation applications in structures of the ruined castle: *a.* Facades and Circular towers, *b.* East-entrance, *c.* Square towers, *d.* Mosque, *e.* Arsenal depot, *f.* Water fountain, *g.* Military headquarters. Source: Authors
