# Overview of the Structural Behavior of Columns, Beams, Floor Slabs and Buildings during the Earthquake of 2016 in Ecuador

## Una mirada al comportamiento estructural de columnas, vigas, entresijos y edificaciones durante el sismo de Ecuador 2016

Ángel Emilio Castañeda <sup>1\*\*\*</sup>, Yordy Mieles Bravo <sup>\*\*\*</sup>

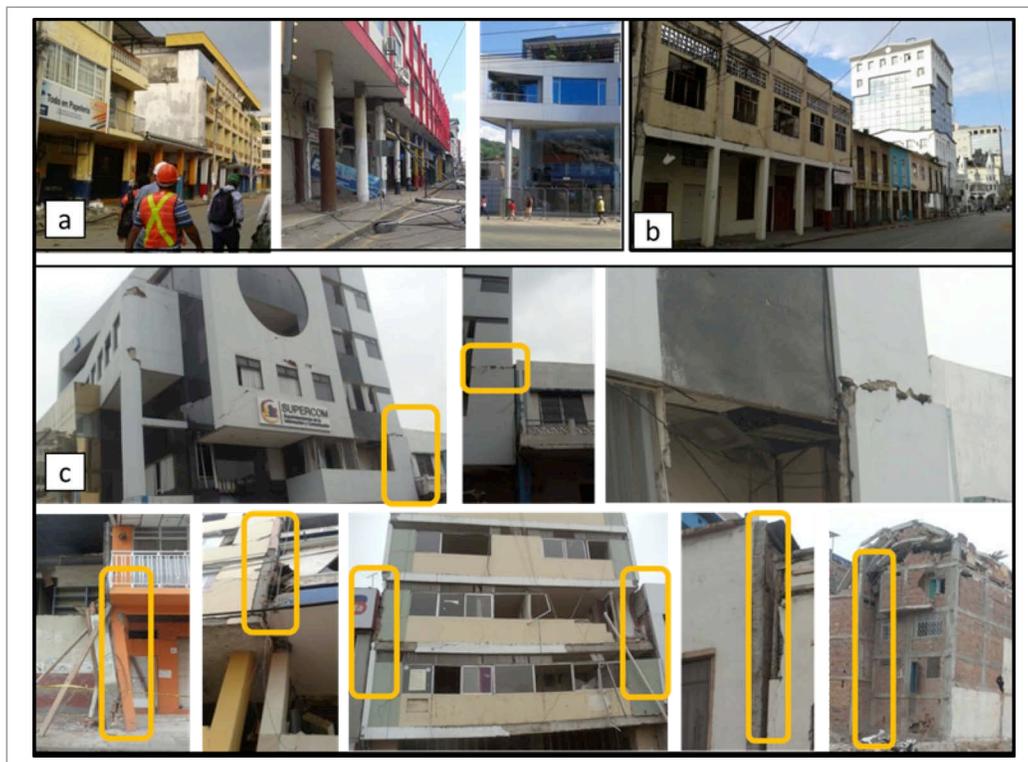
Column failures are usual during an earthquake, and it is an frequent cause of collapse in buildings. The investigated cities gradually modified their columns, introduced new materials and construction technologies, and transformed their regular columns, with similar mass distribution and limited slenderness in low buildings (one or two floors), whose greatest risks were the tapping with adjacent buildings. The modifications consisted in thin and slender columns, irregularly distributed or omitted in the floor plan, with different mass distribution, plus cantilevers and eccentric loading, with a more modern and functional architecture, which demands a greater high-standard engineering and constructive culture, in a high-seismicity region not suitable for these types of construction (Figure 1).

**Figure 1.** a) Changes in column slenderness due to changes in the urban architecture; b) areas with continuous changes in the architecture of the city; c) Pounding damage from adjacent buildings, built in the property limit, in different periods and with diverse typologies

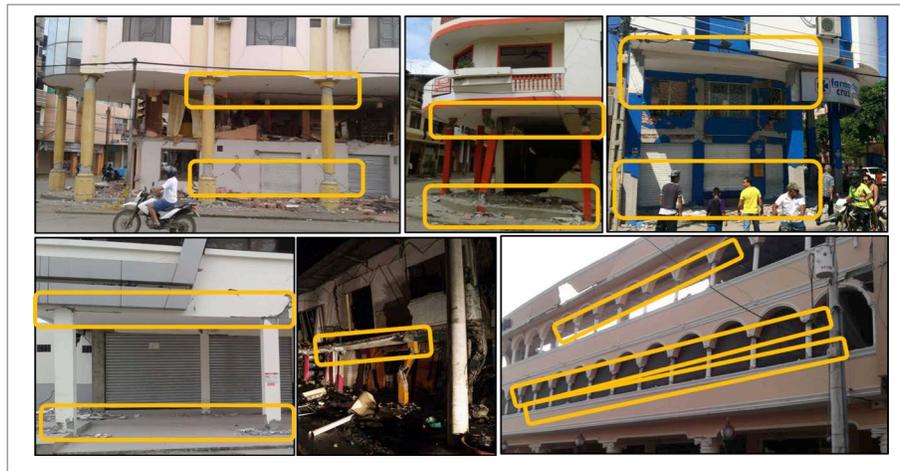
Thus, some buildings, which did not collapse by acceleration fractions, show confinement zones that concentrated shear failures in the column ends (Figure 2); within the expected limits for  $l_0$  in heading 21.4.4.4 of CEC 1993 and  $L_0$  in section a of heading 4.3.4 of NEC SE-HM 2011 and 2015, based on ACI 318S-14, 2014.

Figure 2. Building of the city of Portoviejo showing  $L_0$  zones where shear failure and column confinement are concentrated

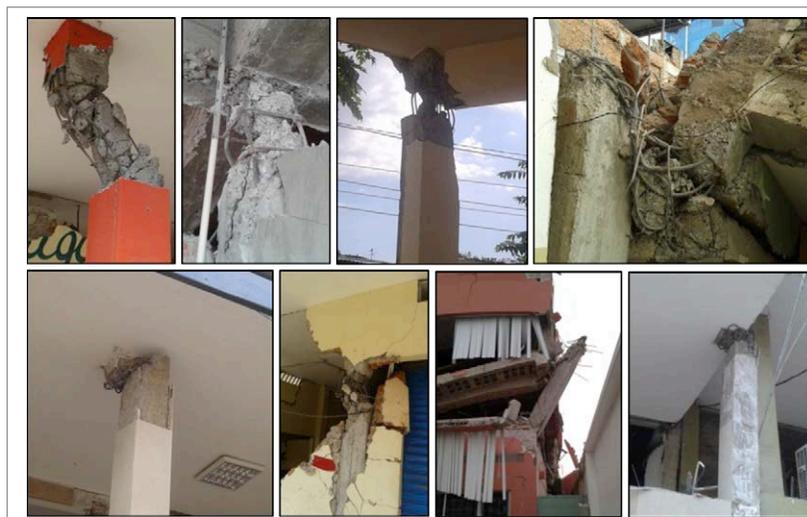
Moreover, in many columns, the stirrups' spacing did not comply with 21.4.4.2 of CEC 1993 nor with section b of 4.3.4 of NEC SE-HM 2011 and 2015. The standard requires a maximum spacing of 70 mm, for 12 mm steel columns or smallest side of 300 mm. Furthermore, the lack of confinement and seismic hooks, due to constructive negligence or non-application of the standard, were the probable cause of several failures, in addition to an insufficient use of spiral reinforcement and enclosure hanging beams that would allow better distributing the seismic drag force, in its interaction with the slabs (Figure 3).

Figure 3. Seismic-related damage was amplified by technological indiscipline, violations of code regulations, and negligence in construction

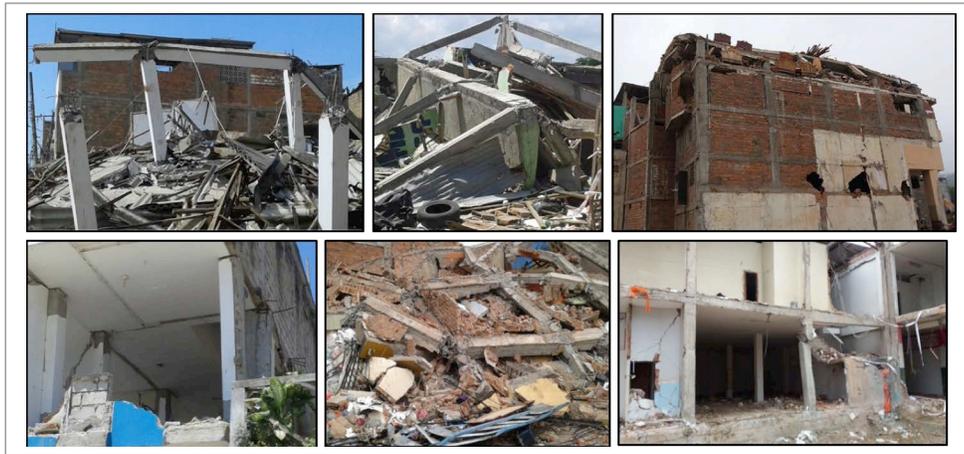
continued and stirrups were not placed in the mid-span of the original spacing. Furthermore, short columns were added (Aguiar, 2010), and columns were designed without a bracing system, thus modifying their dynamic properties while braced to partition walls (López and Espinoza, 2016). Moreover, weak columns with strong beams, together with columns of less than 300 mm and poor steel detail, which did not comply with the established standards either, thereby causing brittle failures (Aguiar, 2008; Blanco, 2012, ACI-318S-14, 2014), were observed (Figures 3 and 4).

Figure 4. Low buildings collapsed by column failures

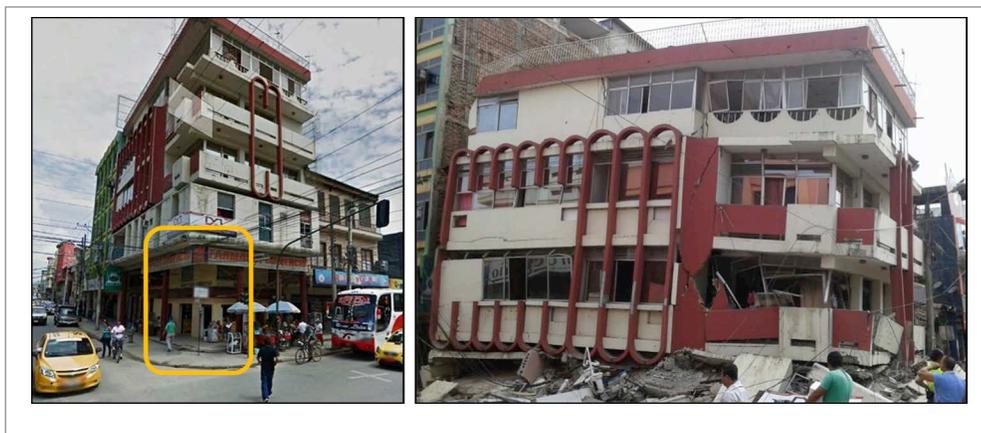
In these cities, another failure cause was the lack of any reinforced-concrete corner columns in the ground floor, for allegedly architectural reasons, but unacceptable from the engineering point of view in such high-seismicity regions (Figures 5 and 6).

Figure 5. Collapsed building in Portoviejo, without corner column in ground floor

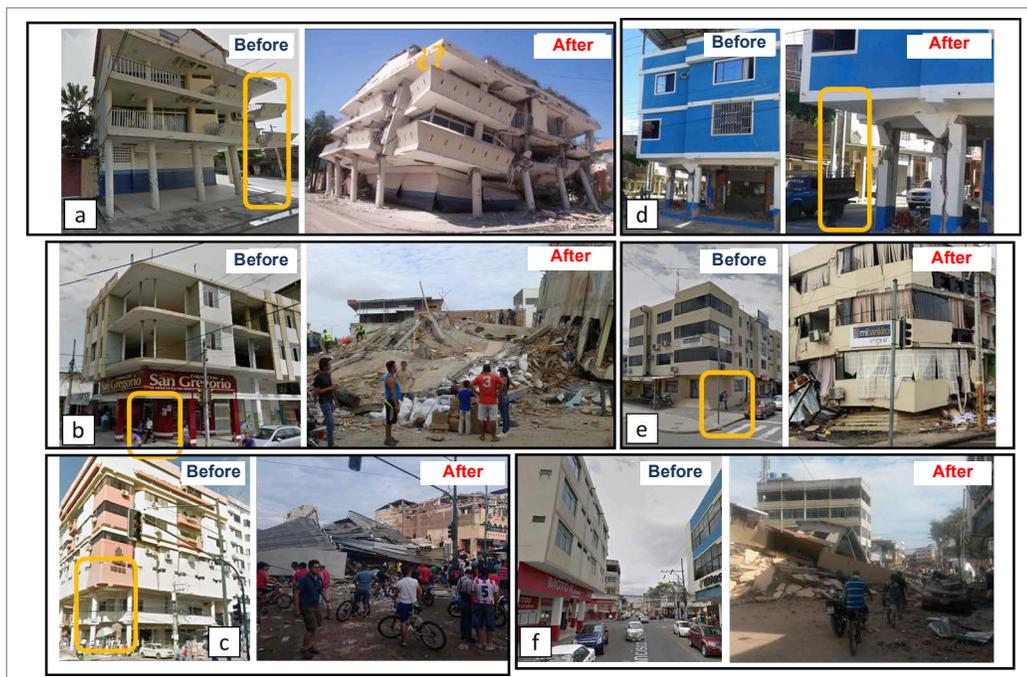
Figure 6 shows several collapsed buildings without corner column in the ground floor. Witnesses of the 6-b building confirmed that they saw its diagonal swing before falling down, a fact that can also be deduced from the photos of the 6-a building. The remaining 6c-6f suffered shear failure and soft floors.

Figure 6. Other collapsed buildings in Portoviejo, without corner column

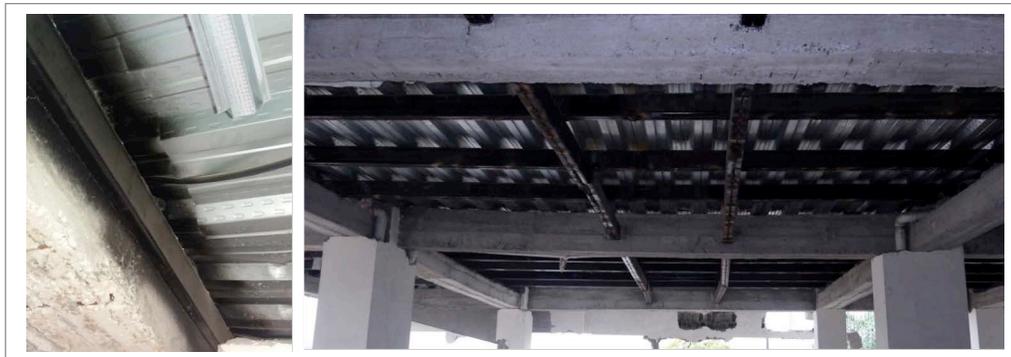
These buildings showed no slab swelling caused by loss of stability in their plan, and the loss of local stability in steel beams and steel decks was reduced (Figure 8).

Figure 8. Local failure by buckling of steel decks and steel beams

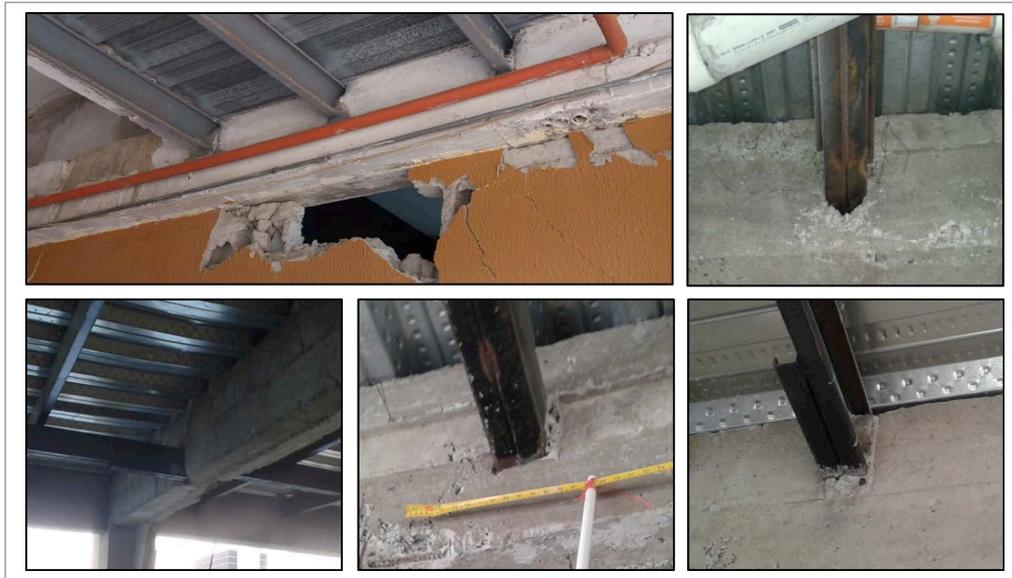
There were multiple evidences of displacement or rotation of the steel beams in the "hybrid nodes" with the reinforced concrete beams (dowel effect) (Figure 9), which showed very small damages and good energy dissipation during the earthquake (Perea, Mora and León, 2014).

**Figure 9.** Evidence of displacements of steel beams in the hybrid nodes

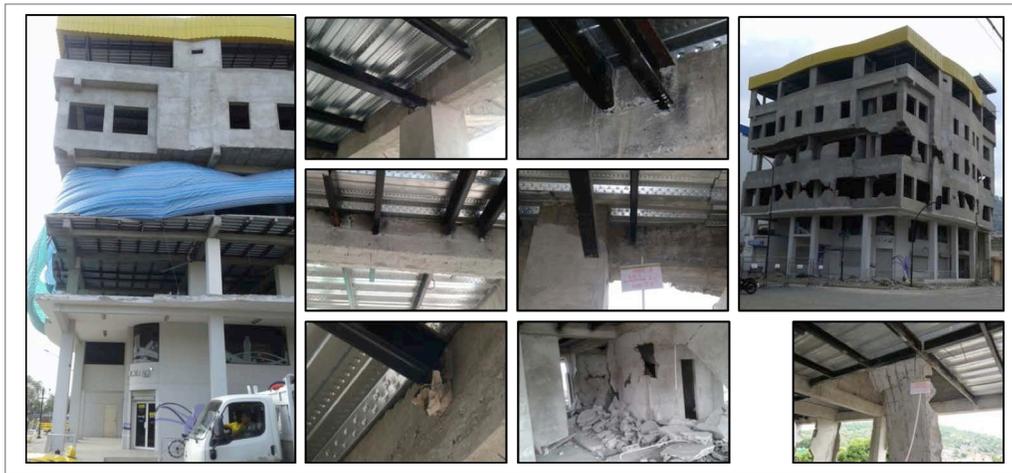
Buildings in progress (without their whole gravity load) and with severe constructive irregularities, did not collapse (Figure 10). They just showed buckling and deflection of some steel beams, which are easily replaced by shear and welding.

**Figure 10.** Building in progress, with constructive irregularities, not collapsed during earthquake

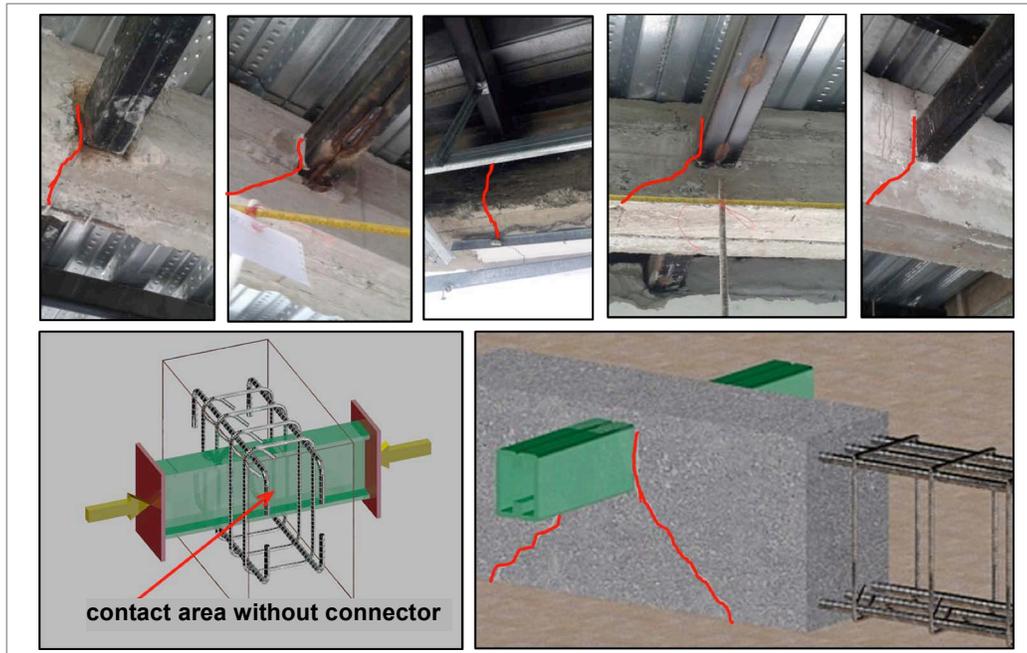
Figure 11 shows the cracking patterns in the hybrid nodes of primary beams. They initiate at the contact interface between one steel beam face and the bonded concrete, and they spread  $45^\circ$  towards the tension zone, or perpendicular to the steel beam. Moreover, cracks appear in the bended side and center of the spans, from the neutral axis to the lower part of the concrete beam at an angle of  $45^\circ$  or  $90^\circ$ , while in areas close to the support, shear cracks are extended from the neutral fiber to the upper edge of the concrete beam (Mieles and Castañeda, 2016c).

These patterns confirm the dowel effect through hybrid nodes (Figure 9 and 11) and the presence of geometric and load discontinuities with stress concentrations in both elements, which create a D region (ACI-318S-14, 2014; Schlaich, Schäfer and Jennewein, 1987). Where the hypothesis of flat sections does not apply to the design, because in this region, the principles of compatible deformation nor the corresponding force balance, are not satisfied (ACI-318S-14, 2014). Modeling of these nodes by the Finite Element Method (FEM) shows a qualitative change in the isostatic network of the trajectories of internal stresses in the hybrid node of the concrete beam (Mieles and Castañeda, 2016a), which turns the issue of spatial layout and physical-mechanical behavior model of the node into a pertinent and current research subject.

**Figure 11.** Checking and crack patterns observed in the nodes area

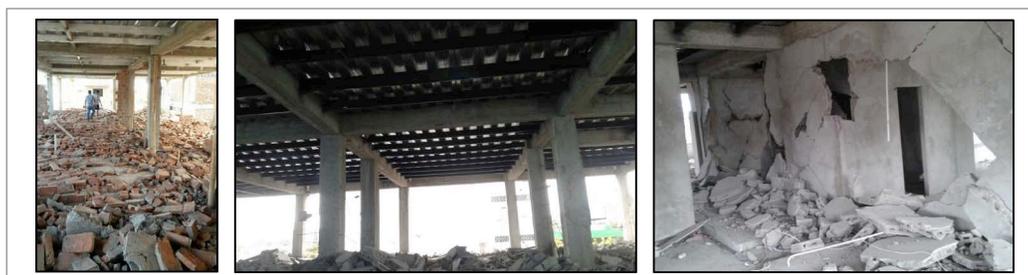
However, failures in RC rigid frame buildings with steel-deck slabs were often caused by the absence of structural walls for reducing the flexibility of the frames and the floor drift. This caused non-structural walls (spandrels and partition walls) to suffer unacceptable displacements and massive collapse under horizontal load, which, according to the modeling, should have been supported by the columns (Figure 13).

**Figure 13.** Rigid frames and steel deck slabs without structural walls

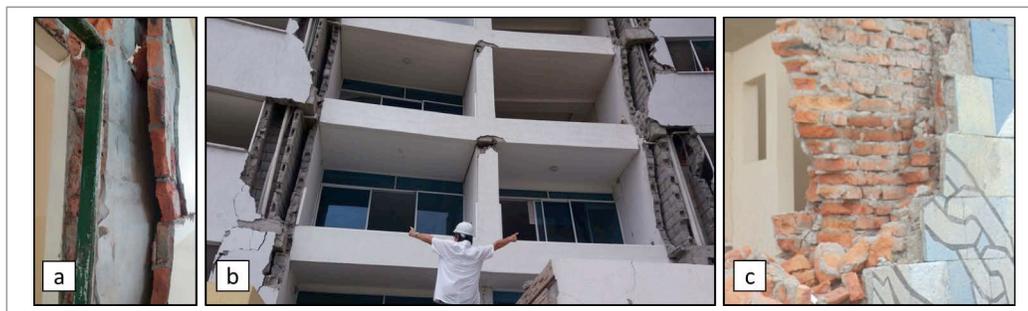
A number of rigid frame buildings without structural walls had block rectangular boxes for service facilities (electrical, hydraulic, etc.) close to other partition walls, thus creating areas with high geometrical stiffness, without physical-mechanical stiffness to support horizontal loads. Therefore, when the IFD occurred, they attracted load for which they were not designed, thus increasing the deformation damage in the building without affecting the rigid frame (Figure 15-b). Figures 15-a and 15-c show other cases of double walls that attracted horizontal loads and caused the failure.

Figure 15. Duplication of walls and vertical ducts with high geometrical stiffness create false diaphragms that attract horizontal loads without having the physical-mechanical capacity to support them

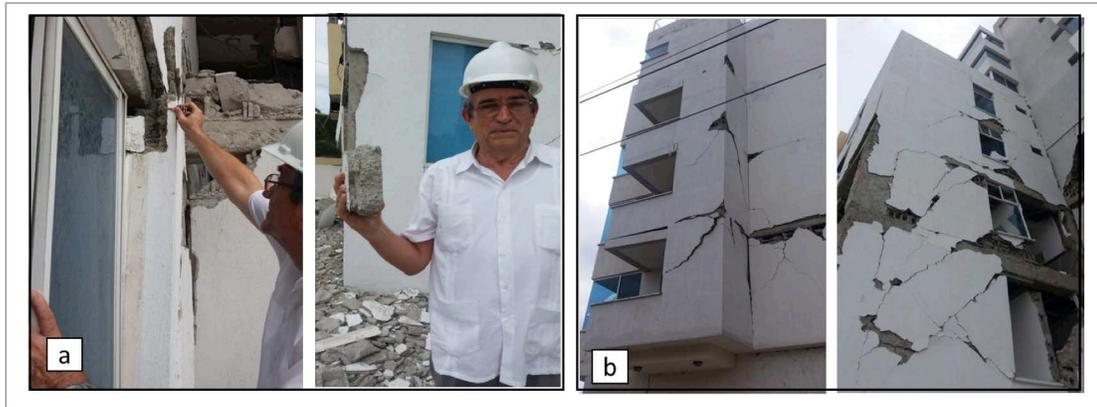
The excess of plaster (6 to 9.5 cm) caused other failures in buildings with steel-deck slabs and rigid frames without structural walls, which created sandwich walls of 30 cm thick that attracted seismic loads that were not considered in their physical-mechanical design (Figure 16-a).

A plaster sample showed increases of 112 kg/m<sup>2</sup> per face, transforming the block wall into a wall of 300 kg/m<sup>2</sup>, sometimes with no continuity in the ground floor. This caused beam failure, because the load was triplicated and the mass hanging from the cantilevers increased, thus evidencing shear in upper floors that they could not resist (Figure 16-b), and

**Figure 16.** High plaster thickness generated sandwich walls and attracted seismic load that they could not resist

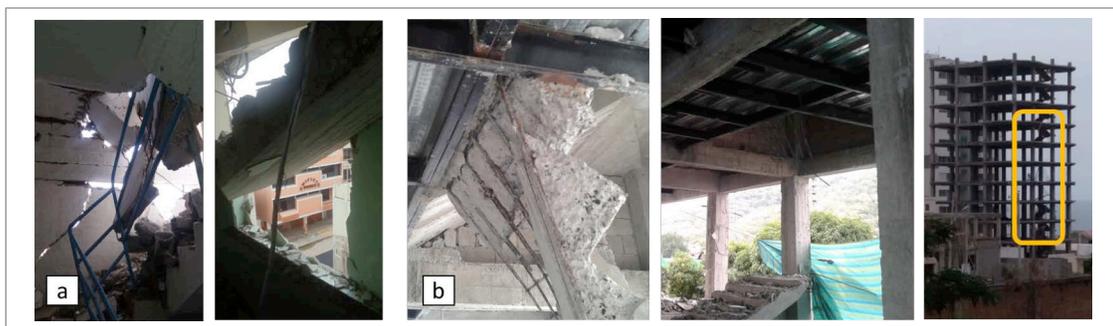
**Figure 17.** Inadequate conception of the stairs anchorage and their location in non-structural "boxes"

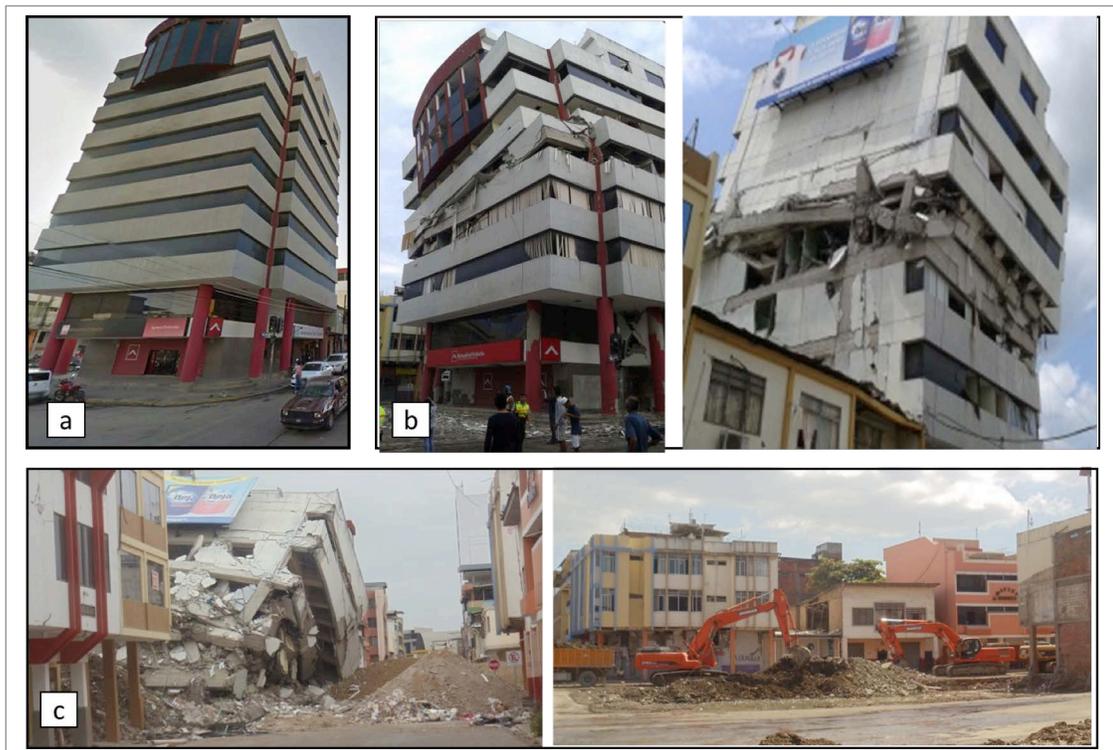
**Figure 18.** Beginning and end of a building damaged by the earthquake of April 16, 2016, which took along many lessons that could have been useful to the engineering field

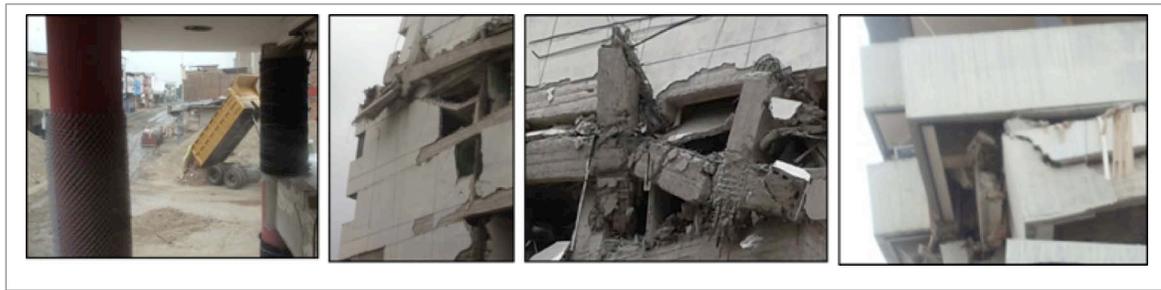
One look at the building allows identifying short columns; weak columns together with string beams (NEC-SE-RE, 2015); and high beams with  $l/d=4$  ratios associated to a possible shear failure (NEC-SE-HM, 2015) (Figure 21).

Figure 21. Short columns and weak columns facing strong beams

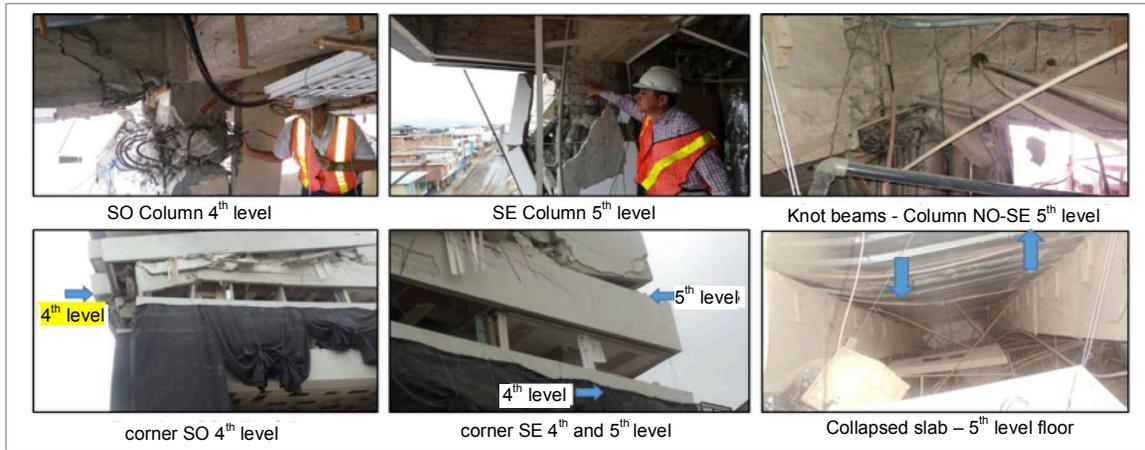
The Technical University of Manabí revealed images of the 4<sup>th</sup> and 5<sup>th</sup> level of the building, where columns resisted the fall of the upper floors without an immediate collapse. They also show shear failures in the RC short columns and the effect on the longitudinal long beams, thus turning the plan of upper floors into the surface of a hyperbolic paraboloid over two crossed straight lines. This is consistent with the hypothesis of horizontal and vertical shear in the floor slabs of the 6<sup>th</sup> and 7<sup>th</sup> level during the earthquake (Figure 23).

**Figure 23.** Columns and beams of the 4<sup>th</sup> and 5<sup>th</sup> level

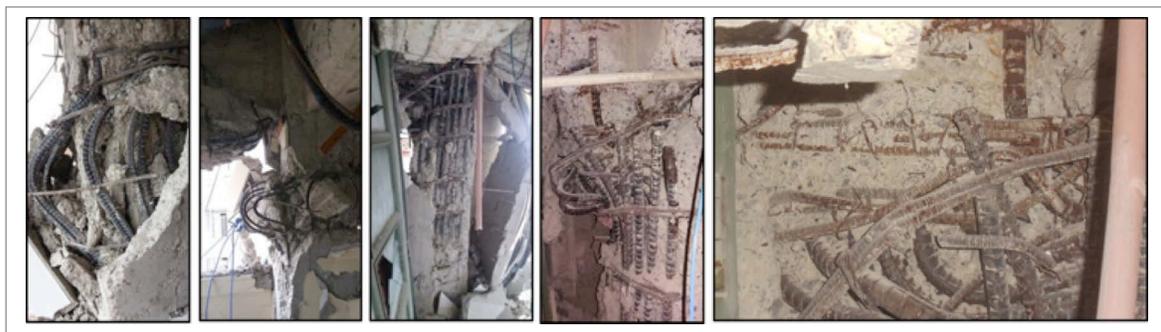
Additionally, the floors' impact on the columns caused a stability loss of longitudinal reinforcing steels and horizontal tensile strength by Poisson effect, which opened stirrups and revealed irregularities during the building construction. For example, overlapping of longitudinal bars in the same section,

too much spacing between stirrups, and absence of confinement nucleus in areas with large amount of longitudinal elements, as standards require (paragraph 10.4 of ACI 314R-11) (Figure 24).

**Figure 24.** Irregularities revealed by the earthquake in the construction of the building

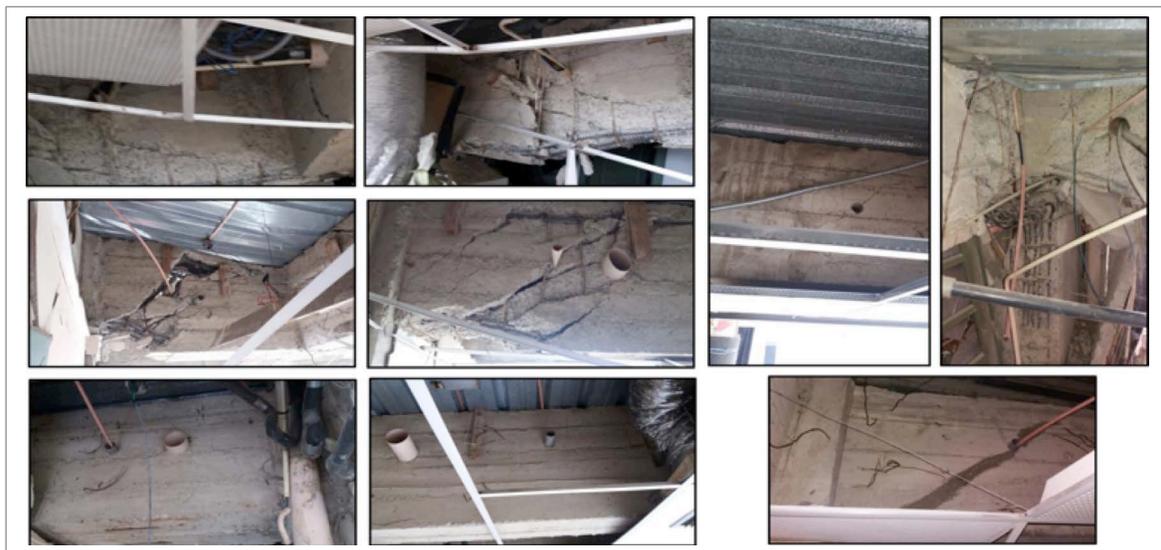
The influence of the ducts' size and position in RC I-beams as a failure hypothesis, concealed ever since the construction of the building, is an issue that revives with the photos revealing multiple inclined cracks that cross or are born in ducts located at places not complying with the standards. There are even traces of repairs before the earthquake, which may be related to the overall failure of the building and will remain within the hypotheses that this "overview" was unable to find out (Figure 25).

**Figure 25.** Inclined cracks crossing the ducts in I-beams
