Diagnosis of degradation state through non-destructive tests: case study of the public building of federal education institution

Abstract

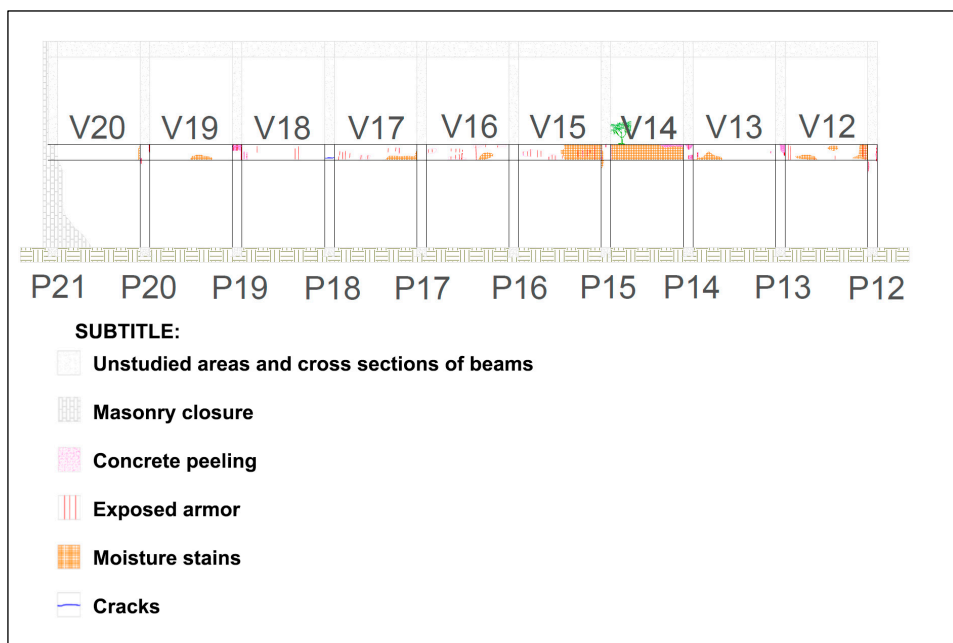
In the selected area, the damage map of slabs, beams and pillars was demarcated (Figure 4).

Figure 4. East facade damage map

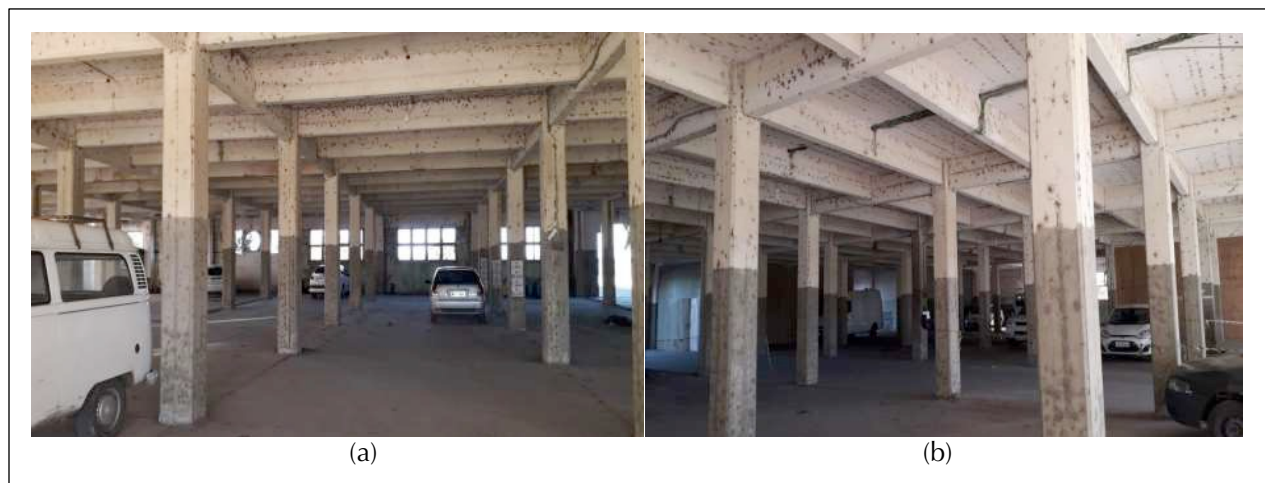
The damage map allowed a clear and objective visualization of pathological manifestations existing scenario, providing a powerful instrument of conservation evaluation. In addition, the damage map helped to select elements of sclerometry tests execution, coverings measurement and carbonation and chloride verification. For further evaluation, the elements with higher and lower degradation percentage were clear observed. Apparent pathological manifestations were not observed in internal pillars and beams. However, dirt was present in all building elements as can be seen in (Figure 5a) and (Figure 5b).

Figure 5. (a) Dirt - North Facade. (b) Dirt - South Facade

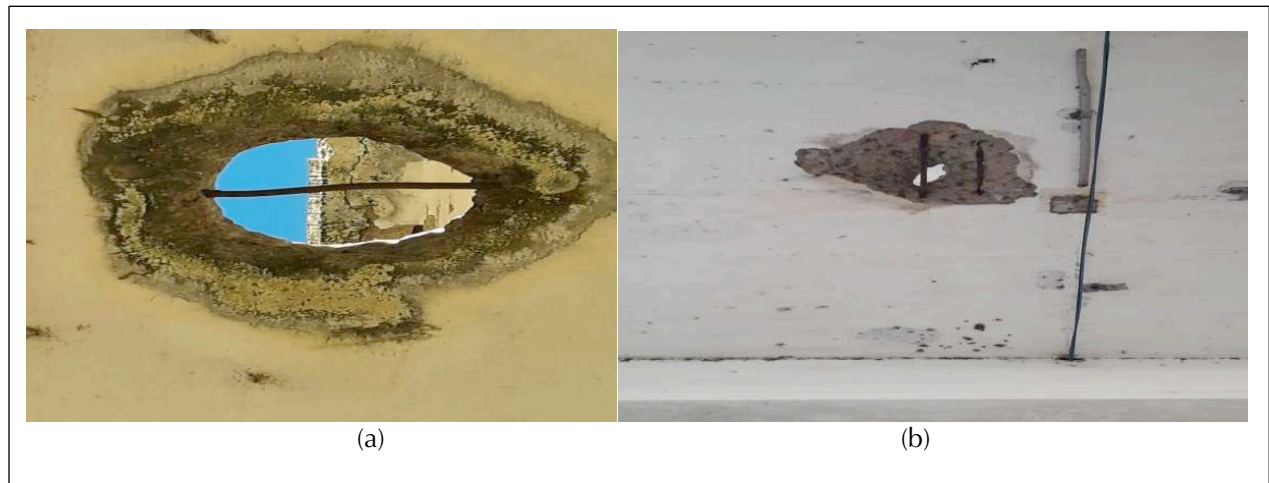
The most representative pathological manifestations in the slabs on the first floor are concrete displacements with the exposed reinforcement shown in (Figure 6a) and (Figure 6b). In addition, mold stains near the metal tubes placed near the slabs.

Figure 6. (a) Opening the slab. (b) Slab with peeling and exposed reinforcement

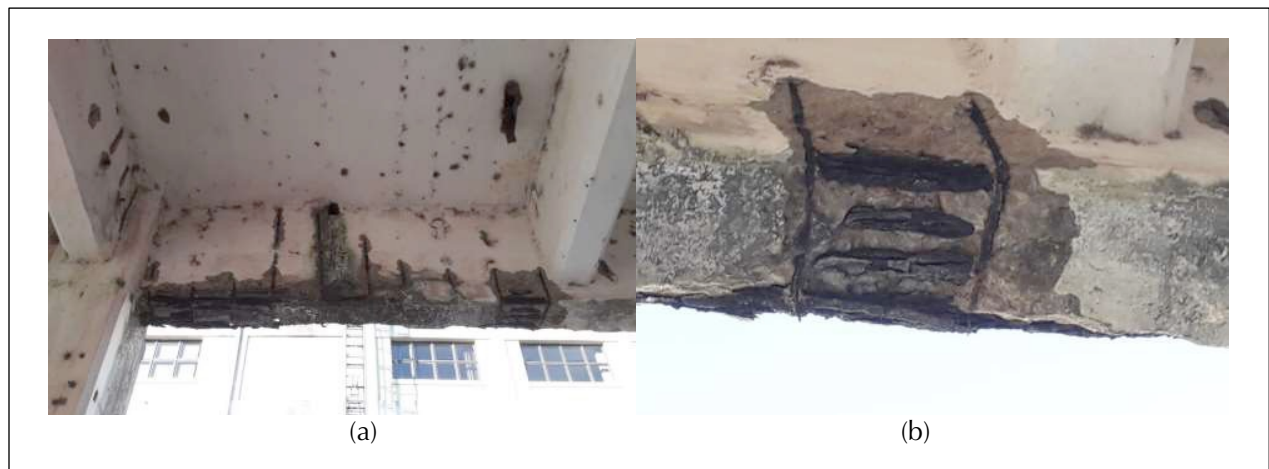
The highest pathological manifestations were identified in the perimeter pillars and beams. Moisture stains, concrete detachment, exposure, and reinforcements corrosion, some at a high degradation level can be seen in (Figure 7a) and (Figure 7b).

Figure 7. (a) Beam armature exposure and mold stains. (b) Beam with concrete detachment and corrosion and exposure of reinforcements

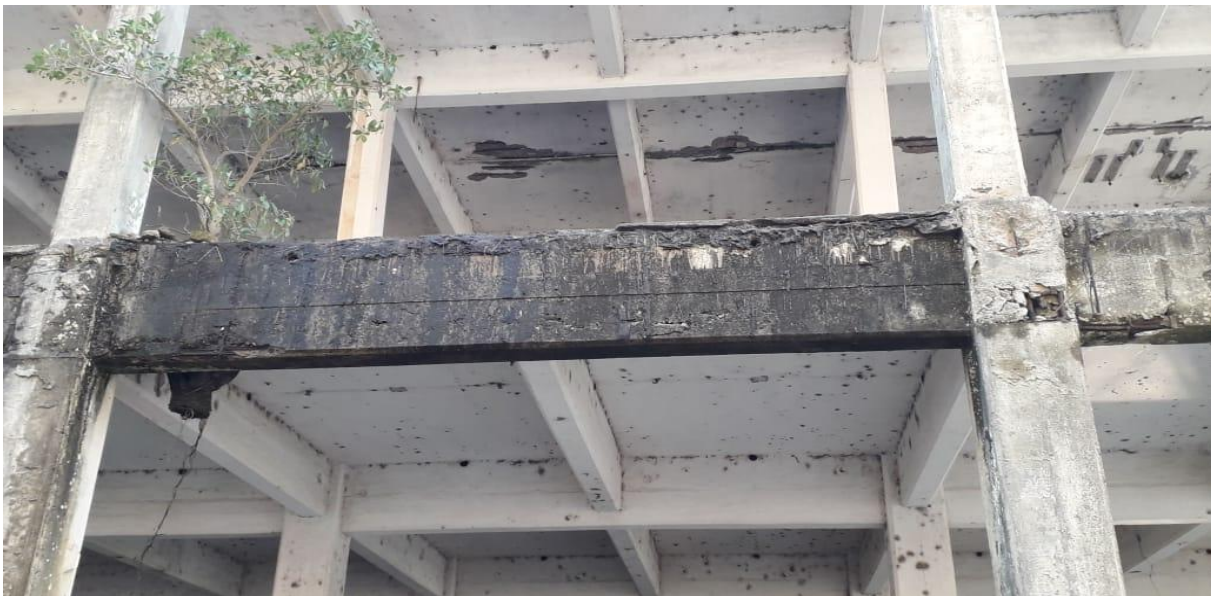
Figure 9a. V14

As presented in (Figure 8), there are some peak of surface degradation of elements in beams V14 and V15 (Figure 9a) and (Figure 9b) on East face, due to moisture spots reaching 88% and almost 60% of total faces area affected beams. Both are located on East facade, and they are the most affected by pathological manifestations, probably due to the sun exposure period of shortened by shadow of the neighboring building. These peaks are linked to plant formation in V14, which concentrates moisture in its roots, seeking or creating flaws in concrete, increasing susceptibility to pathological manifestations caused by moisture. Pillars of East facade did not present moisture stains. However, they are concentrated in South and West faces in view of the lowest sun exposure. Detachment was the pathological manifestations most found in the pillars of the East facade. Some points of armor exposure were found, mostly, in the upper part of the column, at the height of the beam, possibly by concentrations of stresses in these regions added to the thermal variations. This factor is subjected to the facades of longer sun exposure periods.

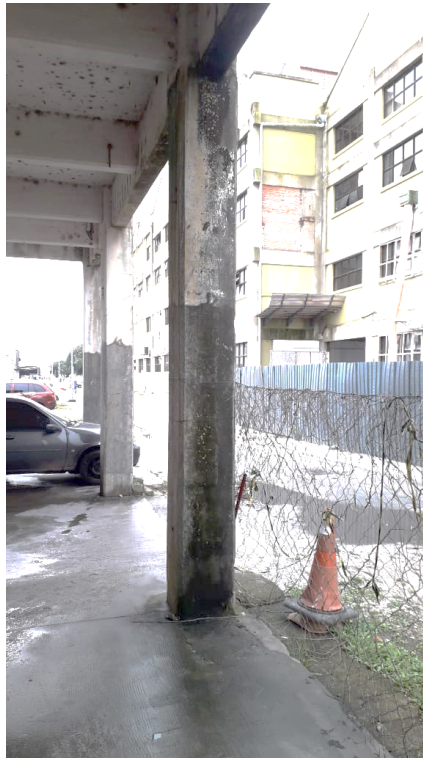
Figure 11. P14

Surface degradation percentages of West face is shown in (Figure 16). Pillar P14 presented the highest percentage of degradation, 29% of degraded in East face. In addition, V14 (Figure 17) presented 20% of percentage of detachment area. This fact was attributed to failures in the material due to the accumulation of moisture and degrading agents. All aspects evidence moisture coming from the interior of the beam reached the pillars as can be seen in beam V14 (Figure 9a) with the present of plant. Moisture stain on pillar P15 (Figure 13), which is connected to P14 (Figure 11) by V14 was observed.

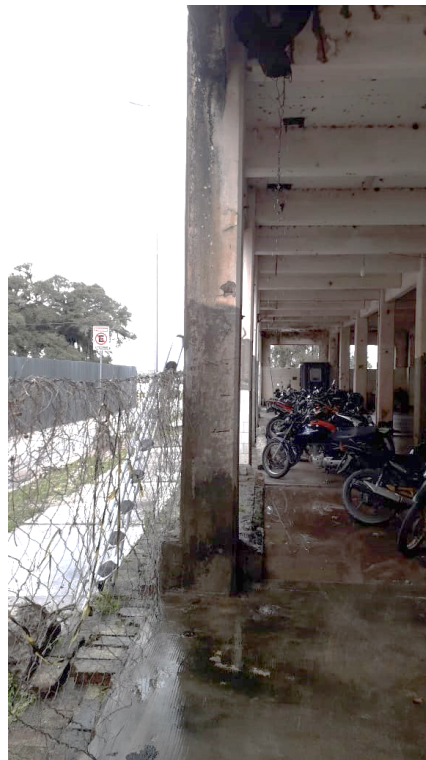
Figure 13. P15

(Figure 12) shows moisture degradation in North face. Only on the pillars of East facade presented a peak of surface degradation of elements in P15 column (Figure 13) presenting 46% surface degradation area. Among the pillars of the North facade with greater sun exposure, none presented moisture stains. Only detachment and exposed reinforcement were observed in two pillars (Figure 14). On the North face of the pillars located at East facade, moisture stains were found as in P15 (Figure 15), evidencing the shadow period is sufficient to facilitate pathological manifestations mechanisms. The sun exposure favored the facade beams and the absence of moisture stains in North

face of the pillars. The elements presented concrete detachment and exposed reinforcements areas due to the absorbed stresses, resulting in material deformation from temperature variations, carbonation, and chloride occurrence, and adequate nominal cover lack.

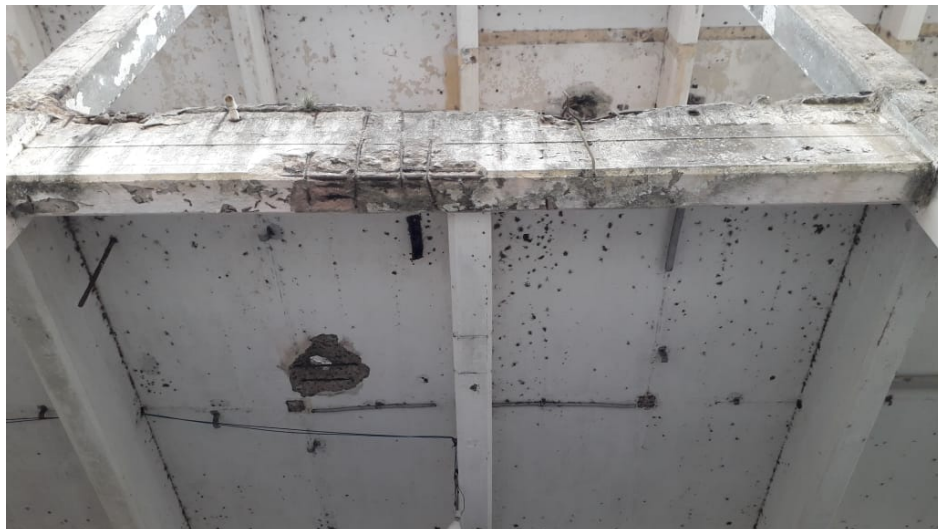
Figure 19. V15.

Considering the twenty beams, six of them have an index higher than 50%, adding moisture, exposed armor, and detachment area, especially V2 and V5, in addition to V15, presenting 34% of its lower area (Figure 19).

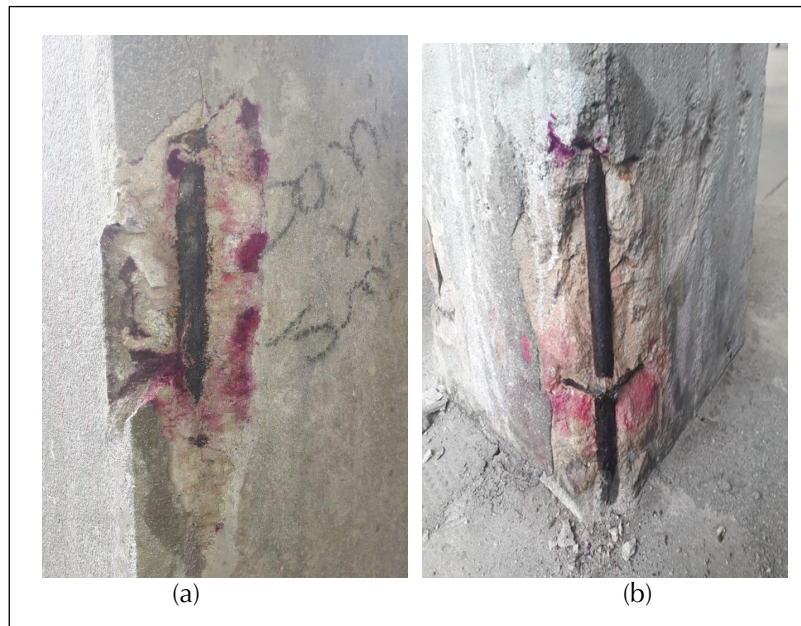
(Figure 32a) and (Figure 32b) show the existence of carbonation in all five pieces tested, including around the reinforcements.

Figure 32. (a) Carbonization test near the vertical center of the column. (b) Carbonization test at the base of the column

Comparing the results with those obtained by (Canteiro et al., 2019) in building built at the same time and belonging to the same industrial complex, carbonation was observed only in some specific regions. Differently from the results obtained in “Paliteiro”, (Ferreira et al., 2019) and (Nicolini et al., 2019) conducted the carbonation depths in specimens exposed on the second floor of “Paliteiro”, proving the occurrence of this phenomenon in all specimens. Currently, the building is used as parking with daily traffic of vehicles, exposing the structural parts to the high concentration of carbon dioxide (CO_2), which may be contributing to the parts of the structure are carbonated. In addition, the absence of sealing masonry on two of the four facades and roofing, as well as the lack of maintenance, may also be collaborating.

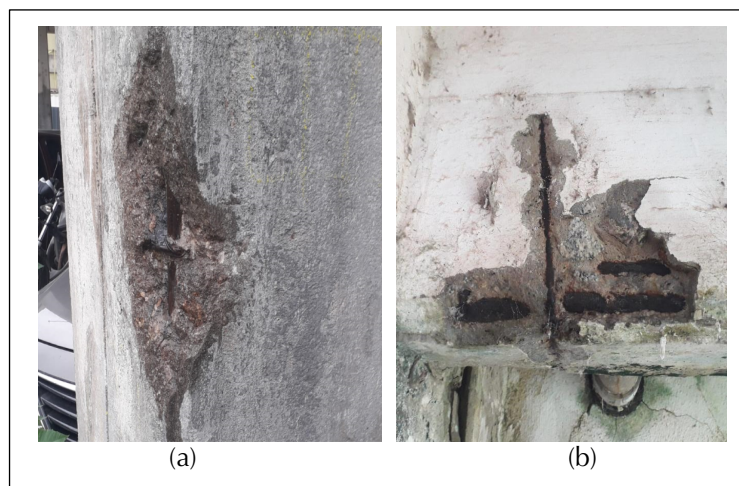
In the chloride penetration assay, chlorides presence was confirmed (Figure 33a) and (Figure 33b). Comparing the results to those obtained in (Canteiro et al., 2019), which the presence of chlorides in beams with exposed reinforcement, the sealing with masonry and the coverage of the building hindered the action of chlorides. In the situation of lack of coverage and sealing, the results obtained by (Teixeira, 2019) and (Ferreira et al., 2019) confirmed the presence of chlorides in the environment of “Paliteiro”. The action of chlorides presents its mechanisms facilitated in this building with the long period of exposure to weather and its location on the banks of a canal combined with the high rates of relative humidity of the air in Pelotas.

Figure 33. (a) Application of silver nitrate in the abutment stripped area. (b) Silver nitrate applied in abutment peeling
