Quality pathology assessment in historic buildings – case of the “basilica and convent of San Francisco”

* Universidad Nacional de Ingeniería, Lima, PERU

Keywords: Pathologies; historic buildings; quality; visual inspection; Pareto chart

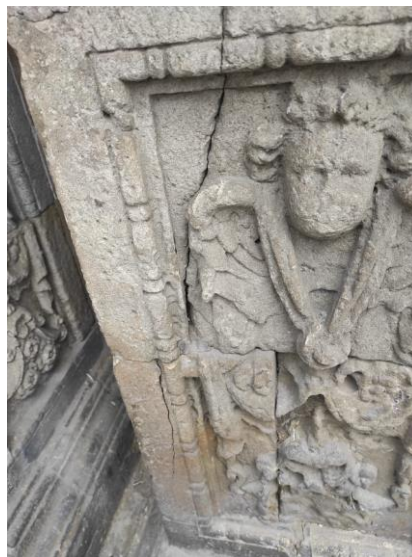
Figure 2. Crack detection (medium)
 Source: Self-prepared Source: Self-prepared

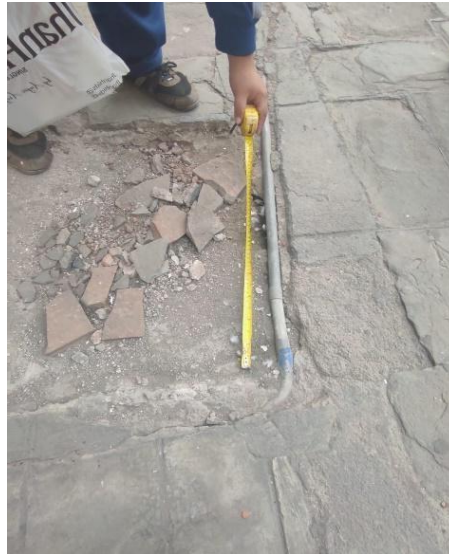
Figure 3. Hole in the project (large)
Source: Self-prepared
