# Identification of a steel stairs by operational vibration measurement

## Identificación de una escalera de acero por mediciones de vibración operacional

M. Campos <sup>1\*</sup>, C. Martins \*, R. Fonseca \*

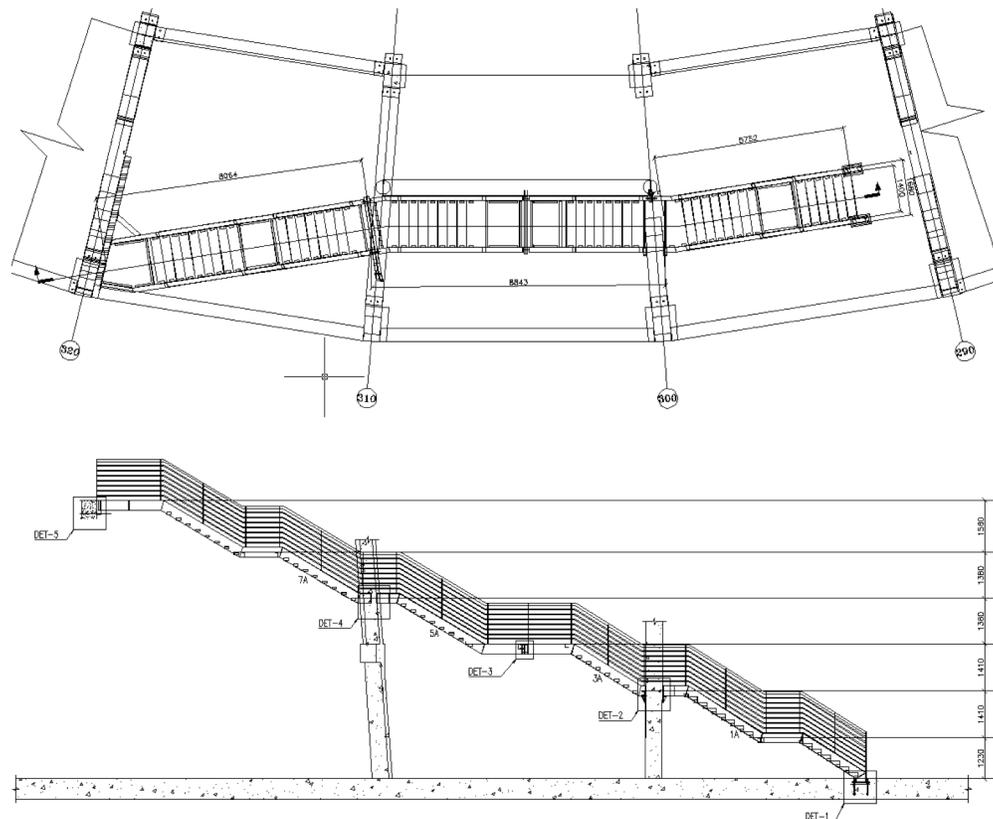
The stair tested has its steps composed by steel plates with 6.30 mm thickness. These ones are supported by lateral beams with double 2C300x140x4.75 section. The stair is anchored in the existing concrete structure by means of anchors bolts of varying diameters and lengths. (Figure 1) shows a draft of the geometry. (Figure 2) shows front and bottom view while (Figure 3) shows existing connections. (Table 1) describes the main mechanical characteristics of the materials composing the structure.

Figure 1. Draft of structure (mm)

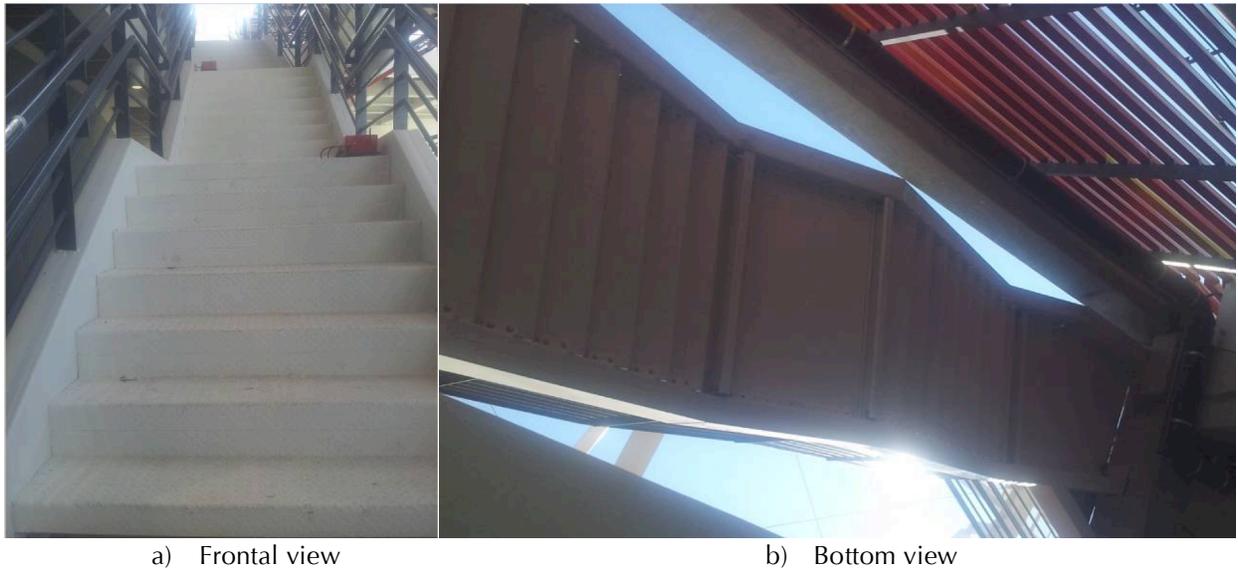
**Figure 2.** View of structure

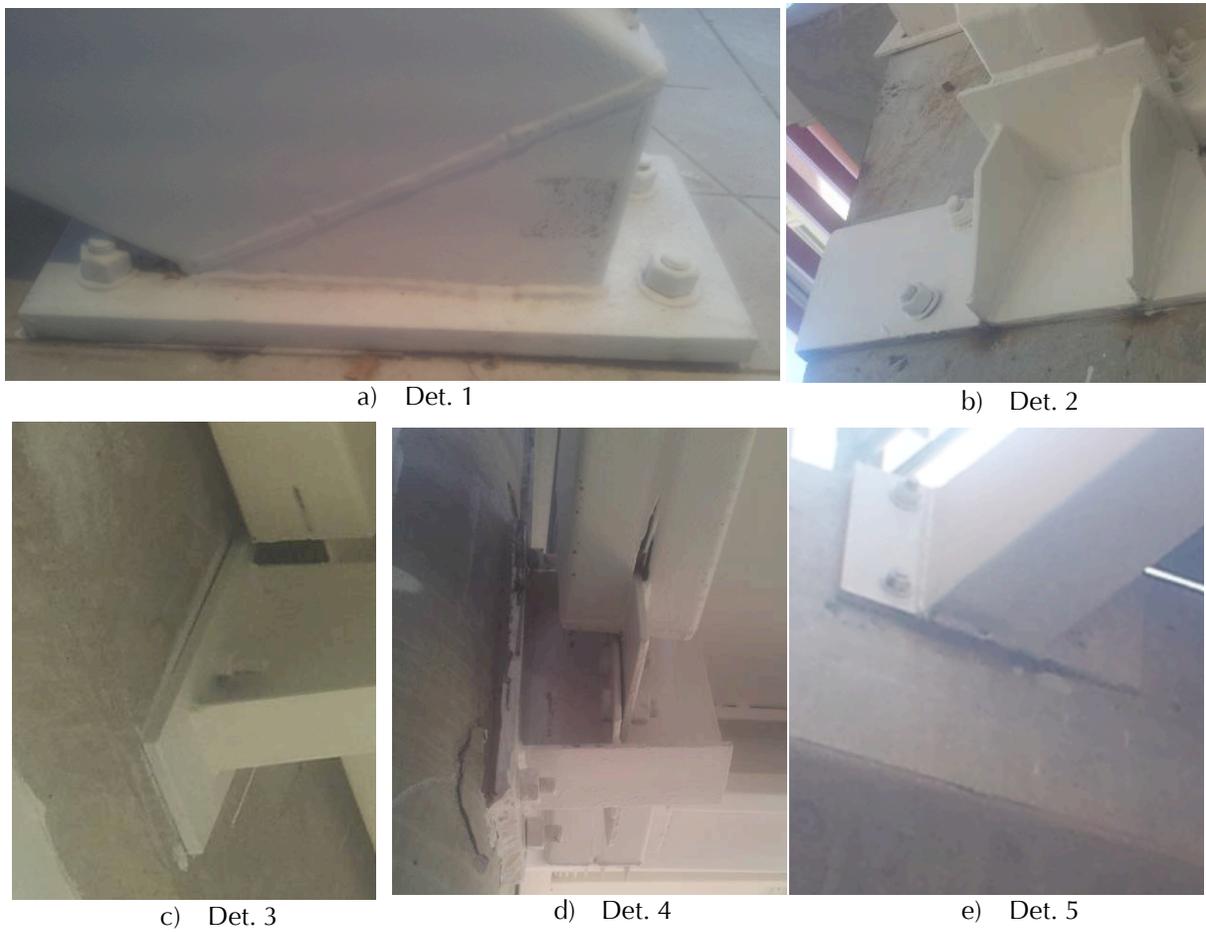
**Figure 3.** Restraints of structure

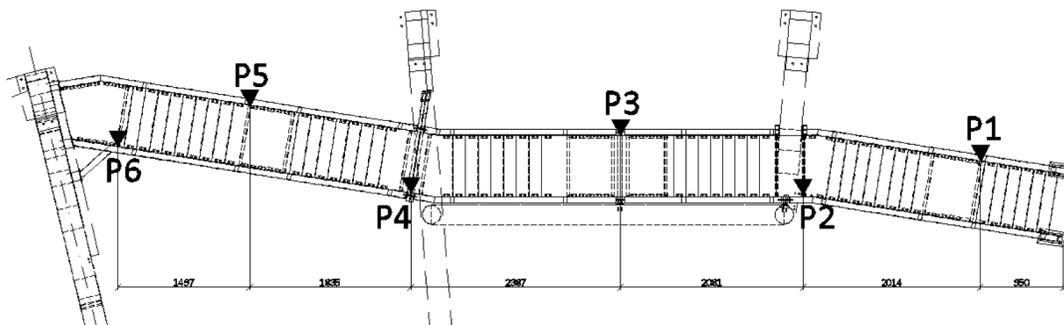
The equipment used to perform the field measurements was the SYSCOM MR3000C which has a wide acquisition frequency range, capable of fully covering the test requirements. It is composed of a 24-bit acquisition system and integrated highly sensitive triaxial accelerometers (1.5 V/g). It was positioned in 6 points (P1 to P6) over structure (Figure 4), selected for capturing as many possible modes. The data acquisition rate was 200 Hz. Each measurement had duration of 1 hour, totalling 6 hours of vibrations recording.

**Figure 4.** Modal test setup

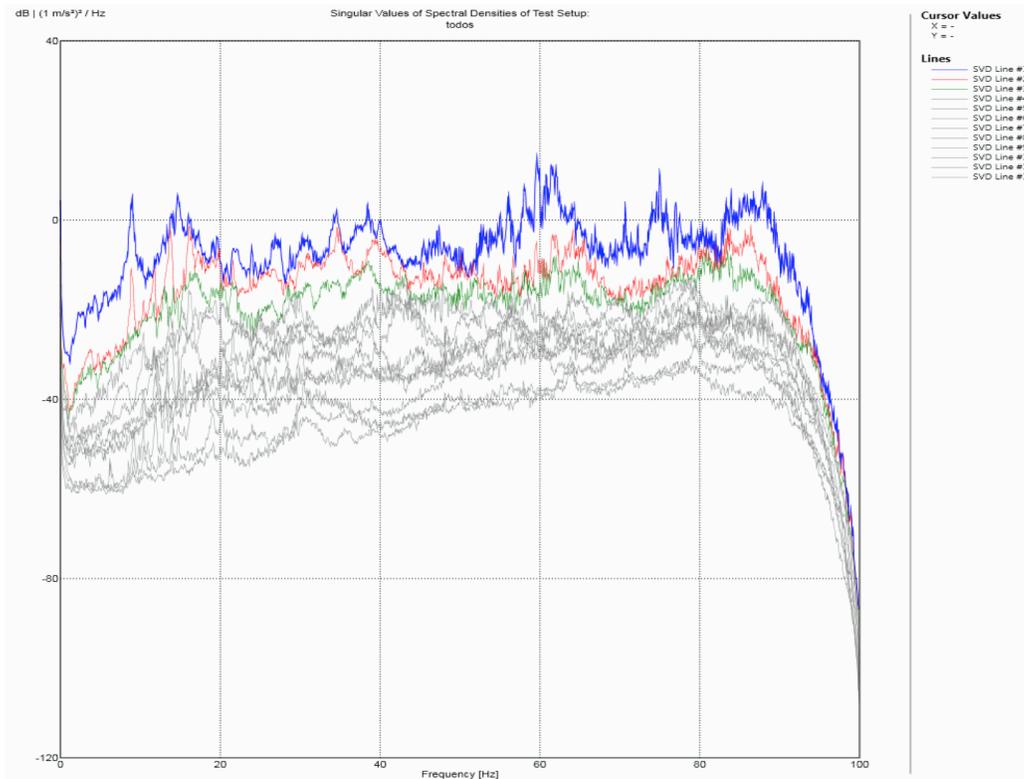
The measures of accelerations captured along structure were processed using stochastic signal process procedure based on frequency domain decomposition (FDD). The processing considered several options for FDD parameters related to resolution, standard deviation, among others, which were omitted due to the large number of analyzes performed. For this activity, the ARTeMISv3.0 software was adopted. (Figure 5) shows the main singular values of the spectral density matrix. Modal parameters of the structure, obtained from data processing, are presented in (Table 2).

Figure 5. Single value decomposition of recorded signals

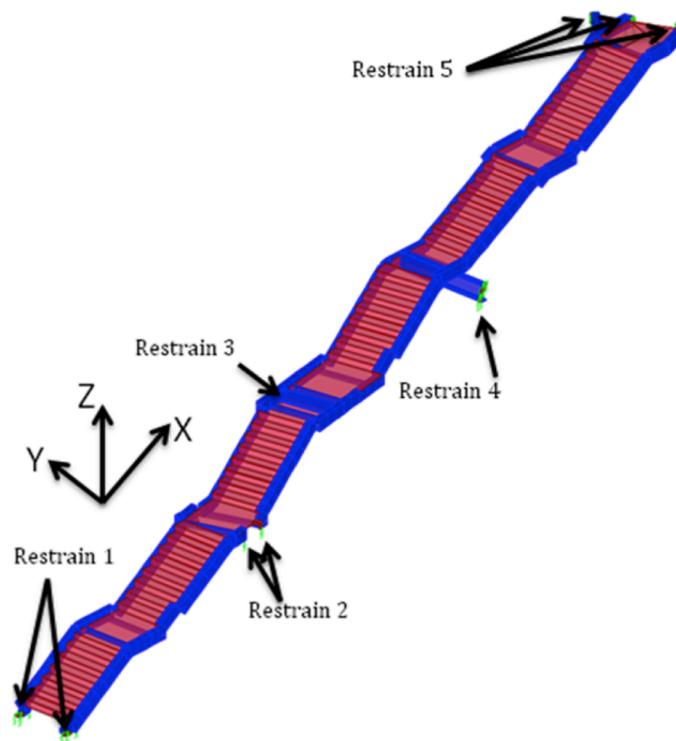
An initial numerical model (used at design stage) was developed in SAP2000v16 software, based on the finite element method. 2857 linear thin shell elements were used for the floor and base plates and 1157 linear elements for support beams (Figure 6). The handrails were included in the model as mass linearly distributed over the lateral beams, considering the value of 19.97 kg/m. The restrains were inserted in the positions of the connection of the anchors bolts, considered initially pinned supports.

Figure 6. FEM numerical model

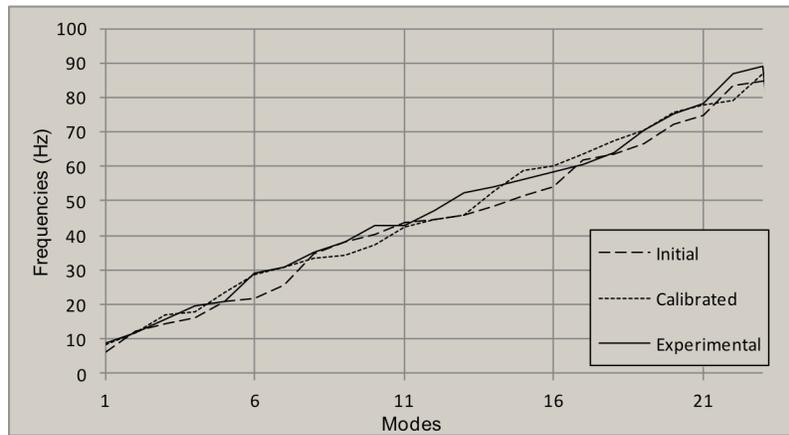
Figure 7. Vibration modes x natural frequencies

Next, the numerical model previously described was calibrated. This calibration process is an iterative process where changes in the structure stiffness (material properties, restraint stiffness, element releases) to approximate the natural frequencies of the numerical models to the respective experimental frequencies. At (Figure 7) it is showed the natural frequencies obtained by means of signal processing, obtained from the numerical model and those resulting from the calibrated one are plotted. (Figure 8) shows the error of the natural frequencies of the calibrated model in relation to the experimental data. The trend line of these errors is also showed for the 23 vibration modes captured in the test.

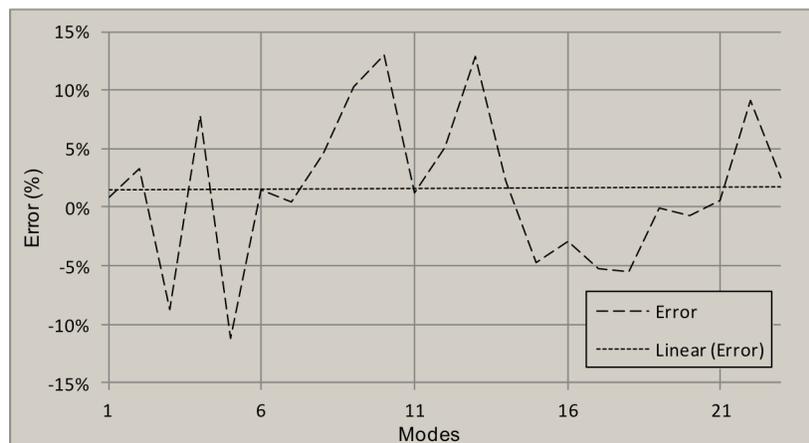
It is observed that the errors resulting from the calibration procedure are always less than 15.00%, and the error trend curve is approximately constant with an average value of 1.40%. In addition, by the mass participation curve of each mode (Figure 9), it can be observed that the most important modes, that is, modes 1, 7 and 11, present errors of 1%, 0%, and 1% respectively. These numbers indicate that the calibrated numerical model will accurately represent the dynamic behavior of the actual structure.

Figure 8. Calibration error

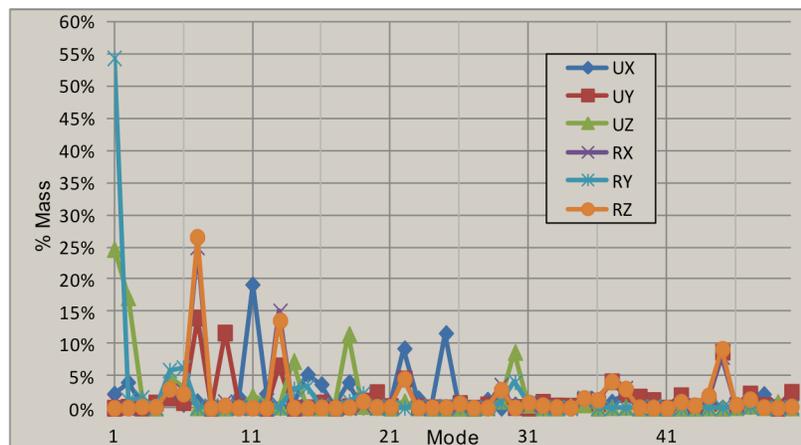
Figure 9. Mass participation factor of vibration modes

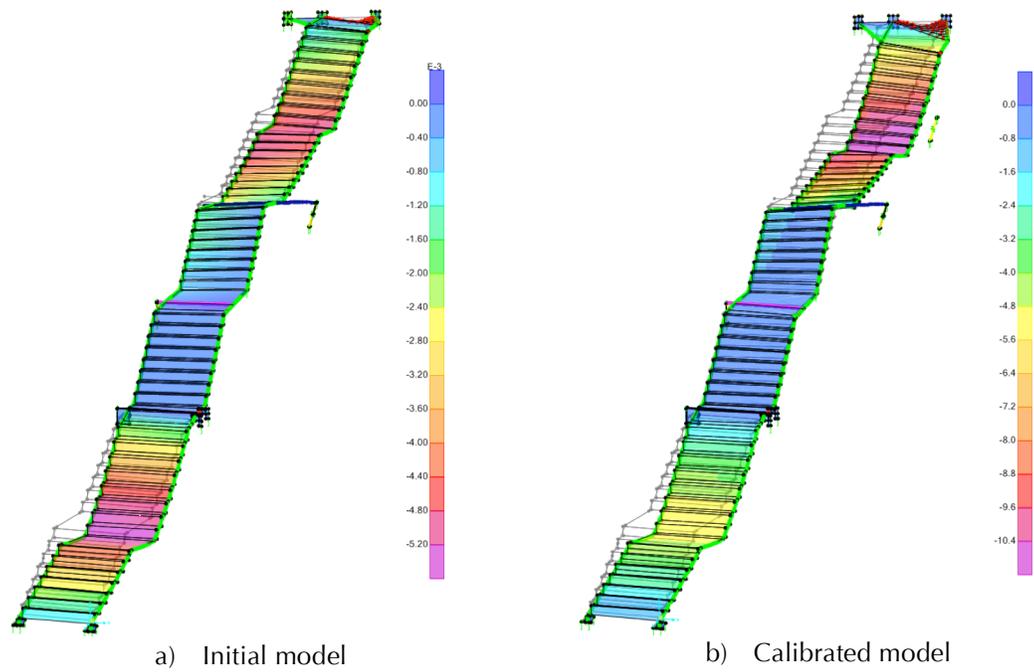
(Figure 10) presents the results of displacements for the initial and calibrated numerical models. The maximum displacements found were 5.20 and 10.98 mm, which correspond to distortions of 1/690 and 1/327 for initial and calibrated models, respectively. These values are less than the standard code limit, that is, 1/300. (Figure 11) presents the results of structural verification for beams. The relationship between the applied and structural capacity is presented. Value smaller than unit indicate that code criteria were met. It is observed that all values shown in (Figure 11) are less than one. A good approximation between the initial and calibrated models is observed. Von Misses tensions for shell elements showed at (Figure 12) indicates that the values found are lower than 75% of the yield limit, indicating that the stress level meets the limit state criterion. In addition, there is a good approximation between the two models.

Figure 10. Displacements (mm)

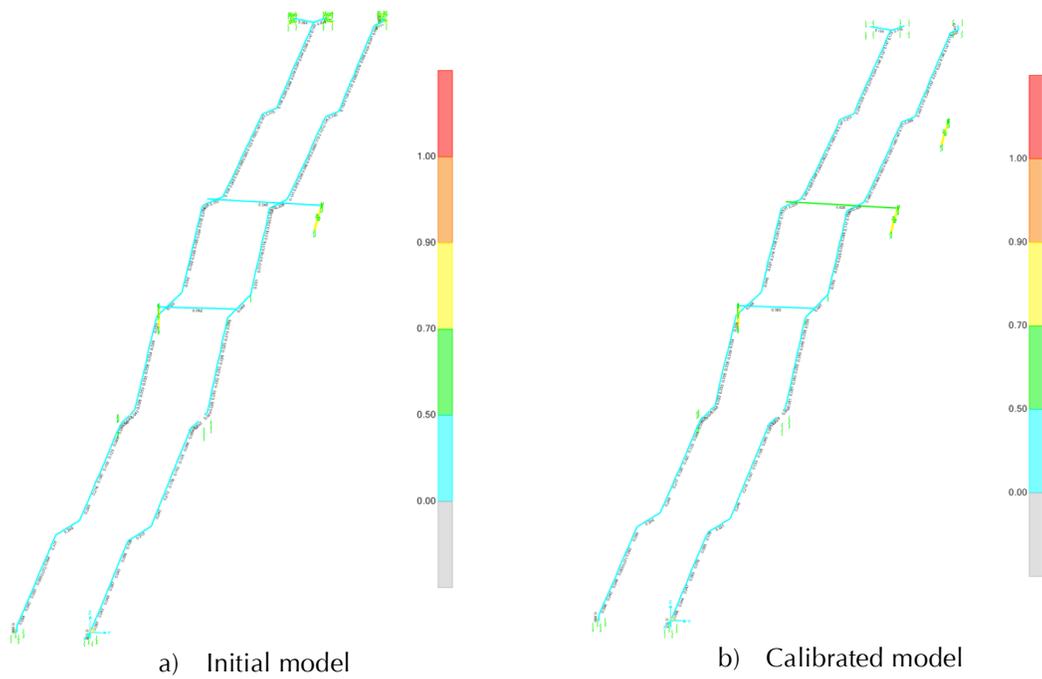
Figure 11. Stress applied/allowed factor

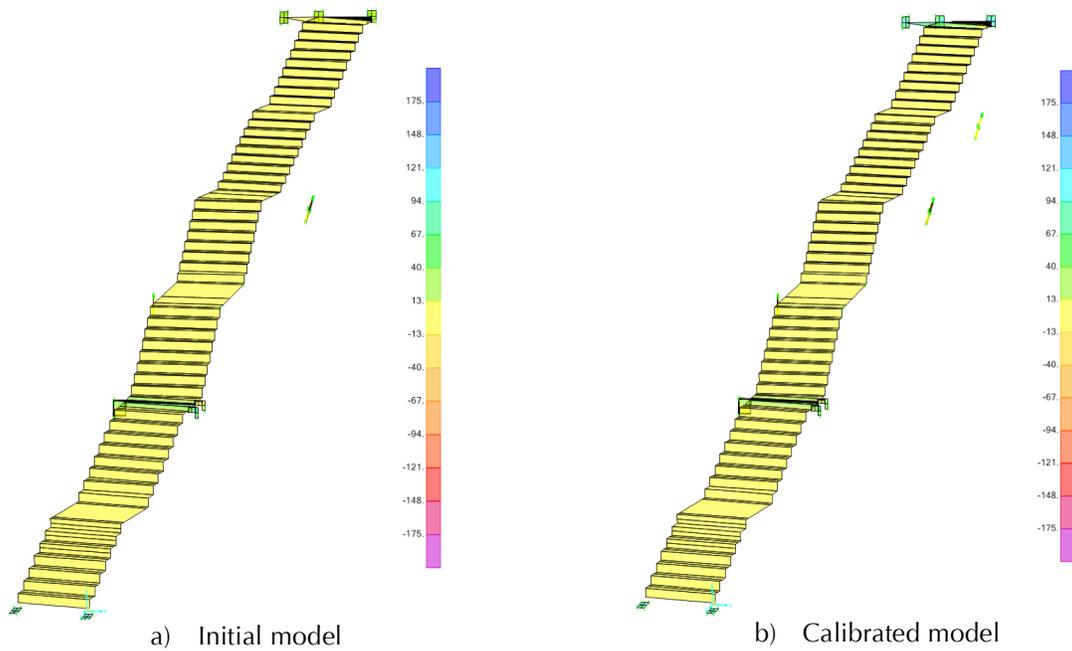
**Figure 12.** Von Mises Stress (MPa)

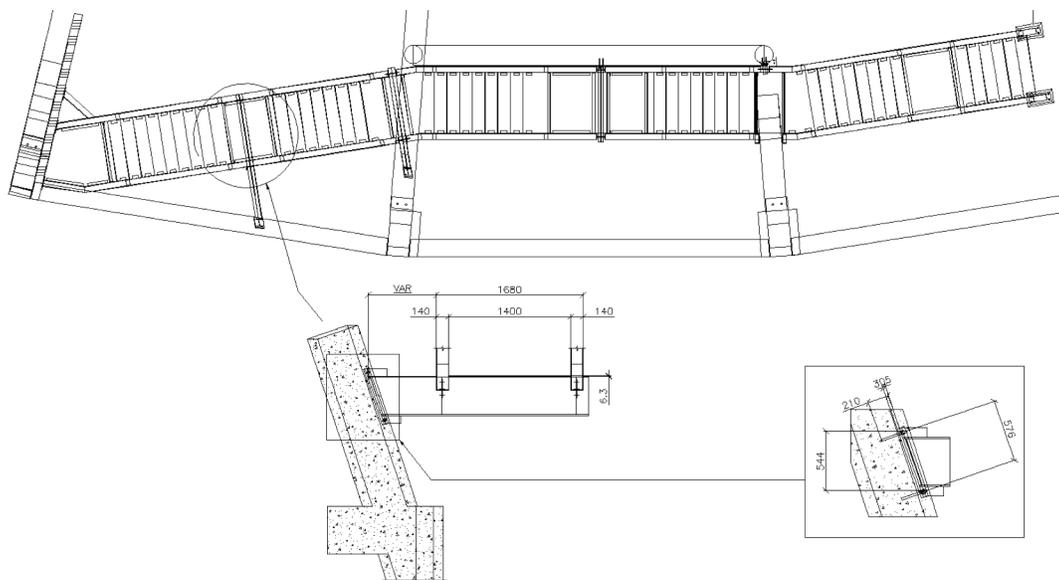
(Figure 13) presents the proposed reinforcement with the aim of attenuating the vibrations predicted in the numerical analysis via calibrated model. (Figure 14) and (Figure 15) present the vertical displacements, structural verification of beam and Von Mises stress for the calibrated numerical model, including the proposed reinforcement. The effectiveness of the reinforcement is clear, and leads to the maximum vibration velocity of 2.59 mm/s, lower than code limit.

**Figure 13.** Proposed structural reinforcement (mm)

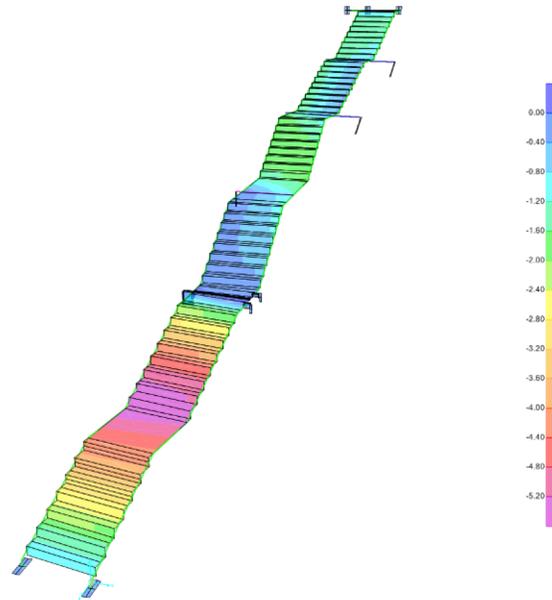
Figure 14. Displacement – reinforced model - (mm)

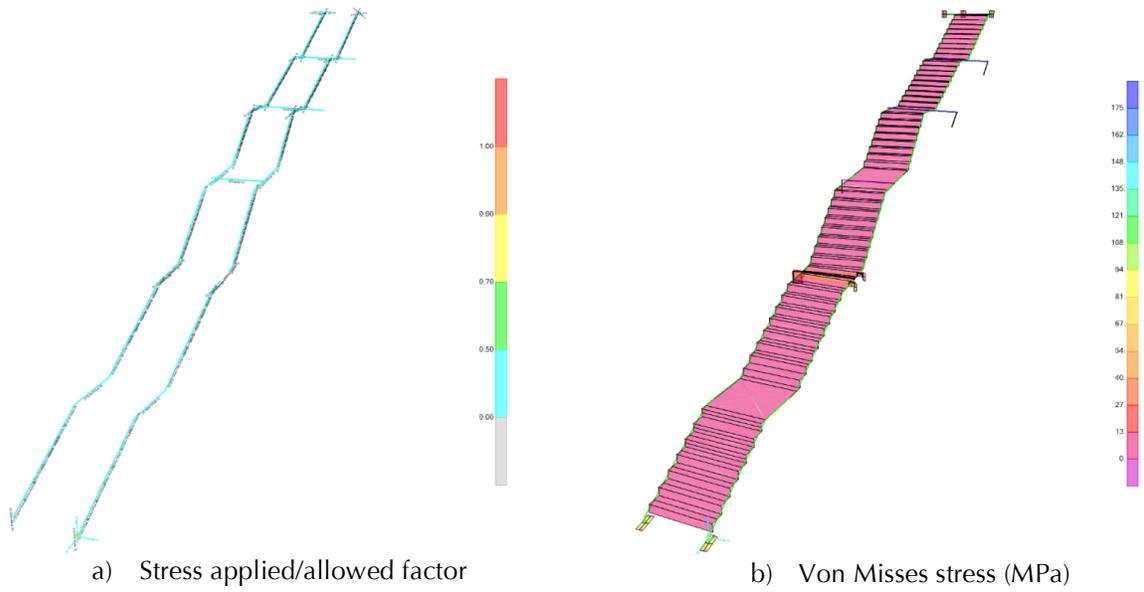
Figure 15. Structural checking – reinforced model
