# Structural conditioning factors of the installation of rooftop hvac equipment on existing load-bearing masonry buildings: Case study

## Condicionantes estructurales de la implantación de instalaciones de climatización en cubiertas de edificios existentes de muros de carga: Caso de estudio

*From the case study of a remarkable brick masonry building located in the historical city center of Madrid, this article analyzes the structural aspects involved in the implementation of large-size HVAC units on the roof of existing masonry buildings, as well as the structural refurbishment typologies necessary for this purpose.*

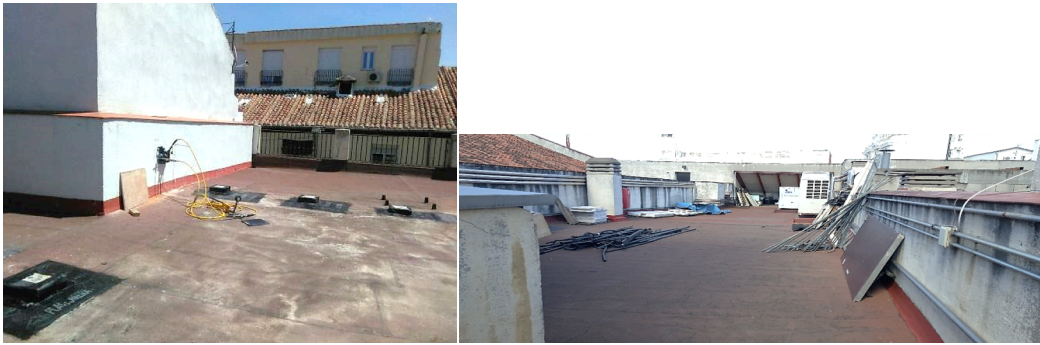
**Figure 2.** General views of the building rooftop

After the damage inspection, a campaign of test cuts was carried out on the rooftop (Figure 2) and on some sections of the load-bearing masonry walls underneath it to determine their configuration.

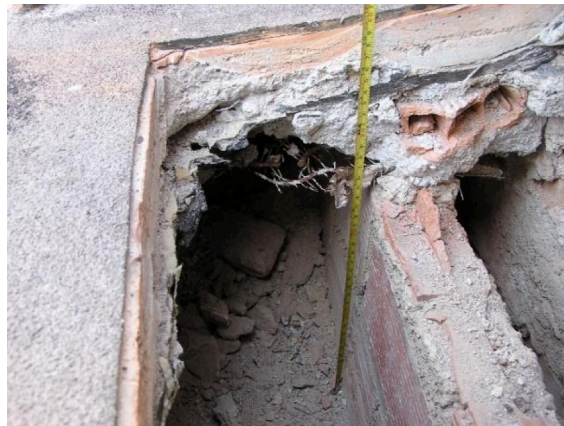
- The lining of the roof structure is composed of 20 cm high checkered brick walls on top of which different layers of rooftop finishings are laid out (thin hollow bricks, waterproofing sheets, etc.) until reaching a total height of about 30 cm. (Figure 3).

**Figure 3.** View of one of the test cuts on the rooftop of the building

- The roof slabs are unidirectional, formed by steel joists type IPN 160, with an interaxis of 75 cm and a small masonry vault of brick rowlock and a distribution area between 2 cm and 3 cm.
- The load-bearing walls are made of brick and are between one foot and two feet thick.

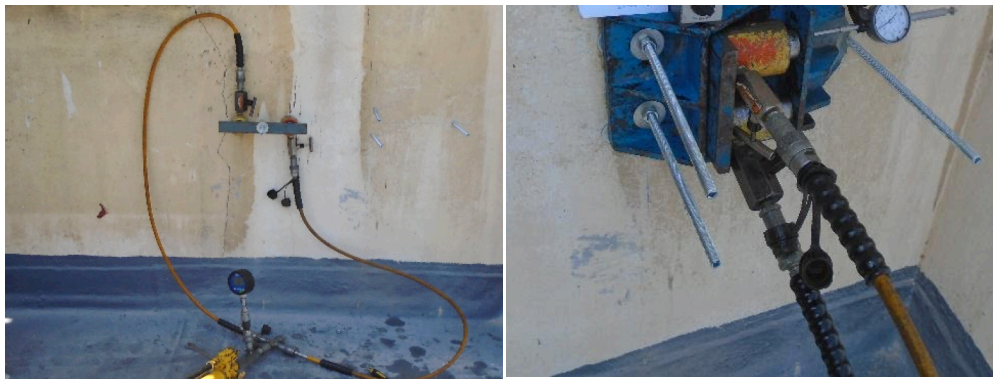
Before installation, the anchors designed for the support and fixing of the grids were tested to verify their suitability through a campaign of tensile and shear tests (Figure 9) on anchors of the same type as those designed for the grids, in conformity with the test requirements described in (EOTA TR 053, 2016).

Figure 9. Tensile and shear testing of anchors

The acceptance criterion for the tests was that they would be valid for tensile loading values higher than 3 kN and shear values higher than 6 kN.

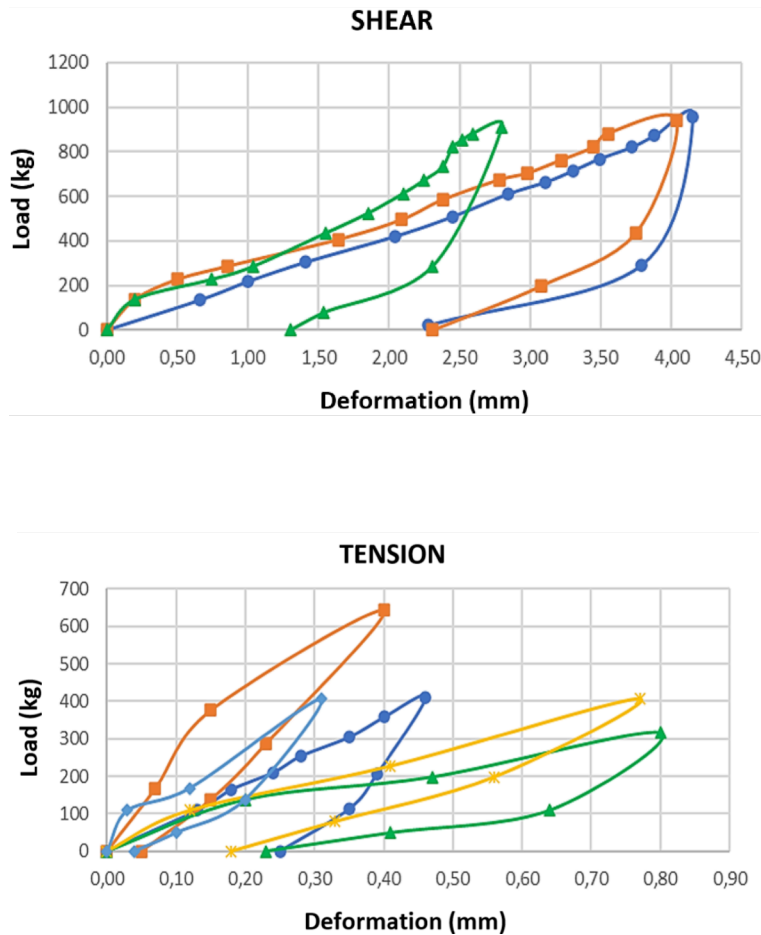
(Table 1) below shows the results obtained in the tests performed. (Figure 10) also shows the load-deformation behavior graphs obtained.

Figure 10. Behavior curves obtained in the shear and tensile tests

The results obtained in the tests confirmed the validity of the proposed solution, as the minimum tensile load (3.0 kN) and shear load (6.0 kN) required to absorb the service loads to which the anchors will be subjected were exceeded in each test

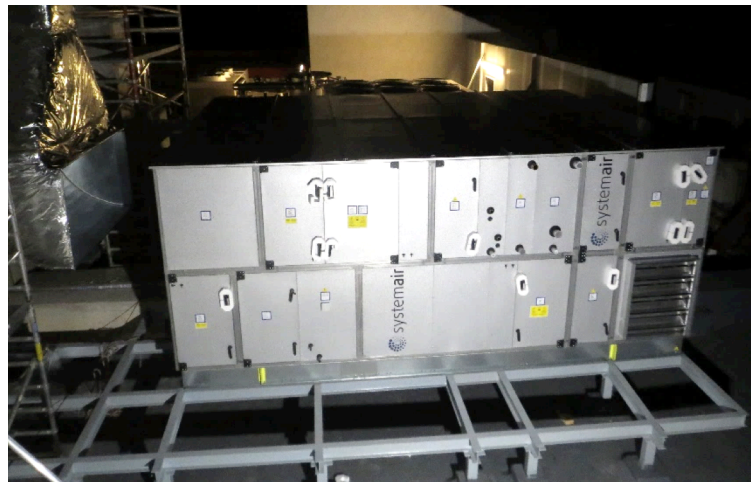
After the design verifications for the support and fixing solutions for the units and the verification tests of the existing structure, to guarantee an acceptable behavior of both the units to be installed and the structures on which they will rest, it is equally important to verify in situ the adequacy of the assembly of the units to what was previously defined (Figure 11).

**Figure 11.** Distribution of two ATUs after assembly

This control also makes it possible to verify that they are arranged in the appropriate form and in conformity with the quality requirements previously established for the same, particularly with regard to the position of their supports, and that their characteristics are in line with their technical requirements. It is important to point out that, in densely populated urban areas such as the one under analysis, these assembly operations have the extra difficulty of being carried out at night, and the equipment is lifted by crane from the first floor.
