Research Article

Investigation of the earthquake behavior of the historical Adana great clock tower using FEM updated based on environmental vibration data

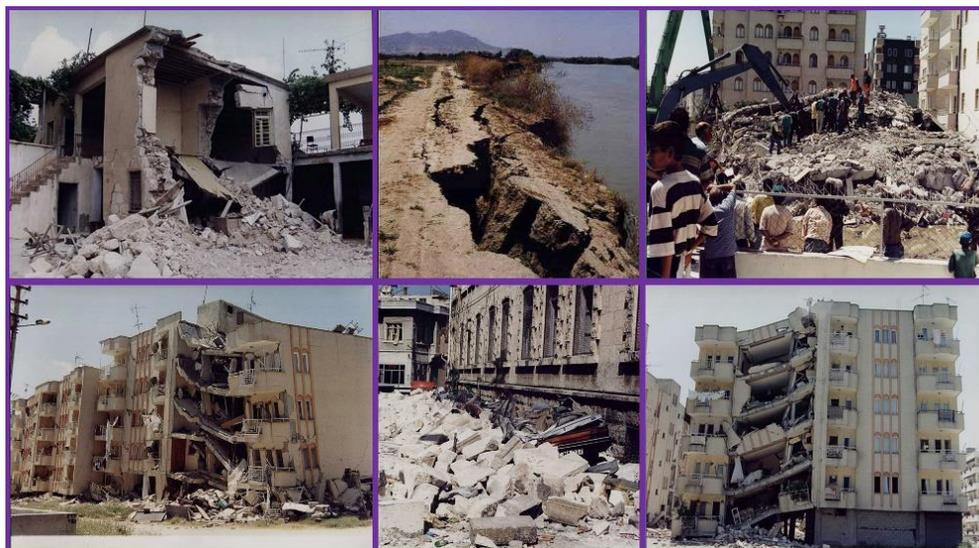
Figure 2. Examples of structures damaged in the 1998 Adana-Ceyhan earthquake (DEMA).

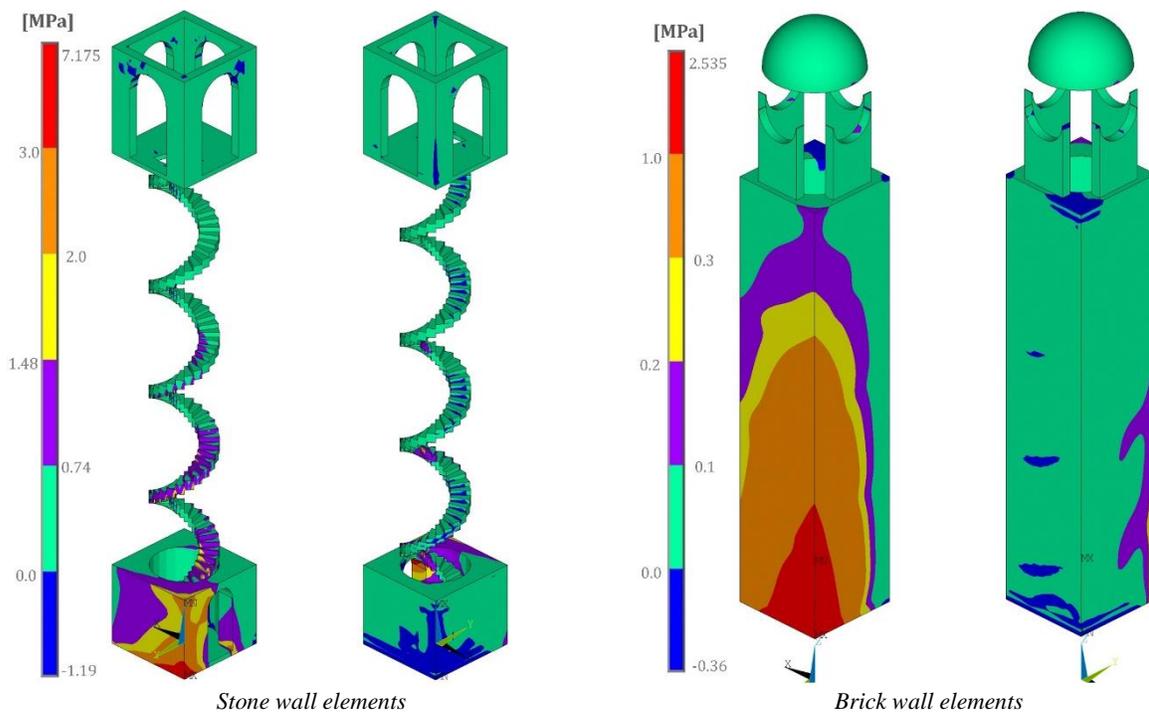
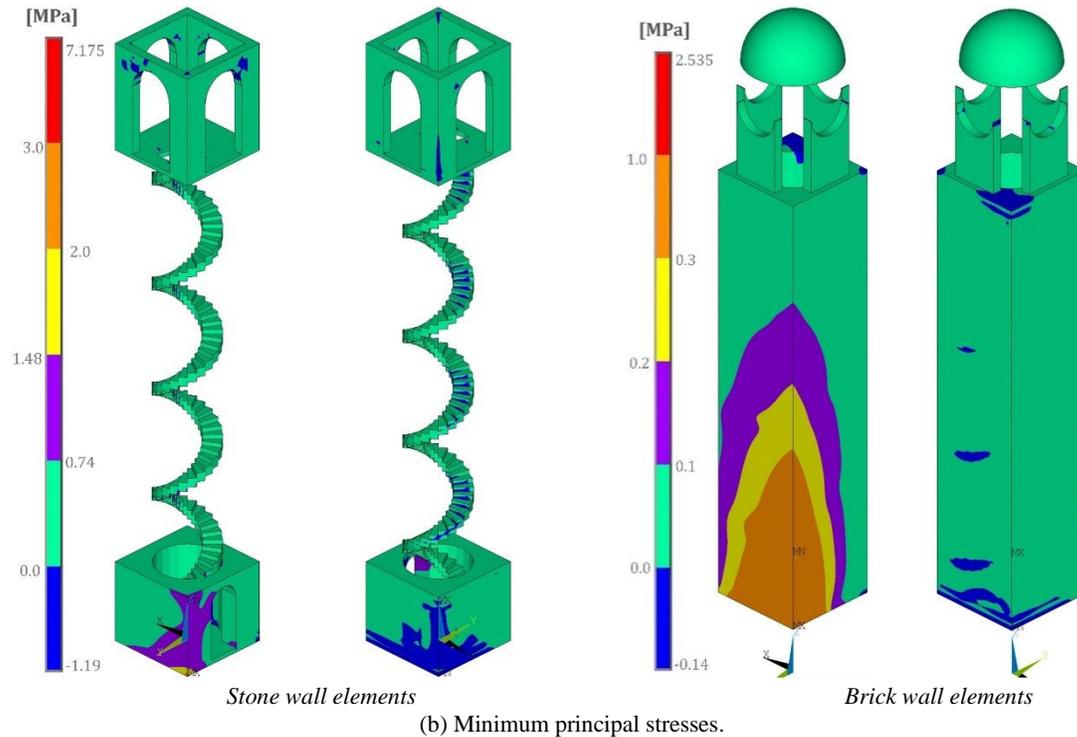
- The maximum principal stresses reach the largest values at the corner to the left of the entrance door at the base and decrease with distance from the corner. At the corner diagonal to the relevant corner, the maximum principal stresses reach the smallest values. In the region where the maximum principal stresses reach large values, the stone wall tensile strength of 1.48 MPa is generally exceeded. This indicates that the damage potential is high in this region for a possible earthquake at DD2 earthquake level.

- The largest absolute values of the minimum principal stresses occur in the base corner region where the maximum principal stresses reach the smallest values. The minimum principal stresses reach the compressive strength of the stone wall (14.8 MPa) in a narrow region near the base. In the corner diagonal to this corner, the minimum principal stresses are the smallest in absolute value.

- The maximum principal stresses reach the absolute maximum values at the connection region of the stone and brick walls at the left side of the entrance door of the clock tower. These stresses decrease with distance from the relevant region. At the corner diagonal to the relevant corner, the maximum principal stresses reach their smallest values. In the region where the maximum principal stresses reach large values, the brick wall tensile strength of 0.20 MPa is generally exceeded. This indicates that the damage potential is high in this region for a possible earthquake at DD2 earthquake level.

- The largest absolute values of the minimum principal stresses occur at the corner region where the maximum principal stresses reach the smallest values. The minimum principal stresses reach the compressive strength of the brick wall (2 MPa) in a narrow area around the connection region of the stone and brick walls. At the corner diagonal to the relevant corner, the minimum principal stresses reach their smallest values.

(b) Minimum principal stresses.
Figure 15. Maximum and minimum principal stress contour graphs for N-S(x)/E-W(y) solutions with DD2 earthquake level.

From the above evaluations, it is seen that damages will occur in the clock tower at DD2 earthquake level due to the exceedance of tensile stresses. In order to see whether the tensile stresses are exceeded in the clock tower at the DD3 earthquake level, which is lower than the DD2 earthquake level, linear seismic solutions of the clock tower were performed using the acceleration records of the Adana Ceyhan earthquake (Figure 10.b) scaled according to the DD3 earthquake level. Since it is a linear analysis, the time variations of the response quantities under the scaled records of the same earthquake for different earthquake levels will show similar characteristics. As in the DD2 earthquake level solutions, the maximum and minimum principal stress values in absolute value occur at 8.705 s for the stone and brick walls in the DD3 earthquake level solutions. The stress contour graphs of the N-S(x)/E-W(y) solutions of the clock tower with DD3 earthquake level at 8.705 s are presented in Figure 16-17, separately for the stone and brick walls. When these stress contour graphs are examined:

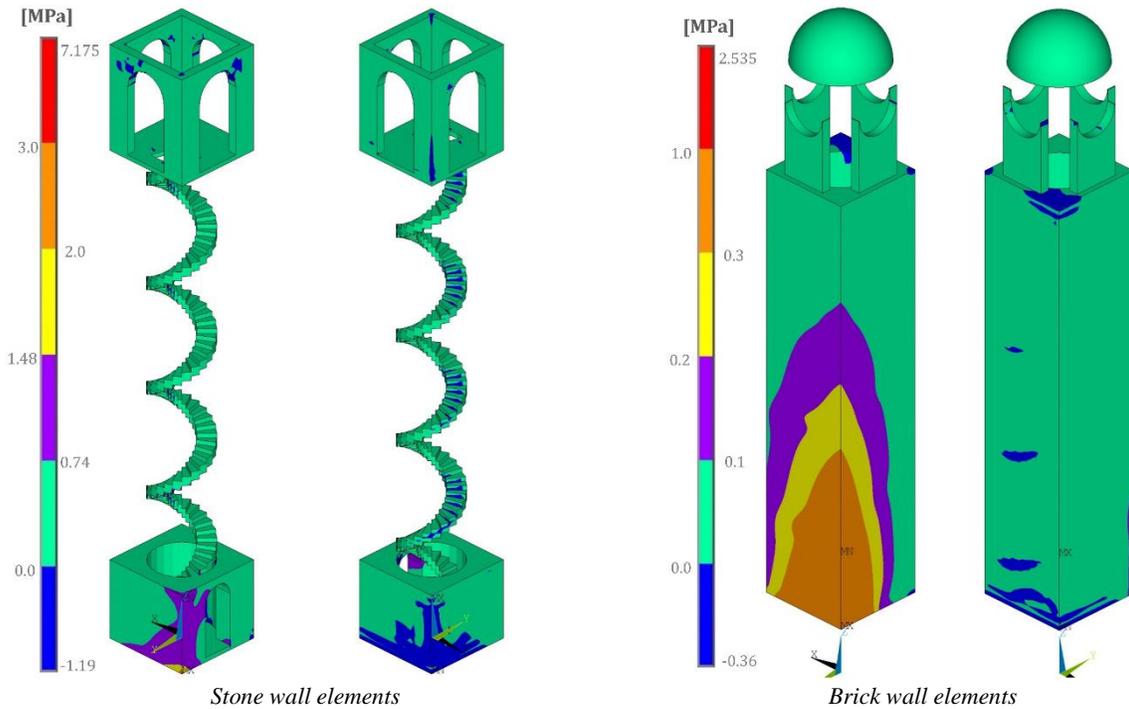
• The variations of the maximum and minimum principal stresses on the walls are similar to the DD2 earthquake level solutions. However, the stresses are lower for DD3 earthquake level solutions.
• Maximum principal stresses in the stone wall exceed the tensile strength in a narrower region than those of DD2 solutions. Similar situation is also observed for the brick wall. This indicates that there is a damage potential in the relevant region for a possible earthquake with DD3 earthquake level.

Figure 16. Maximum principal stress contour graphs for N-S(x)/E-W(y) solutions with DD3 earthquake level.

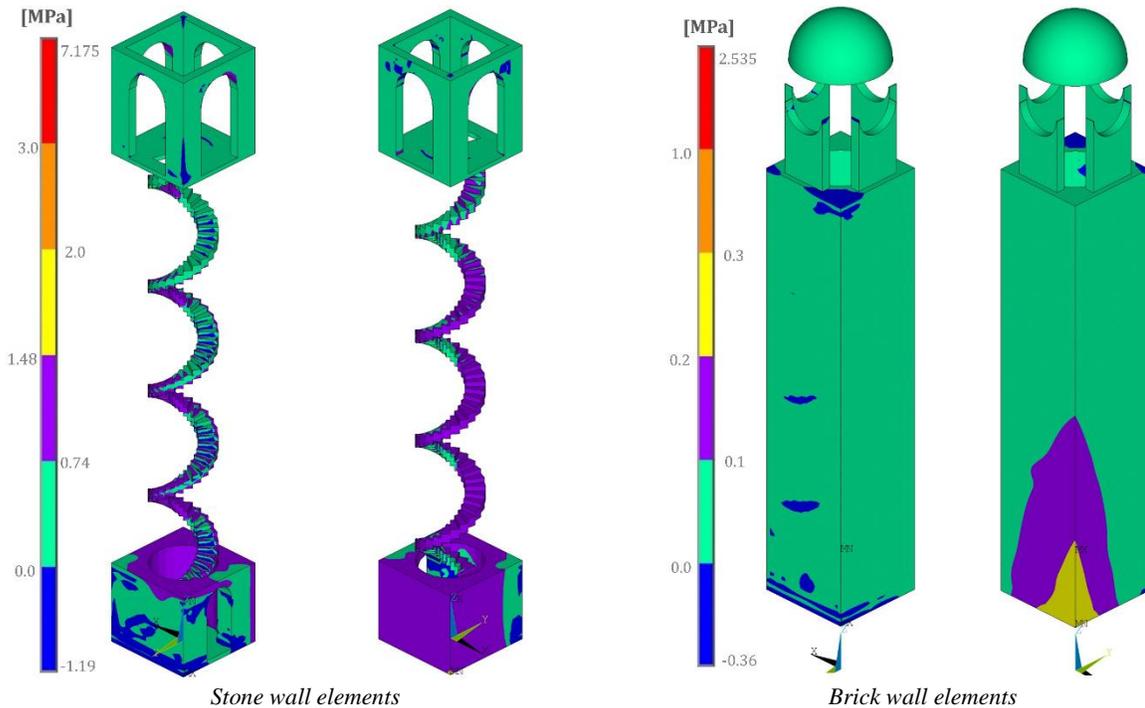
Figure 17. Minimum principal stress contour graphs for N-S(x)/E-W(y) solutions with DD3 earthquake level.
