Evaluation of Estructural performance using Nonlinear Static Analysis applied in an infrastructure

N.M. Gallardo Barreto[*] [1] https://orcid.org/0000-0003-0525-4045

Figure 1. Location of I.E N°10056 Hйctor Rene Lanegra Romero. Note: Google maps

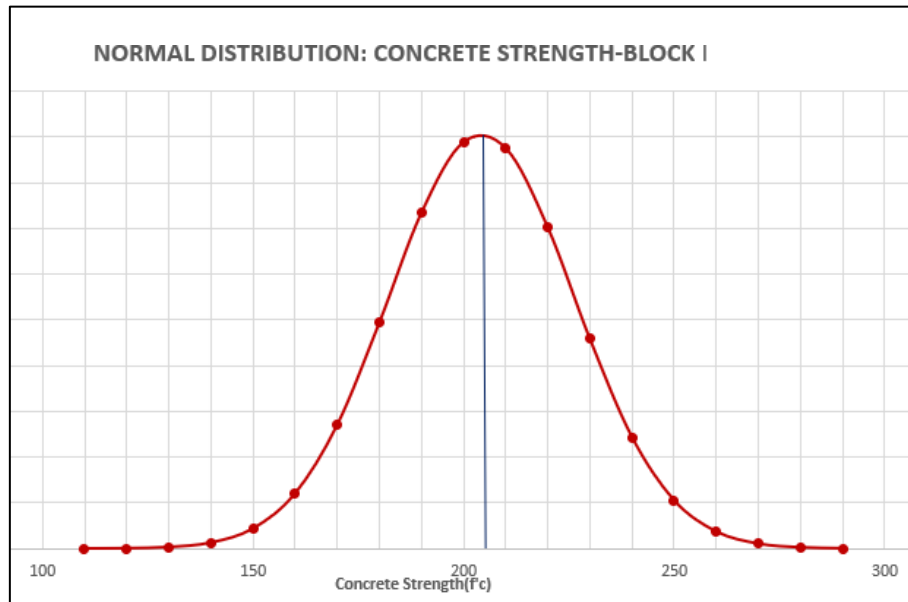
Figure 8. Normal distribution-Strength of the concrete block I. Note: Own Elaboration

To verify the strength of the concrete, the Diamantine Test was performed; which is based on extracting small concrete cores in structural elements such as columns and beams. Fully representative samples were tested; where 4 tests were carried out on beams and 3 tests on columns generating a total of 7 tests for Block I for both floors while for Block Block II a total of 5 cores were tested, 2 in beams and 3 in columns. Annexes 3, 4, and 5 verify in detail that part of the structural elements has already been vertical or horizontal concrete cores have already been tested. In (Table 2) a descriptive table of the resistance that has been obtained when testing the diamond hearts is verified indicating block I. (Figure 8) shows the strengths of the concrete that has been applied to a normal distribution to obtain more accurate data for the test performed. According to the calculations made, an arithmetic mean of 204.0 Kgf / cm² was obtained whose standard deviation generated is 22 Kgf / cm², these data were obtained for block I whose results obtained were within the range of the regulations whose concrete strength data was used for the modeling of the structure will be used is 182Kgf / cm² which results from the subtraction of the mean with the standard deviation.

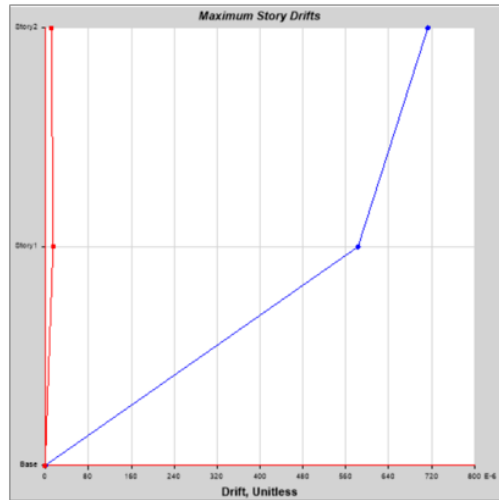
*Figure 11. Distortions on the X and Y axis of block I. Note: Own Elaboration*

distortion between floors 0.75 is multiplied by the reduction factor that the direction X is equal to 8, in the direction Y is equal to 3. As can be seen for the block I generating tables the program with a maximum drift of 0.0021 in the X direction and with a maximum drift of 0.0012 in the Y direction. (Figure 12) and (Figure 13) .

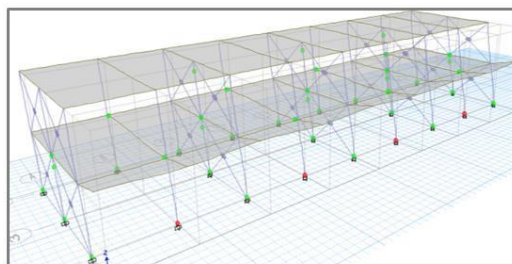
Figure 15. Pushover Analysis – Block I. Note: Own Elaboration

According to the Pushover analysis, applied in the X-X axis, it is observed that in the Image the first structural elements that fail against incremental loads are the columns of the porticoed system that do not correspond to the confined masonry walls of the Y-Y axis, the Graph shows as an example one of the first columns that collapse, this is because it exceeds the rotation limits according to table 11.4 of ATC40 when the moment reaches a value of -11.8785 Tonf-m its rotation results in -0.019588 rad being the maximum point in the graph of Moment – Rotation, however the final collapse point in the curve reaches a rotation of -0.032189 rad which exceeds the level of structural stability performance. The image already shows a generalized collapse in the first level, this is because the limit rotation was already exceeded in each of the columns, in the case of the beams, the graph shows an example in which the maximum rotation of a beam in its moment – rotation curve is 0.002334 rad, which indicates that its level of performance is of immediate occupation, but because it is a porticoed system if the columns fail the structural system would collapse as a whole.

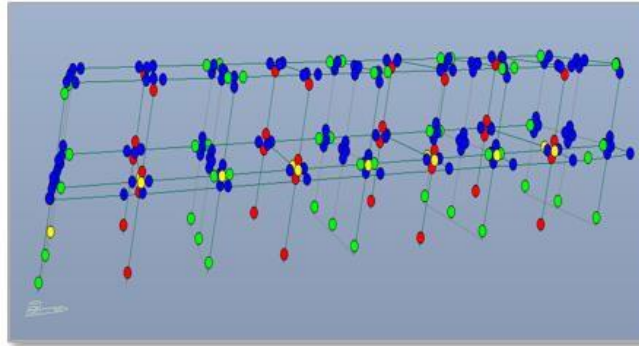
Figure 16. Generation of plastic ball joints – Block I. Note: Own Elaboration

The Pushover analysis, applied in Block I of the X axis through the FEMA356 regulations, shows in (Figure 16) the generation of plastic ball joints. Mainly the structural elements that generate failures before incremental loads we have the columns of the gantry system which do not belong to the confined masonry walls of the Y axis, which break at the base of the columns being in an ultimate state of the element, it is also observed that the rest of the structural elements are at an immediate occupation level, others in life safety and also in collapse prevention.

24.4% has flowed with an insipient creep, 0% security of life and 19.8% of the elements have failed since they are in an ultimate state.

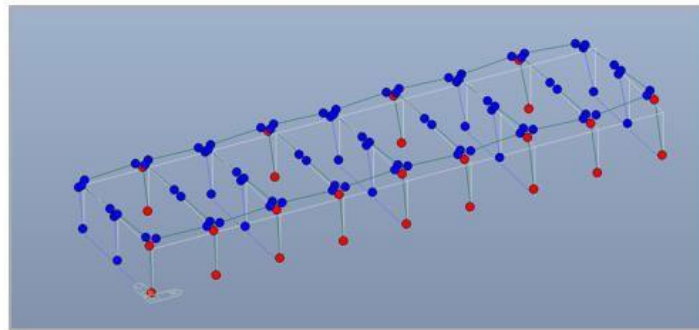
Figure 17. Generation of plastic ball joints – Block II. Note: Own Elaboration

For the Pushover method, which has been applied in Block II of the X axis through the FEMA356 regulations, the generation of plastic ball joints is observed in (Figure 17). The structural elements generate failures before incremental loads are the columns of the gantry system, as previously said that they were not the ones that were related to the confined masonry walls of the Y axis, which break at the base of the columns being in a state of immediate occupation, some in life safety and others in the prevention of collapse. 81.3% and 18.8% of the elements have failed since they are in an ultimate state.

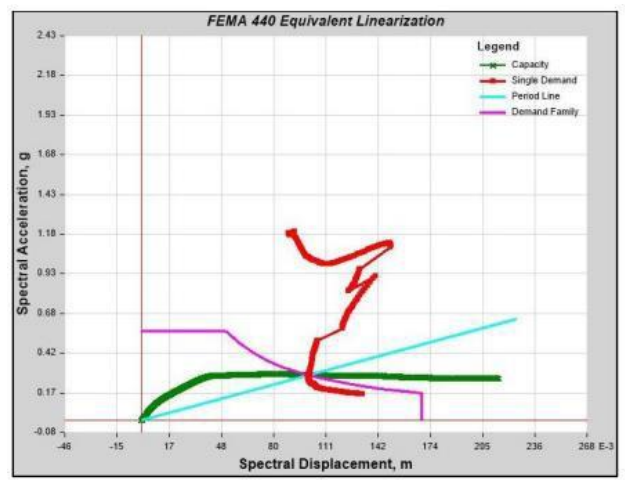
Figure 19. Performance point for a maximum earthquake spectrum – Block I. Note: Own Elaboration

Performance point In order to obtain the performance point, the capacity curve must be converted into a capacity spectrum so that it can intersect in the ADRS (Acceleration Displacement Response Spectra) format with the demand spectrum obtained in the graph. Based on the FEMA 440 criteria, two different performance points were found since the maximum elastic spectrum and the design spectrum were used. The graph shows the performance point for a maximum earthquake, obtaining as an intersection point in the axis of the abscissas a pseudo displacement of 0.1884 m and for the axis of the ordinates, a pseudo acceleration of 0.2679 g, in the case of the graph a performance point is shown based on a design earthquake spectrum, taking the values of 0.1004 m for pseudo displacement and 0.288 g for pseudo acceleration.(Figure 19).
