# Overview of the Structural Behavior of Columns, Beams, Floor Slabs and Buildings during the Earthquake of 2016 in Ecuador

## Una mirada al comportamiento estructural de columnas, vigas, entresijos y edificaciones durante el sismo de Ecuador 2016

Ángel Emilio Castañeda <sup>1\*\*\*</sup>, Yordy Mieles Bravo <sup>\*\*\*</sup>

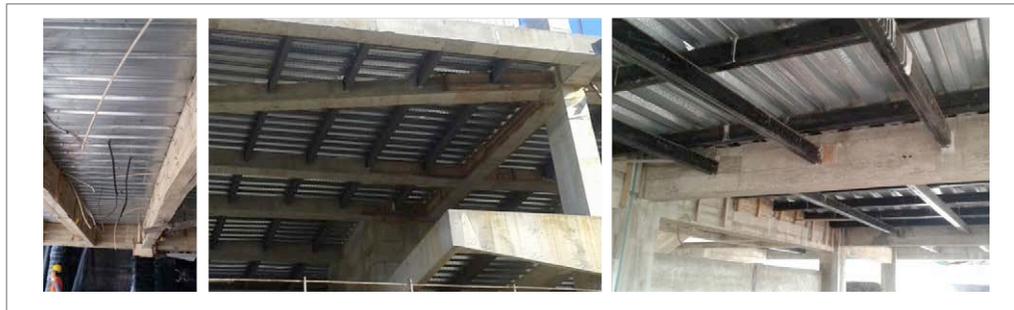
Figure 7. Steel-deck slabs in the cities of Manta, Portoviejo and Bahía de Caráquez

A preliminary damage analysis of ten buildings built with this technology showed a good structural behavior of

steel-deck slabs with these grids, which distributed the lateral load and the floor drift among the vertical elements (Mieles and Castañeda, 2016c). However, given the numerous constructive alternatives, with steel beams in one or two directions, columns in the vortices, and frames closed by non-structural masonry walls or not (Figure 7), an experimental design was required to determine the influence of the height of the building, the rectangularity of the plan, and the physical-mechanical model of the nodes under gravity and seismic loads, on the stress-strain indicators of the slabs. This allowed correlating or not the damages, with just the specific characteristics of these grids.

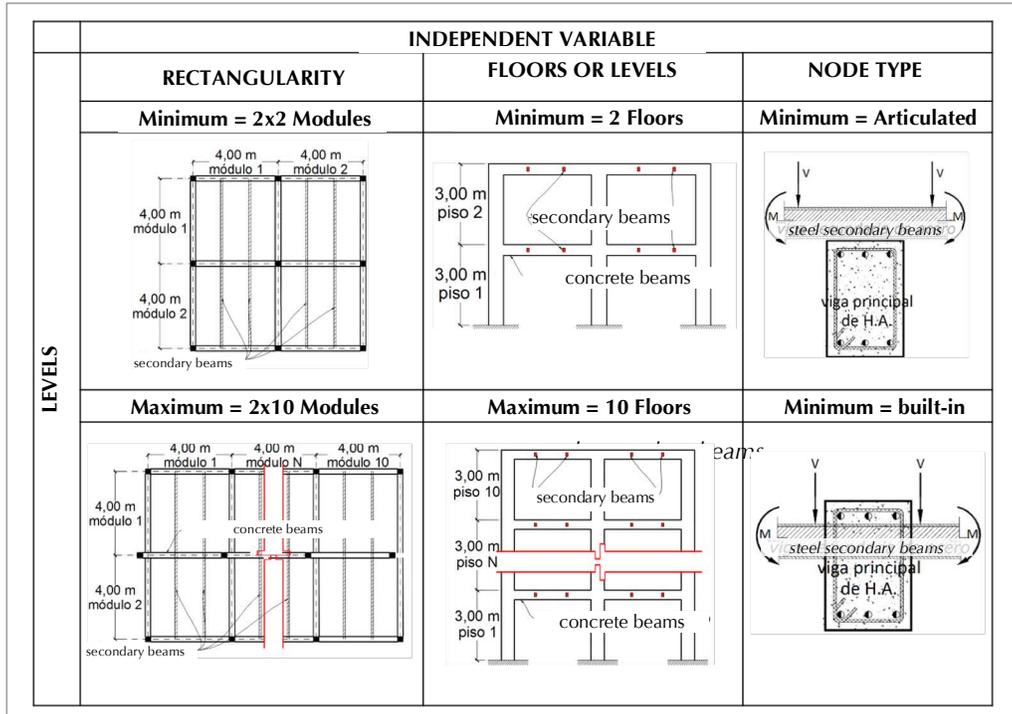
Figure 12. Types and levels of independent variables used in the experimental design

Figure 12 defines three independent variables used in the 2<sup>nd</sup> experimental design to evaluate its influence on the strength behavior of “hybrid nodes” and the floor drift in rigid frame buildings without structural walls, secondary steel beams in one direction, and steel-deck slabs.

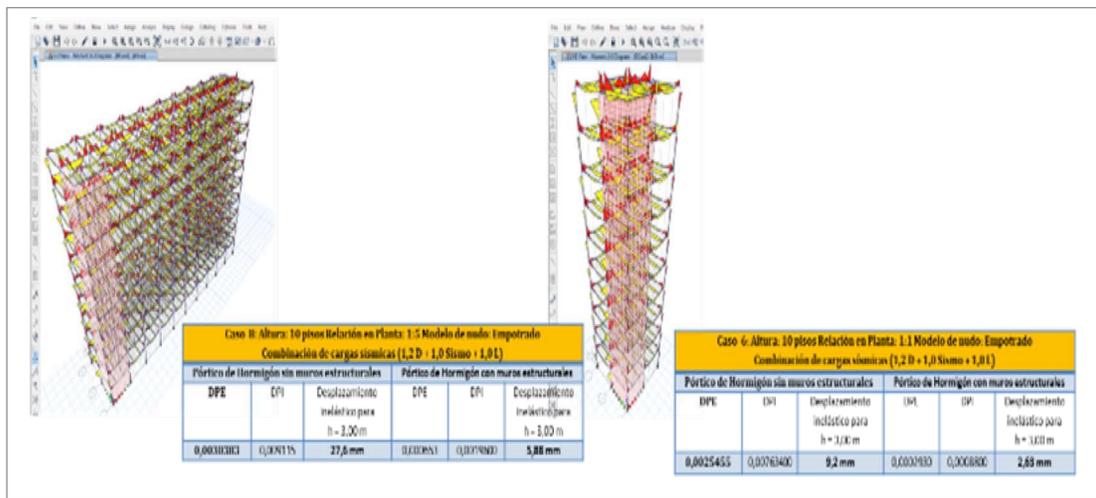
Figure 14. Models and results with ETABS of extreme cases for comparing IFD

In order to confirm this, the maximum floor drift ( $P_{0,95}$ ) was calculated for 5.3.1.b and 5.3.1.e in the extreme cases of Table 1, including two structural walls in both directions. The resulting maximum drifts of 0.00088 and 0.00196 provoked maximum displacements of 2.63 mm and 5.88 mm, which did not cause the collapse of non-structural walls (Figure 14), and lower than 4.5 mm and 9.2 mm in rigid frames without structural walls.

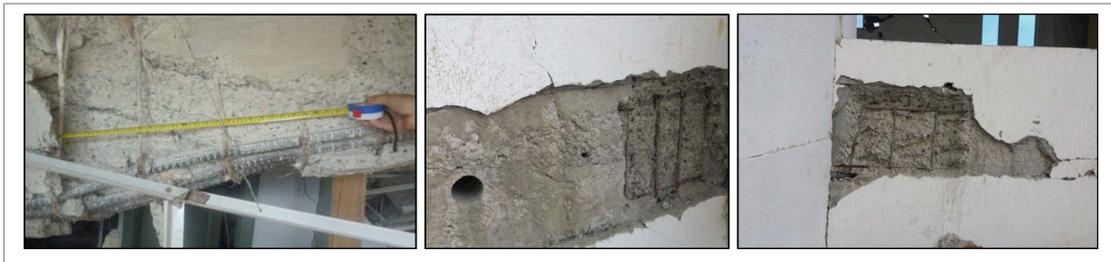
Figure 19. The investigation of a building needs measuring, taking core samples, and even discovering and recognizing that, sometimes while investigating, you may lose the answers

A presumptive diagnosis, a research plan, core sample extraction, the development and negation of hypotheses and other aspects, including legal ones, should be systematically considered in this kind of investigation. However, in this "overview", these actions had only a non-systemic character that did not surpass the most speculative diagnoses (Figure 19).

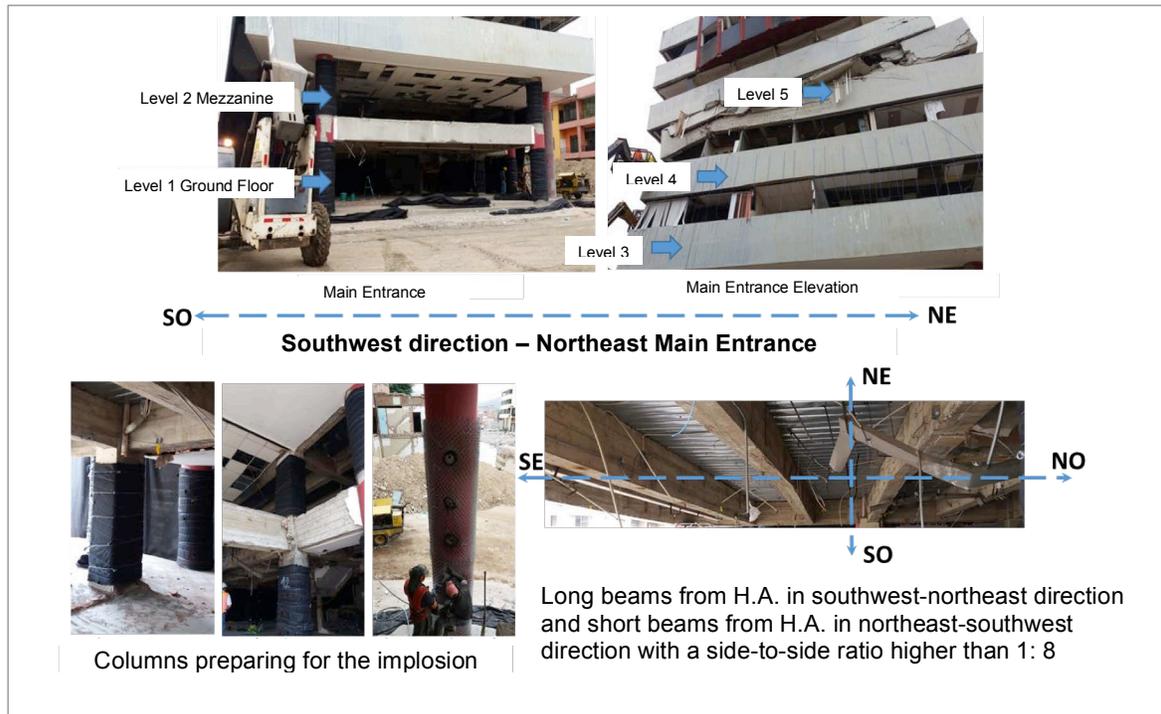
Figure 20. General elements of the building characterization

The Pichincha Mutual Company, with northeast-southwest facade, was constituted of ten levels: ground floor, a mezzanine and eight floors, each one on top of a reinforced-concrete beam grid with a span ratio over 1:8, sustaining steel-deck slabs, supported by circular and rectangular columns of different slenderness in the ground floor. The whole building was built over a concrete slab and three out of four faces were cantilevered (Figure 20).

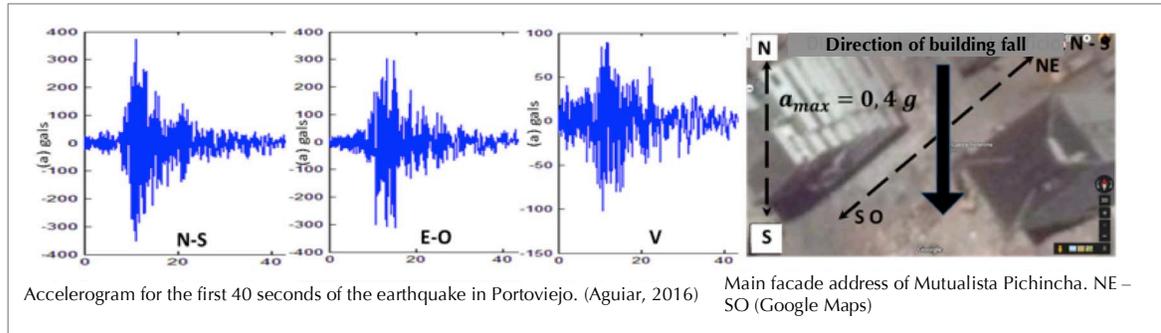
Figure 22. Earthquake-building reference orientation for a preliminary dynamic analysis

The accelerograms measured during the earthquake and the orientation of the building demonstrate that the failure and directionality of the earthquake coincided with their floor plan diagonal (North-South). A preliminary dynamic analysis recognizes the failure in the second oscillating mode and the interrelations between peaks of the accelerograms for the first 15 seconds of the earthquake, and the recovery period of the normal oscillating mode of the building, as one of its possible failure causes (Figure 22).
