Diagnosis of degradation state through non-destructive tests: case study of the public building of federal education institution

Abstract

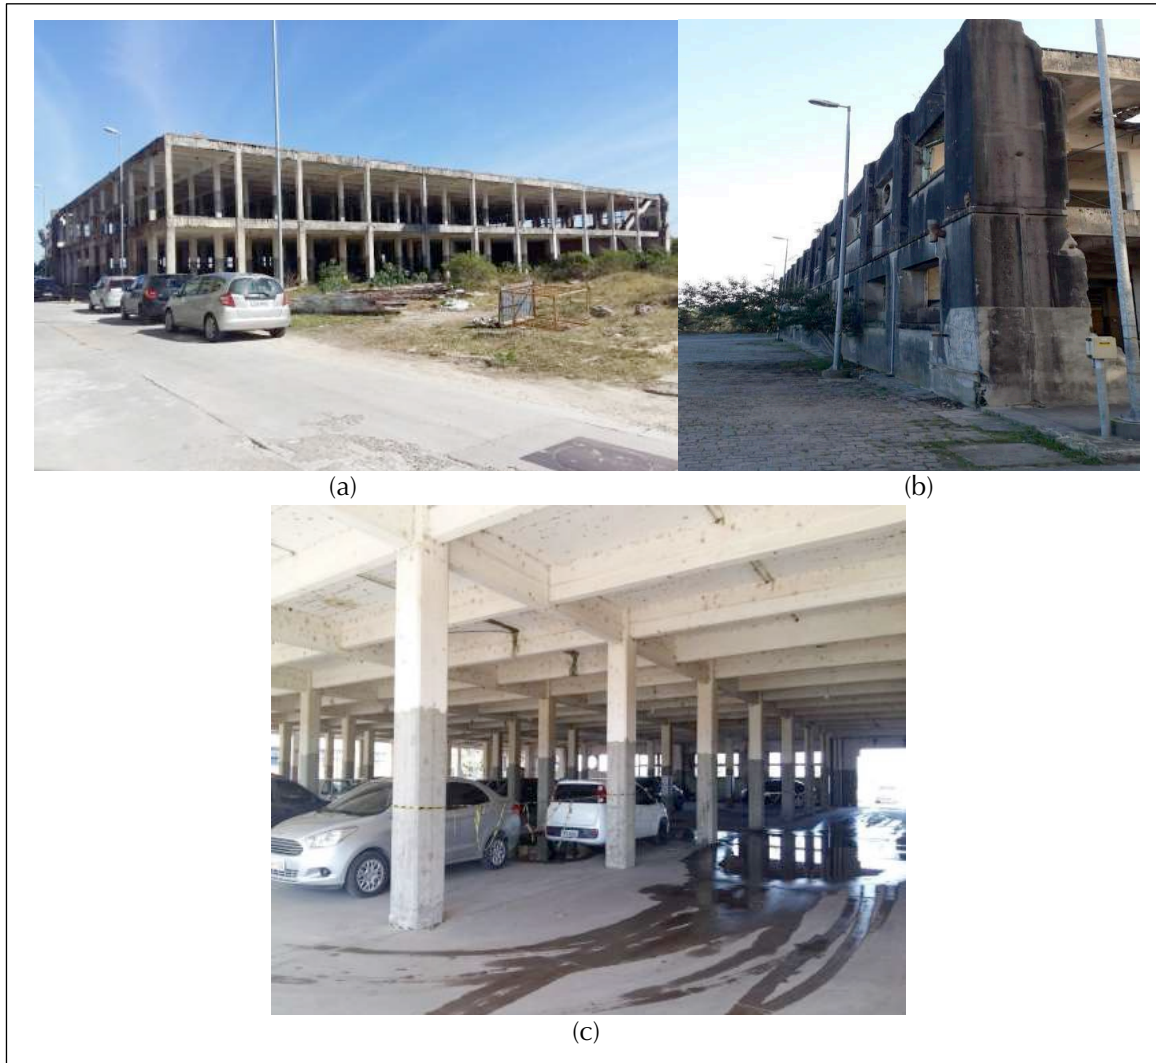
Figure 2. (a) North Facade. (b) South Facade. (c) Building used as parking

Several modifications have been made over years in the complex buildings, but the complex buildings have maintained their industrial aesthetic. “Paliteiro” has not been revitalized, highlighting the north facade in (Figure 2a) and the south facade in (Figure 2b). The building consists in two floors, both containing twelve pillars in longitudinal and ten in transversal, connected between themselves by beams, which support the structure slabs. Currently, “Paliteiro” has been used as a parking (Figure 2c).

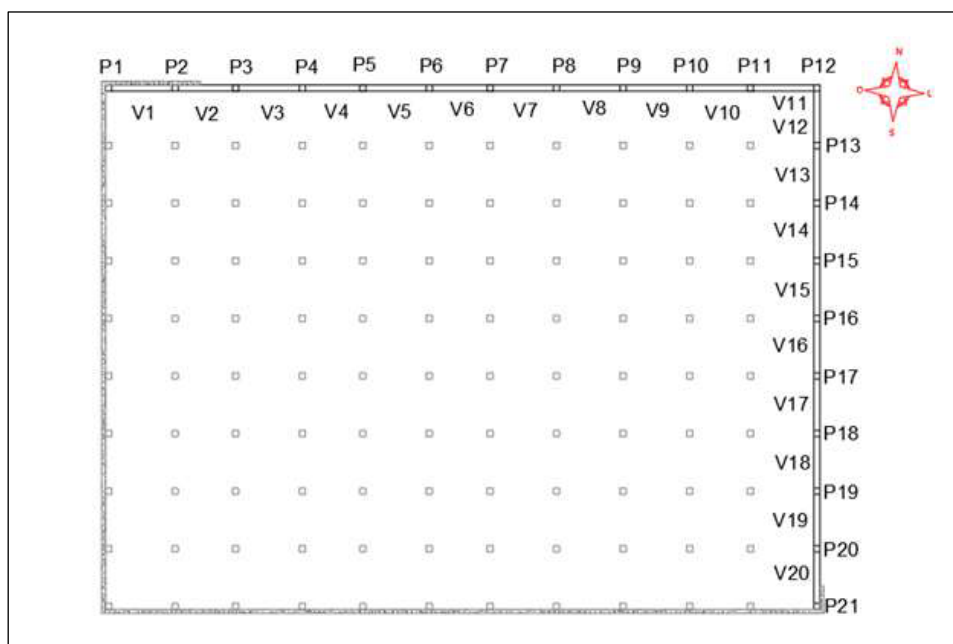
Figure 3. Identification and mapping of the studied elements

Using preliminary visual analysis, perimeter structural of East and North facades were the most damaged, and, therefore, specific objects of this study. Moreover, West and South facades have been closed with masonry limiting their study. The access to West facade is hampered by vegetation. Aiming to facilitate their identification, the pillars elements were numbered and identified as “P” and beams as “V”. The pillars and beams were numbered from 1 to 11 localized in North facade and from 12 to 21 localized in East facade (Figure 3).

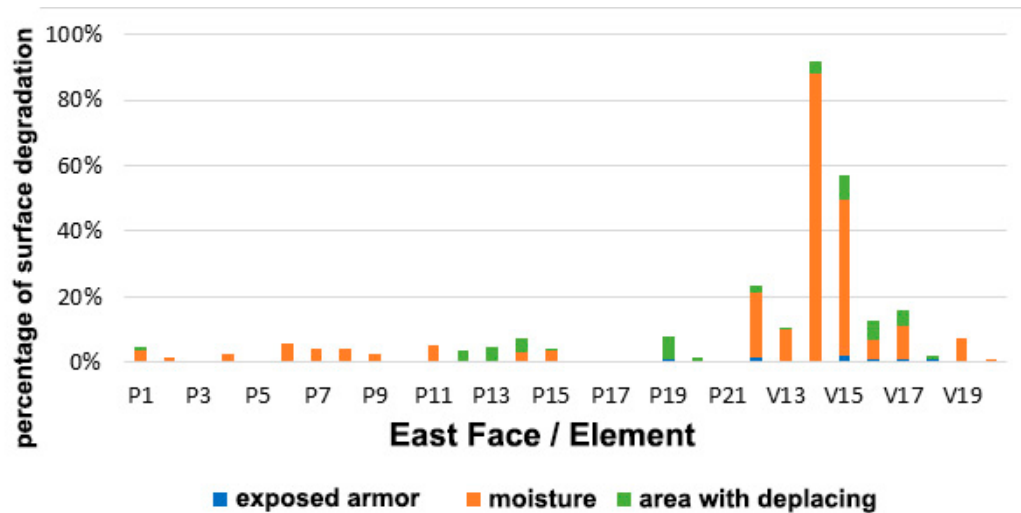
Figure 8. Percentage of surface degradation - Face East

After damage map, superficial degradation elements percentages divided by pathological manifestation type and by elements face were achieved. (Figure 8) shows the surface degradation of elements on East facade.

As presented in (Figure 8), there are some peak of surface degradation of elements in beams V14 and V15 (Figure 9a) and (Figure 9b) on East face, due to moisture spots reaching 88% and almost 60% of total faces area affected beams. Both are located on East facade, and they are the most affected by pathological manifestations, probably due to the sun exposure period of shortened by shadow of the neighboring building. These peaks are linked to plant formation in V14, which concentrates moisture in its roots, seeking or creating flaws in concrete, increasing susceptibility to pathological manifestations caused by moisture. Pillars of East facade did not present moisture stains. However, they are concentrated in South and West faces in view of the lowest sun exposure. Detachment was the pathological manifestations most found in the pillars of the East facade. Some points of armor exposure were found, mostly, in the upper part of the column, at the height of the beam, possibly by concentrations of stresses in these regions added to the thermal variations. This factor is subjected to the facades of longer sun exposure periods.

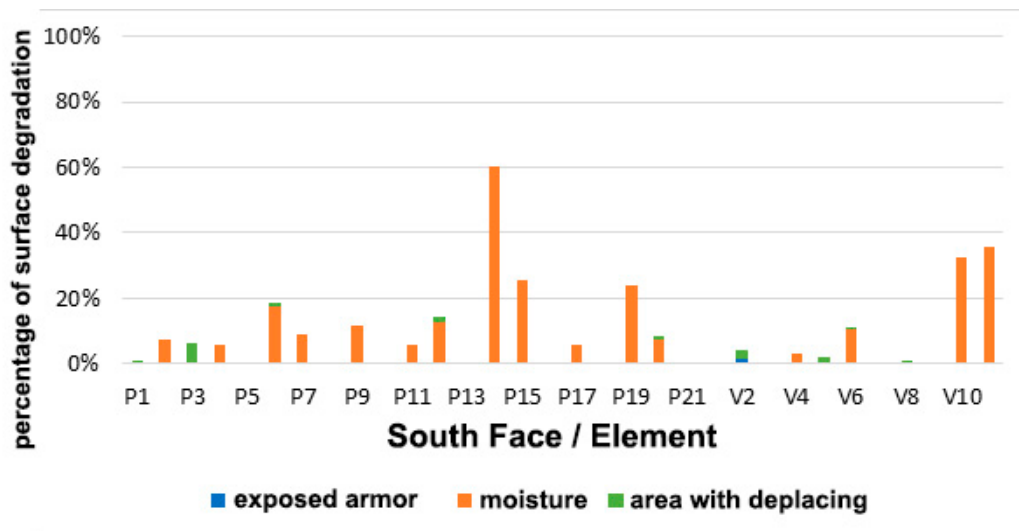
Figure 10. Percentage of surface degradation - South face of the elements

(Figure 10) shows the surface degradation percentage on the south facade.

(Figure 10) shows peaks in beams V10 and V11 belonging in North facade reaching 32% and 36% of degraded area percentage. These peaks, possibly, are due to the beams faces close to the São Gonçalo channel, increasing the aggressive agent actions. The interior beam in North facade is not receiving solar radiation and fungus spots are founded. There is a peak in P14 pillar (Figure 11) of East facade, probably related to their proximity to the most degraded beams V14 and V15. The cause of the faults in pillar are related to moisture from these beams and the pillar faces presented the lowest sun exposure in sight of the shade from the neighboring building.

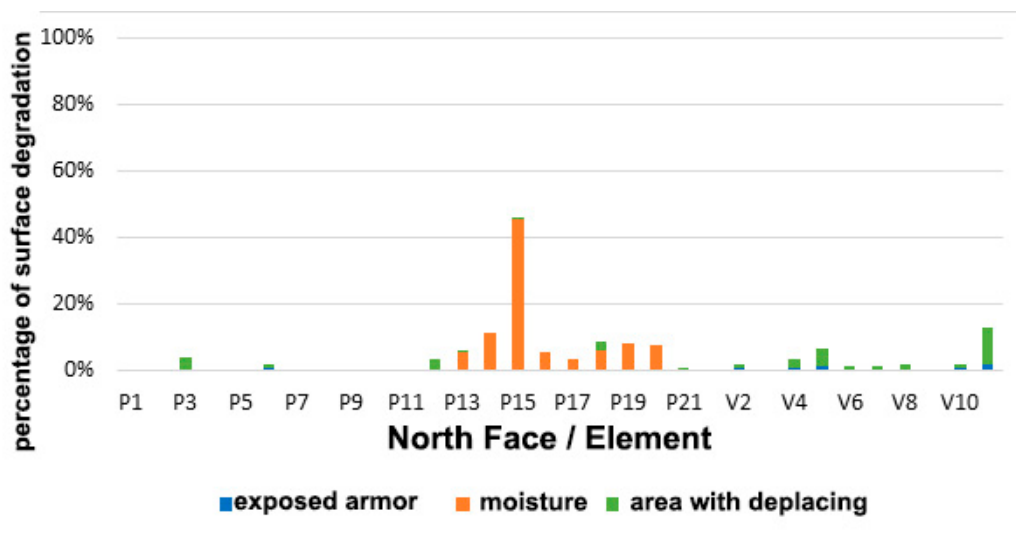
Figure 12. Percentage of surface degradation - North Face

(Figure 12) shows the surface degradation percentage on the North façade.

(Figure 12) shows moisture degradation in North face. Only on the pillars of East facade presented a peak of surface degradation of elements in P15 column (Figure 13) presenting 46% surface degradation area. Among the pillars of the North facade with greater sun exposure, none presented moisture stains. Only detachment and exposed reinforcement were observed in two pillars (Figure 14). On the North face of the pillars located at East facade, moisture stains were found as in P15 (Figure 15), evidencing the shadow period is sufficient to facilitate pathological manifestations mechanisms. The sun exposure favored the facade beams and the absence of moisture stains in North

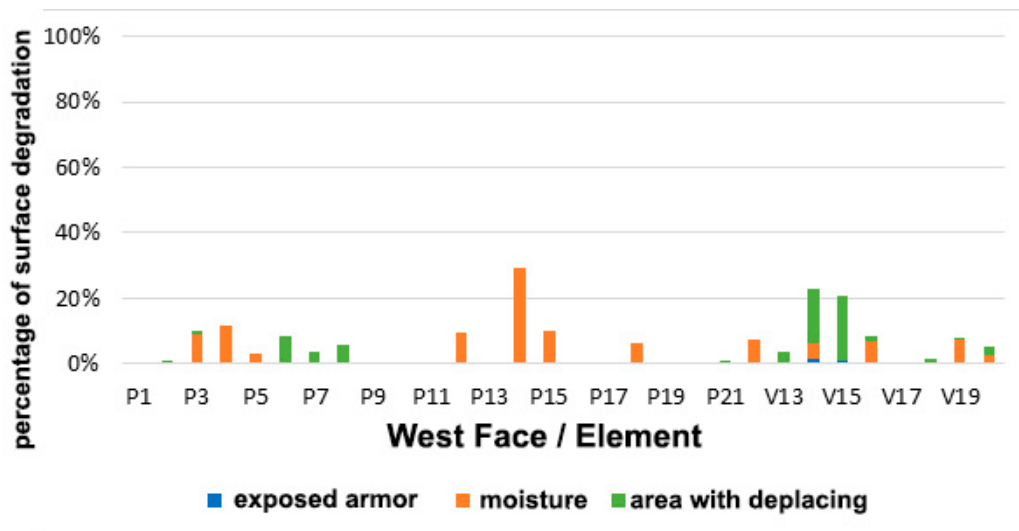
Figure 16. Percentage of surface degradation - West Face

Surface degradation percentages of West face is shown in (Figure 16). Pillar P14 presented the highest percentage of degradation, 29% of degraded in East face. In addition, V14 (Figure 17) presented 20% of percentage of detachment area. This fact was attributed to failures in the material due to the accumulation of moisture and degrading agents. All aspects evidence moisture coming from the interior of the beam reached the pillars as can be seen in beam V14 (Figure 9a) with the present of plant. Moisture stain on pillar P15 (Figure 13), which is connected to P14 (Figure 11) by V14 was observed.

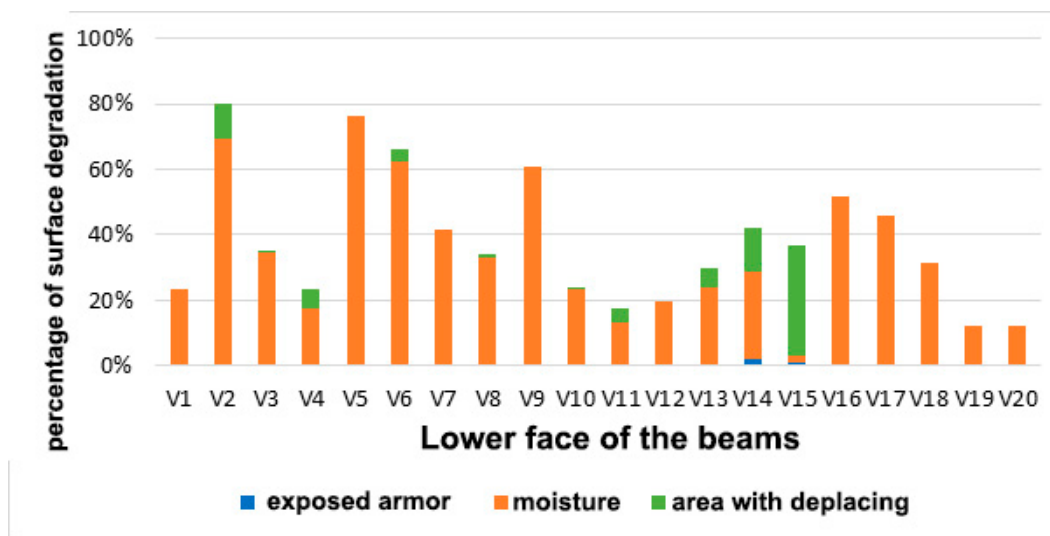
Figure 18. Percentage of degradation - Lower face of the beams

(Figure 18) represents the degradation of the lower face of the beams. These faces of the elements presented higher degradation index due to the accumulation by gravity of moisture from the other faces. North facade presented four beams with more than 60% degradation area of its lower face, while the most degraded beam of the East facade presented 51% of degraded area.

Considering the twenty beams, six of them have an index higher than 50%, adding moisture, exposed armor, and detachment area, especially V2 and V5, in addition to V15, presenting 34% of its lower area (Figure 19).

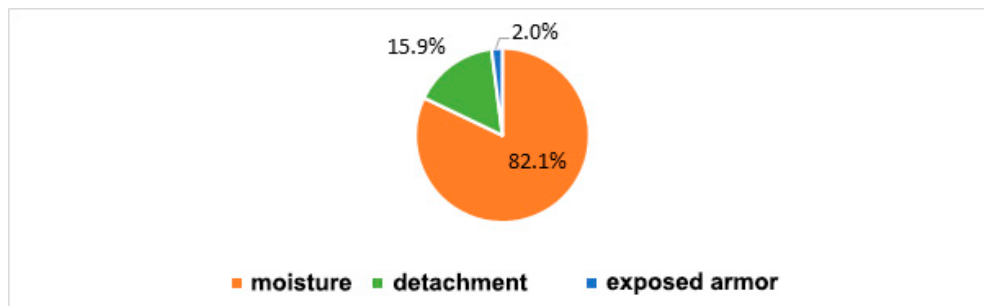
Figure 20. Pathological manifestations identified in structural parts

According to (Figure 20), humidity spots are the highest incidence among the pathological manifestations observed, totaling 82% area of pathological manifestations. This result can avidinated the need to maintain the building.

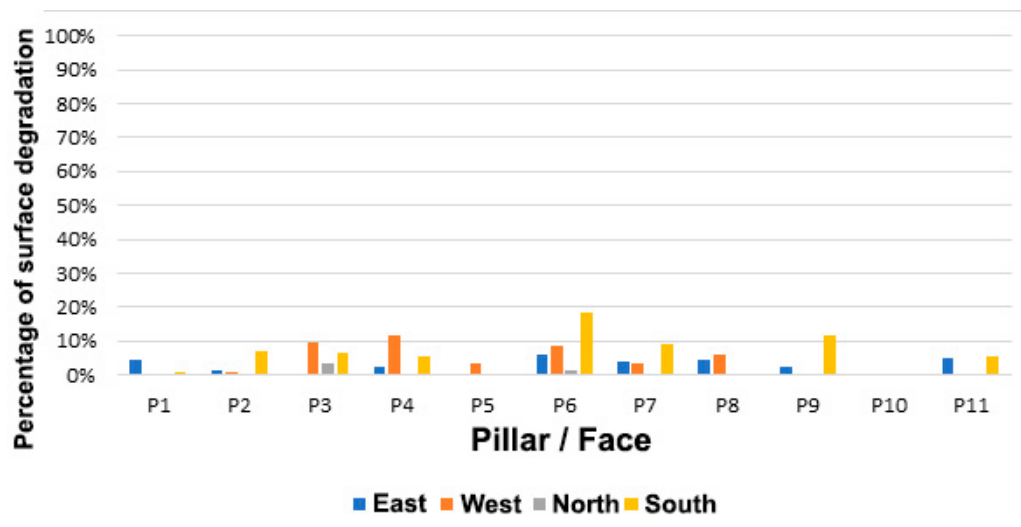
Figure 21. Percentage of surface degradation of the pillars of the North facade.

(Figure 21) and (Figure 22) represent the surface degradation of the pillars percentage per face.

Although with relatively low indexes, pillars of North facade and South face are the most degraded due to the lower sun exposure. For the pillars of the East facade, the North face is the most impaired due to the temperature gradients, given the longest time of sun exposure. The elements on the East solar faces through a period of shade got values closer than South facade.

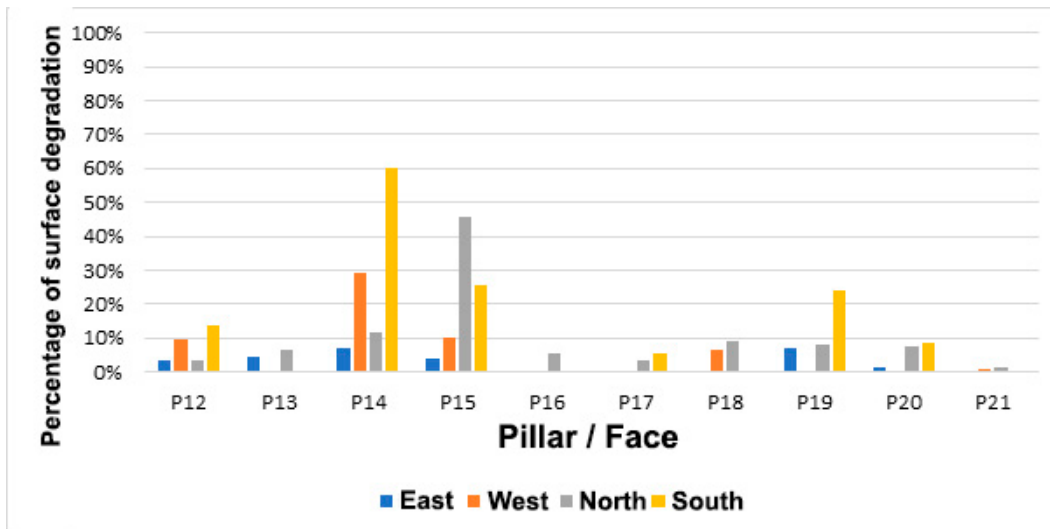
Figure 22. Percentage of surface degradation of the pillars of the East facade

Pillars P14, P15, and P19 in East facade presented the higher indexes of surface degradation than others, but without maintaining a face pattern of sun exposure. P14 presented degradation in the 4 faces, being 60% in South face, 29% in West, 12% in North and 4% in East. P15 presented degradation in 46% in North face, followed by South face in 26%, West in 10% and maintains a standard with P14 for the less degraded face, East in 4%. P18, P19 and P20 presented high indices in West, South and North faces, but absence of pattern, having in common only moisture presence in North face, which is seen in almost all pillars in East facade. P19 and P20 are covered by tile, presenting only dirt, without unplating of the pieces or cracking.

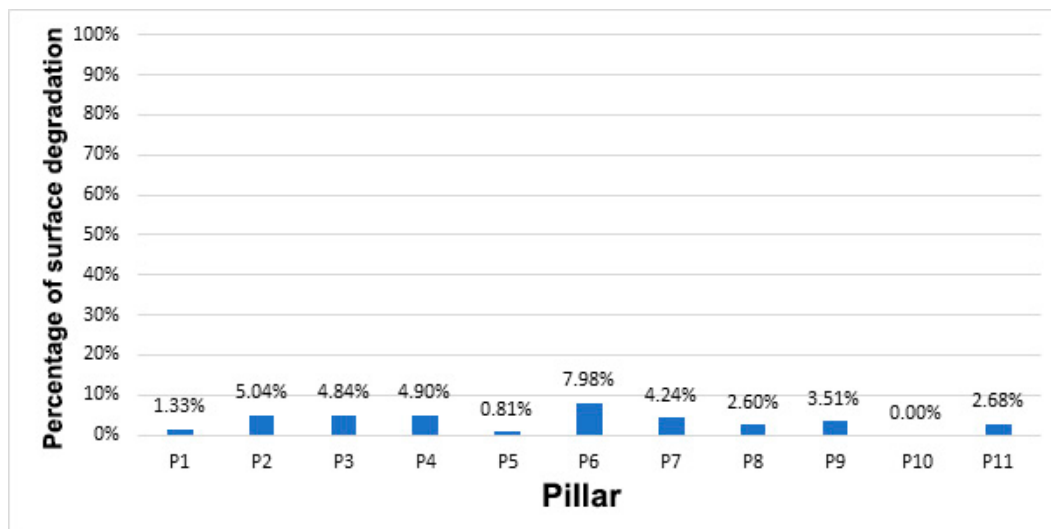
Figure 23. Percentage of surface degradation of the pillars of the North facade

(Figure 23) and (Figure 24) show the pillars degraded areas, the North facade have percentages lower than 8%. On the East facade, five pillars exceed this percentage of degradation, three of them higher than 15%. P14 was the most degraded element with 26% of degraded area mainly due to the moisture stains found in South face. Among all the pillars, only P10 did not present pathological manifestations.

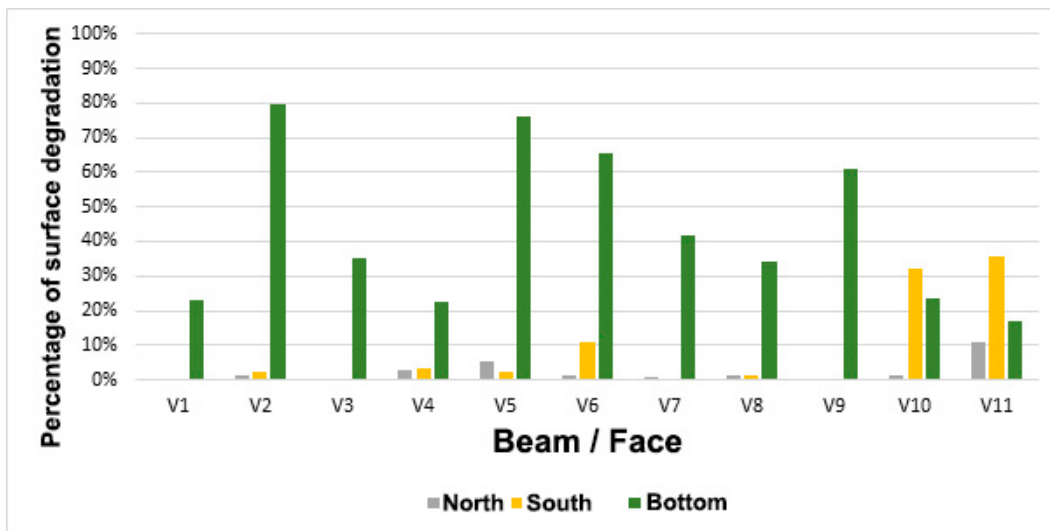
Figure 25. Percentage of degradation of the beams of the North facade

For the beams, a similar procedure was performed (Figure 25) and (Figure 26). Considering two different directions of studied beams, the same solar orientations were not evaluated for beams localized in East and North facade, only the lower face was studied. The lower face of the beams was the most impaired due to the accumulation of water by gravity coming from the other faces and the interior of the pieces. The second most degraded face was to the east because of the high humidity levels found in the perimeter beams of the East facade.

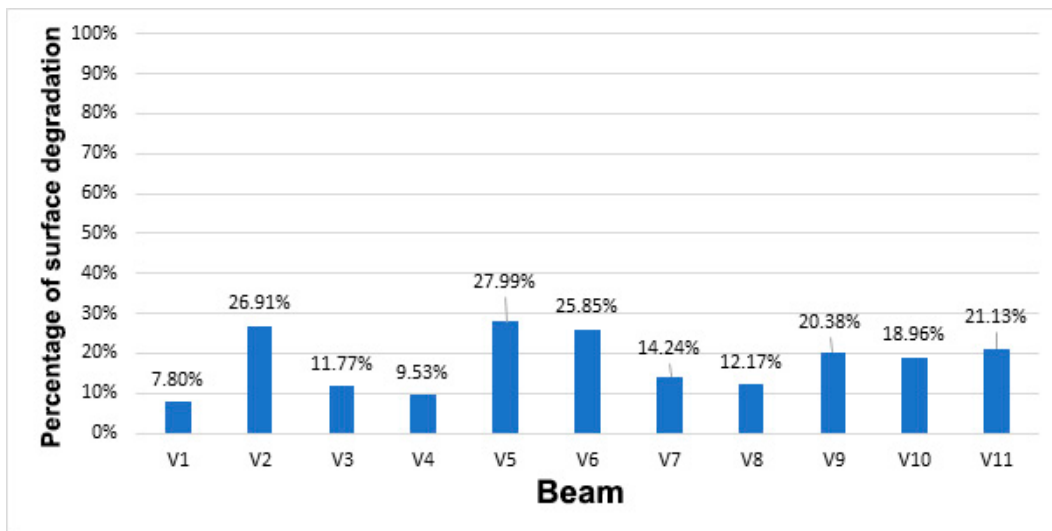
Figure 27. Percentage of surface degradation of the beams of the North facade

(Figure 27) and (Figure 28) show the beams surface degradation percentage considering the total area of the beams. The beams do not present standard, and they are relatively close. On East facade are found the beams with the two highest individual percentages, 60% and 30% for V14 and V15. On North facade are the two lowest percentages of 8% for V1 and 9% for V4. The peak in the values of the East facade is due to the vegetation present in V14.

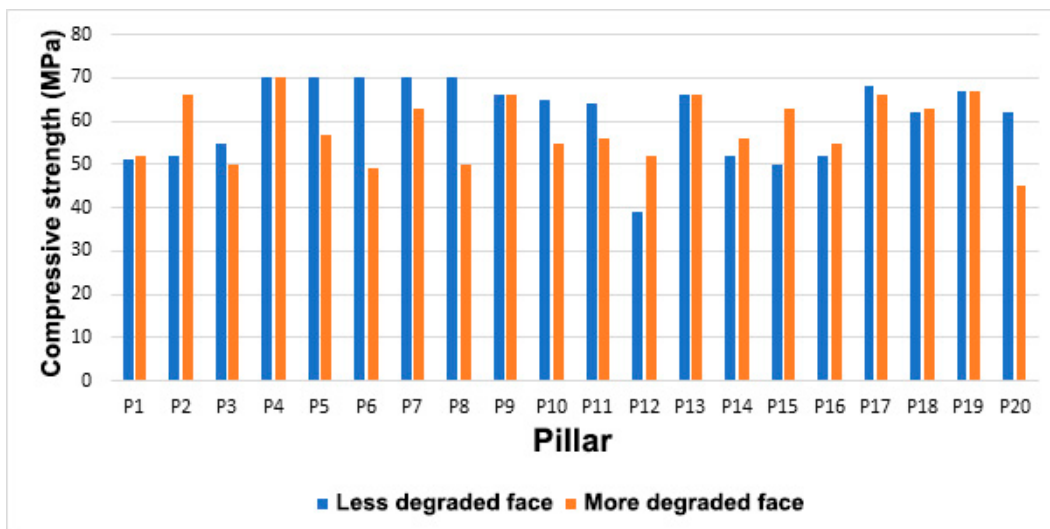
Figure 29. Compressive strength by state of the pillar face

The values obtained from the correlation of the mean sclerometric index through the sclometer abacus present the compressive strength values (Figure 29) and (Figure 30). The pillars of the East facade presented on average values of compressive strength of 58.39 MPa. This value is close them results of North facade with 60.7 MPa of average values of compressive strength.

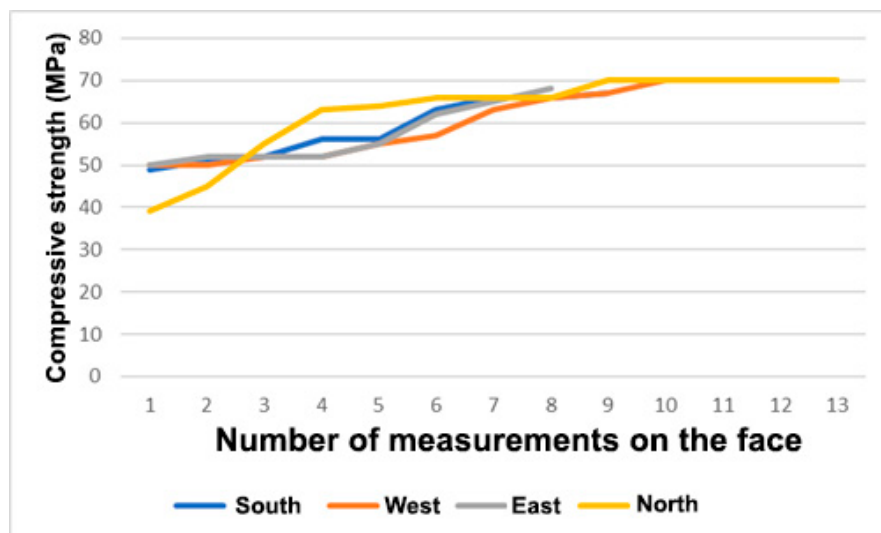
Figure 31. Compressive strength by the face of the pillars

North face presents effective sclerometric indices higher than other faces as can be seen in (Figure 31). This result can be caused by high incidence of sunlight, accelerating the degrading agents flow as CO₂ in the pores leading to the filling of these voids. After being filled, this occurrence led to a present sclerometric indices higher than those obtained in pieces of less intensity phenomenon occurrence as suggested by (Lima and Martins, 2014). The other faces did not show a pattern. The lowest average compressive strength with 45.5 MPa was in P12. This pillar presented 2% of degraded area total. The most degraded elements as P14, P15 and P20, presented effective sclerometric indices greater than 53.5 MPa. Columns presenting low degradation rates as P1, P5 and P10 presented average rates of 51.5 MPa, 63.5 MPa and 60 MPa.
