Análisis sobre el crecimiento de hongos en diferentes revestimientos aplicados a sistemas ligeros Analysis of fungal growth on different coatings applied to lightweight systems

A. Wirth *, F. Pacheco *, N. Toma *, B. Tutikian 1*, V. Valiati *, L. Gomes *

* Universidade Unisinos, São Leopoldo, BRASIL

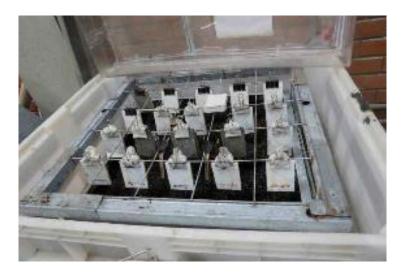
Figure 1. Samples hanged over the test chamber

- a) The samples were arranged and conditioned at temperature of 23 ± 2°C and humidity of 50 ± 5% for four days before being deposited in the test cabinet.
- b) Exposure: the samples were suspended vertically 75 mm above the surface of the soil deposited to allow free circulation of air, as depicted in Figure 1.
