Seismic performance of rammed earth town halls reinforced with confinement wooden elements

Evaluación del comportamiento sísmico de casas consistoriales de tapia pisada reforzadas con maderas de confinamiento

D. Ruiz ^{1*}, M. Silva *, L. Cerón *, C. López *

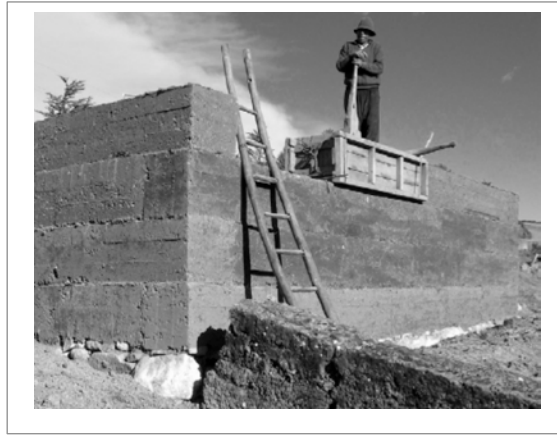
Figure 1. Rammed earth construction process (Chang et al., 2013)

One of the techniques used in earth construction is rammed earth, which is made by compacting layers of approximately 100 mm thick with a tool called rammer or tamper. Compacting is made inside a wooden framework, which is made of two wood boards of 2 m long by 1 m high, called "hojas de tapial", and 2 gates providing the wall's width (see Figure 1).

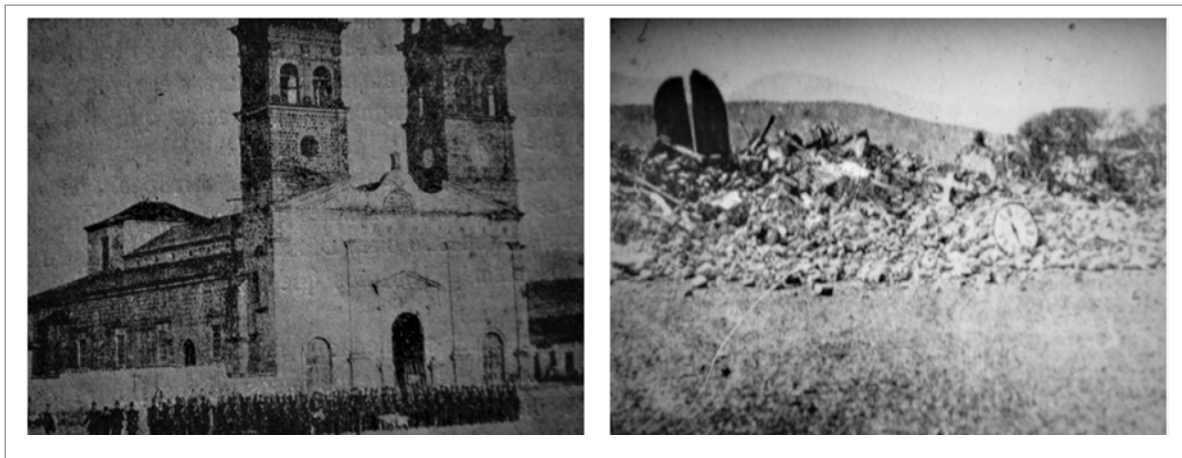
Figure 2. Collapse of the Cúcuta Church (made of earth) during the 1975 earthquake.
Taken from (Ruiz et al., 2012)

vulnerability. Furthermore, the age of these buildings and the deterioration of the mechanical properties of their materials are a determining factor in the behavior of rammed earth as a structure. The material's reduced tensile stress that originates a null flexural strength and the diagonal tensile strength of approximately 0.03 MPa, decreases the material's capacity to bear external forces (Yamín et al., 2007). The reason is that earth is a low cemented material, which makes it susceptible to the erosion or disintegration while being constantly in contact with water (Day, 1993). The consequence of this is a tendency of earth buildings to collapse during earthquakes, as in the Cúcuta earthquake (Colombia) in 1875, when the church collapsed (Figure 2).

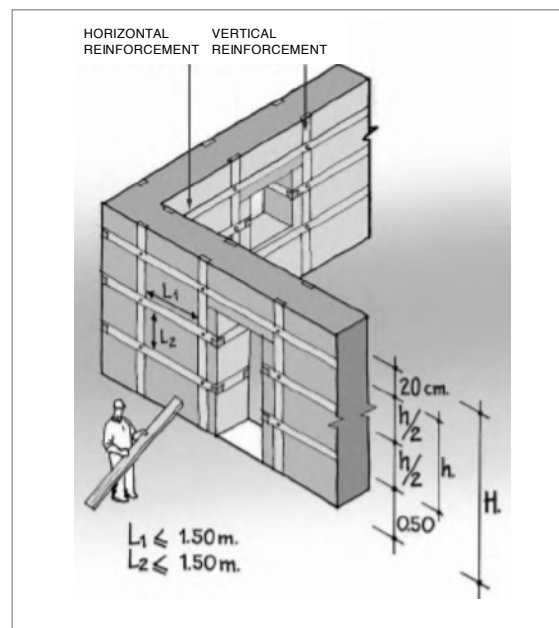
Figure 3. Placement of the confining wood reinforcement (AIS, 2004)

The reinforcement with confining wood elements consists in the installation of horizontal and vertical reinforcements, as indicated in Figure 3, considering the separation between the woods and between the edges, in order to increase the flexural strength of the walls and keep the structure unity. Elements should be placed on the inner and outer faces of the wall; the horizontal elements of the walls are fixed with bolts and steel plates, to prevent the walls

The reinforcement was placed according to the drawing of Figure 3. Based on the scale of 1:20, woods were separated by 75 mm from each other (1500 mm at real scale), at 30 mm from the corners and 25 mm from the cementation (see Figure 19). Likewise, the reinforcement was placed at 20 mm from the floor slab and the roof. In the joints between vertical and horizontal reinforcements, a copper wire was used; corresponding to steel bolts at real scale, and a knot was made on both ends to ensure that walls were confined. In the same way, to guarantee that the reinforcement worked, it was put together with brass sheets (steel plates at real scale) in the inner and outer corners, as well as between doors and windows, that would ensure this union (see Figure 20).

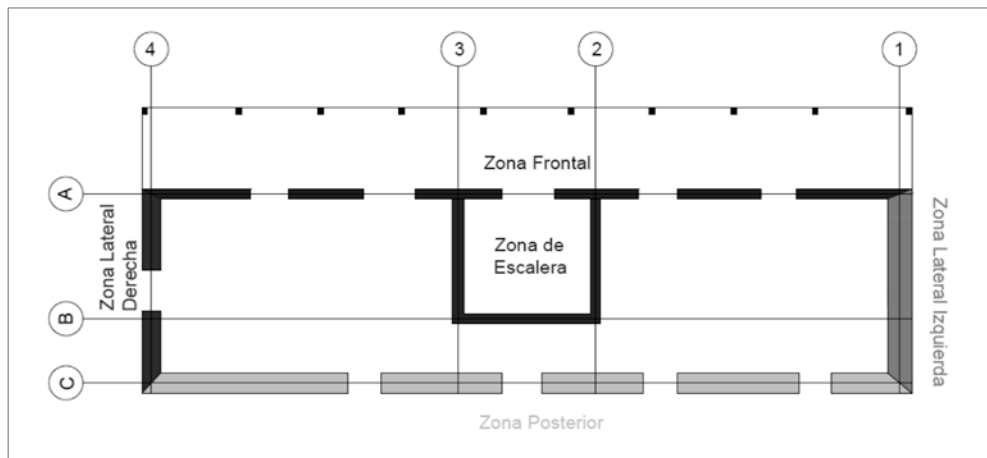
Figure 6. Wall drawing of the scale model

- Mechanical characterization of reinforced walls through diagonal tension tests.
- Reinforced and unreinforced model construction of the town hall of Cagua, at a scale of 1:20 (see Figure 6).
- Shake table test for built models (reinforced and unreinforced with confining wood elements), prior instrumentation of the models.
- Interpretation of the results: cracking levels and comparison of the displacements of the walls reinforced and unreinforced with confining wood elements.

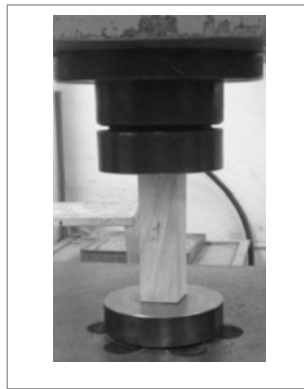
Figure 7. Assembly of specimens under compression on the universal machine

The longitudinal compressive tests were conducted on three specimens made of cedar to determine the wood's resistance. Figure 7 presents the assembly and Figure 8 shows the failure patterns (mainly by shear).

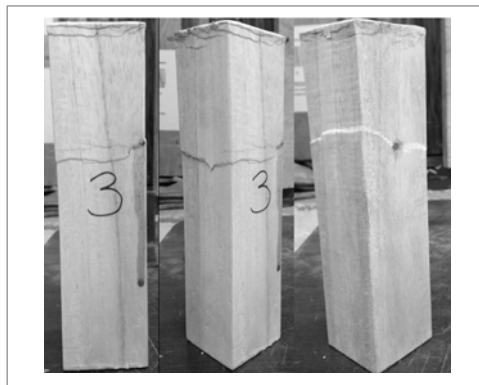
Figure 8. Type of failure in specimen 3

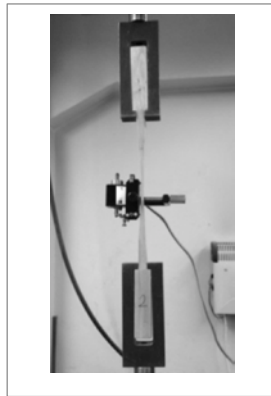
Figure 9. Assembly of wood specimens subjected to tensile test on the universal testing machine

performed, according to the reference technical standards. Figure 9 shows the assembly and Figure 10 presents the failure of the specimens.

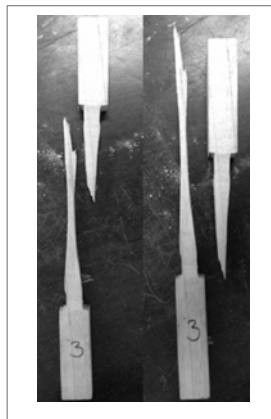
Figure 10. Failure of specimen 3 subjected to stress tests

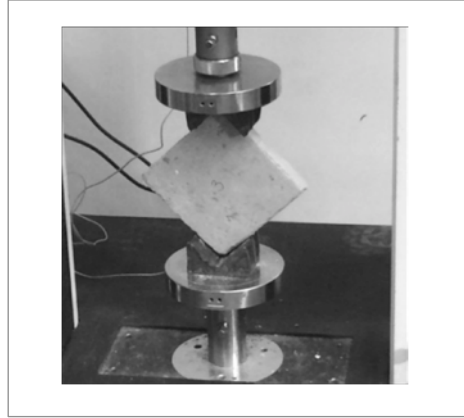
Figure 11. Assembly of the unreinforced wall test specimen

walls were built at scale 1:20 with the dimensions of a town hall scale wall measuring 150 mm x 150 mm x 20 mm. Two of these walls specimens had confining wood reinforcements and two did not. Walls were made with the earth previously described. Once the drying process was over (1 month) and with the wood reinforcement already installed, the walls were tested by the diagonal tensile test, according to the ASTM E519 standard (ASTM 2010) (see Figure 11 and 12).

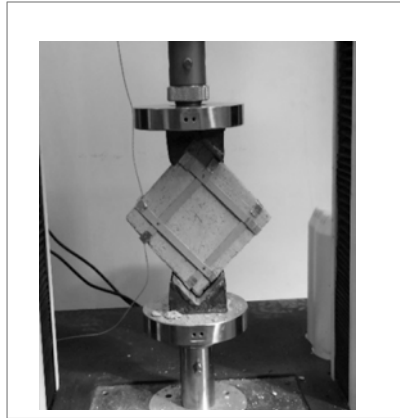
Figure 12. Failure of the reinforced and unreinforced wall test specimens

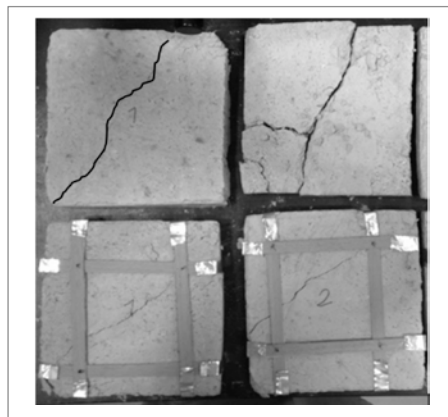
Figure 13. Cracks in the reinforced specimen walls caused by diagonal tensile stress

All walls specimens had a crack in one of the diagonals (see Figure 13).

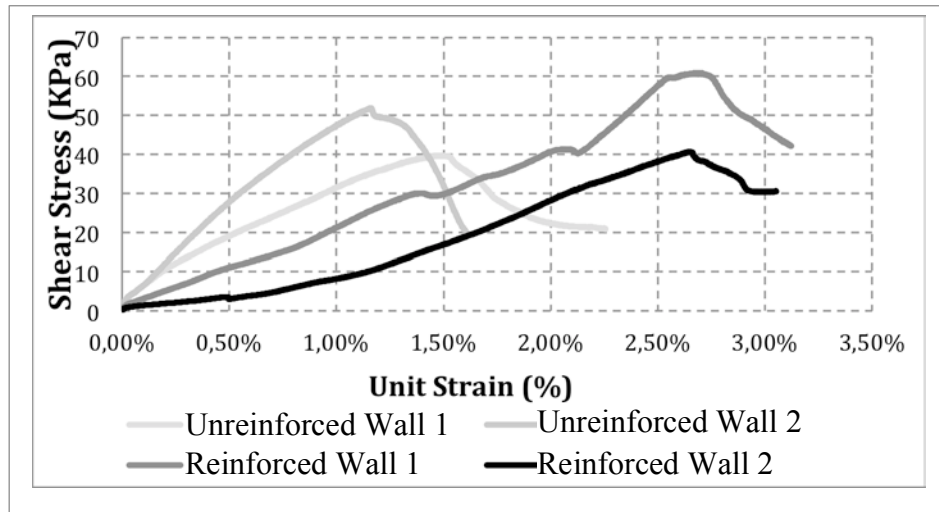
Figure 14. Shear stress vs. unit strain of wall specimens subjected to diagonal tensile stress

These diagonal tensile tests showed ductility capacity to unit strain of walls reinforced with confining wood. This is shown in Figure 14, in the records of shear stress vs. unit strain. Unlike the unreinforced wall, reinforced walls kept their unity once the test was over.

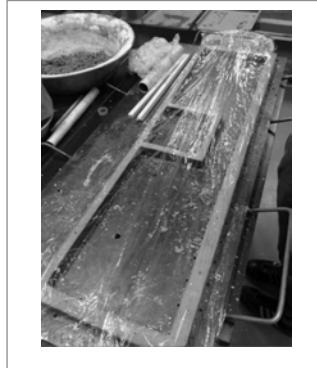
Figure 15. Foundation of the structure

The foundation consisted in strip footings made of compacted filling, conforming a framework of different

thicknesses, under the main walls of the building. The same foundation was used for unreinforced and reinforced models (see Figure 15), and the material described in the soil characterization paragraph was used.

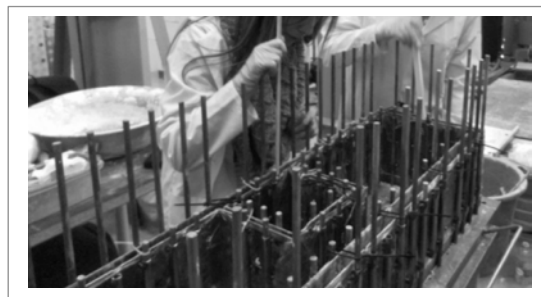
Figure 16. Walls' compacting process

Afterwards, the framework of the first floor was assembled, covered with plastic film to avoid adhering to the material, and tied between the edges to prevent thickness differences in the walls. The material was compacted in layers of approximately 5 cm (see Figure 16).

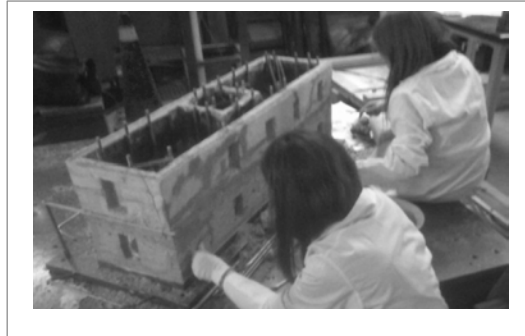
Figure 17. Opening process of doors and windows

One week after finishing the compaction, the formwork was removed (see Figure 17) and then the walls, joists and columns were painted (see Figure 18).

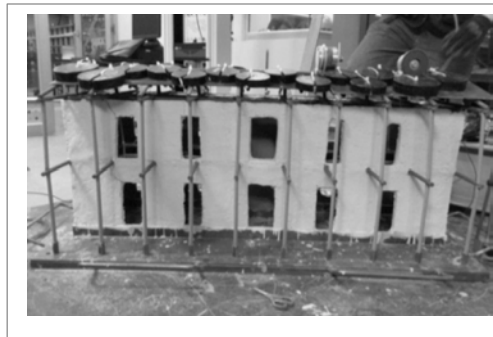
Figure 18. Unreinforced model before the failure

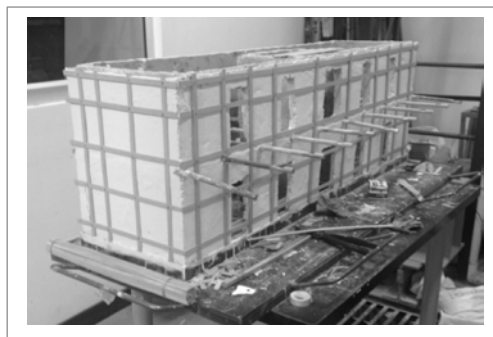
Figura 19. Placing of the reinforcement wood

The reinforcement with confining wood was made with cedar plywood of 1 cm wide and 1 mm thick (at real scale it would be 20 cm wide and 20 mm thick).

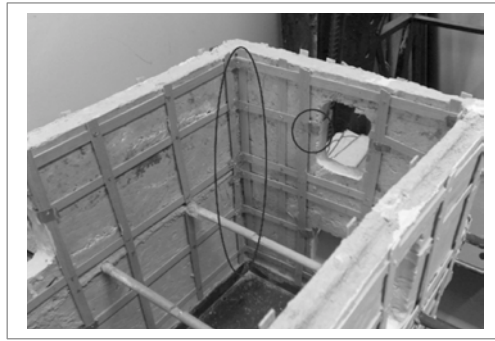
Figure 20. Union of corners, doors and windows

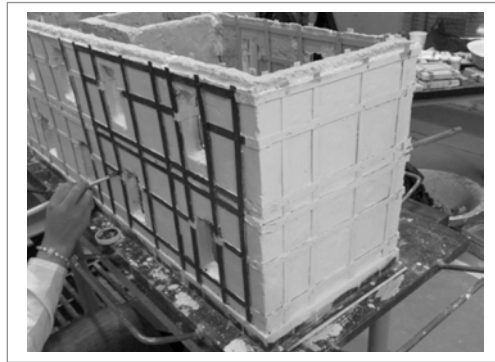
Figure 21. Painting process of the confining wood elements

Finally, woods were painted to get a better visibility of their behavior during the earthquake simulation test (see Figure 21). Reinforced and unreinforced models were subjected to loads on the roof and the floor slab to simulate the seismic mass (see Figure 22).

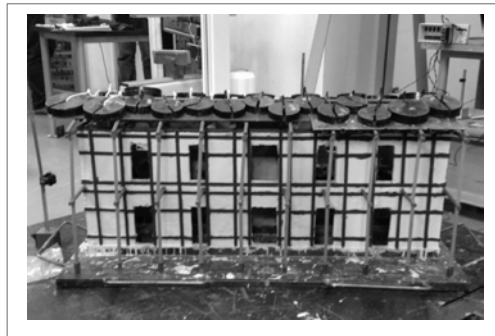
Figure 22. Reinforced model with loads before the earthquake

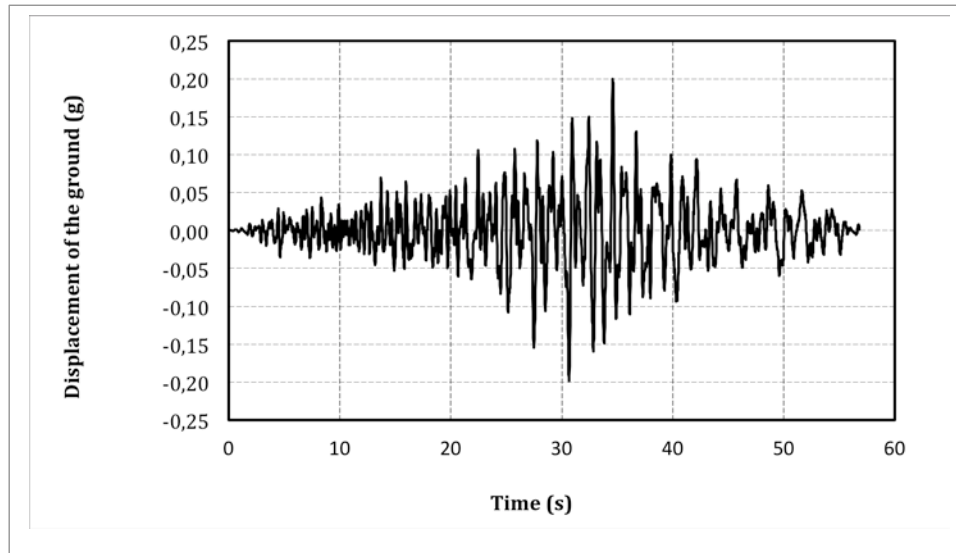
Figure 24. Earthquake signal of Tauramena

Models were subjected to the Tauramena earthquake (see Figures 24 and 25) recorded in 1995 (Rosal Station, Colombia), which is a characteristic signal that could take place in Bogota during an earthquake, with source in the frontal fault of the Eastern Mountain Range of Colombia (Ruiz et al., 2014; Yamín et al., 2003).

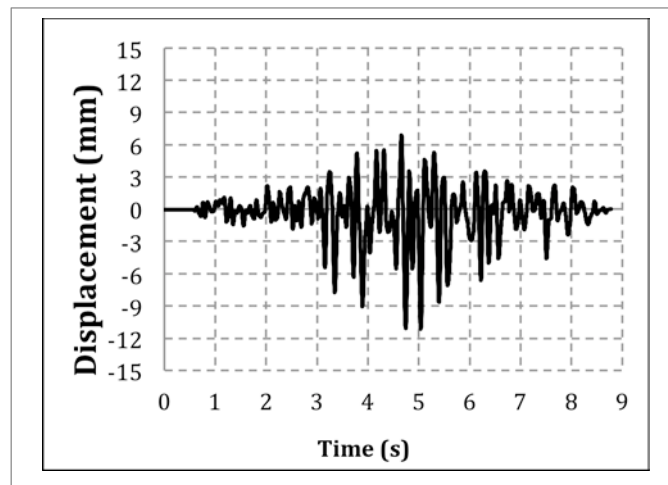
Figure 25. Displacement of the ground for the Tauramena earthquake used in the tests

In order to consider the scale model, it was necessary to modify the time scale of the input signal, to maintain the similarity dynamic force of excitation (Yamín et al., 2003). Therefore, Figure 25 shows the displacement record against the time used in the shake table, which is significantly shorter than the real signal, but generates acceleration levels that are in accordance with the scale model, as established in (Harris and Sabnis, 1999).

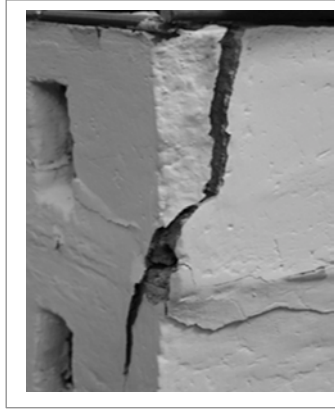
Figure 26. Cracking on the left lateral area after the seismic activity

After subjecting the unreinforced model to the motions of the shake table, the town hall presented cracking on the left lateral area, in the union of the axis 1 – C on the second floor, starting in the roof (see Figure 26), and reaching the first floor. Additionally, a sequence of cracks was evidenced in the union of axis A and 1, which generated independent

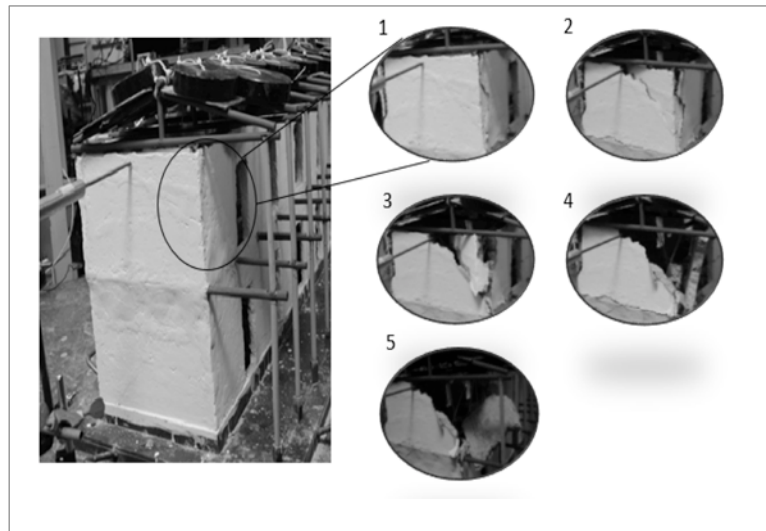
Figure 27. Collapse sequence on the left lateral area

vibrations from one wall to the other, producing the collapse of most of the wall, as shown in Figure 27.

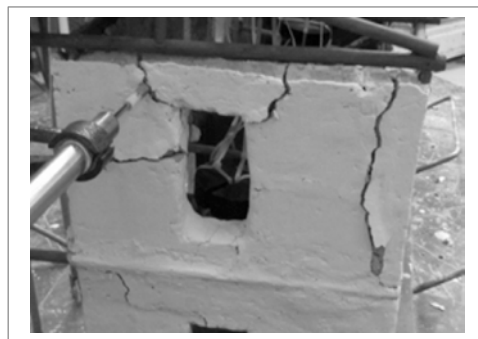
Figure 28. Cracking on the right lateral area after the seismic activity

On the right lateral area, the edge of the axis C – 4 cracked in the second floor and cracking was evidenced in the window opening of the second floor, crossing the wall horizontally as far as axis A, as shown in Figure 28.

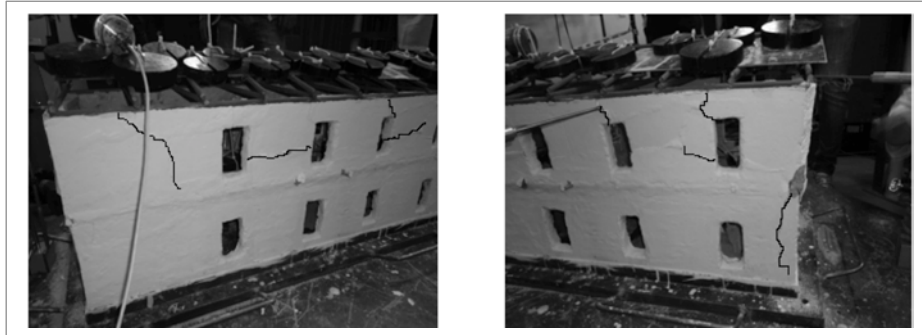
Figure 29. Cracking produced in the back by the seismic activity

In the back, on the second floor, vertical cracks between axis 3 and 4 of axis C and horizontal cracks between axis 2 and 3 of axis C, were detected. At the same time, cracks in the window openings were observed between axis 1 and 2 of axis C, and a vertical crack was generated on the first floor in the union of axis 1 – C, from the floor slab to where the foundation starts (see Figure 29).

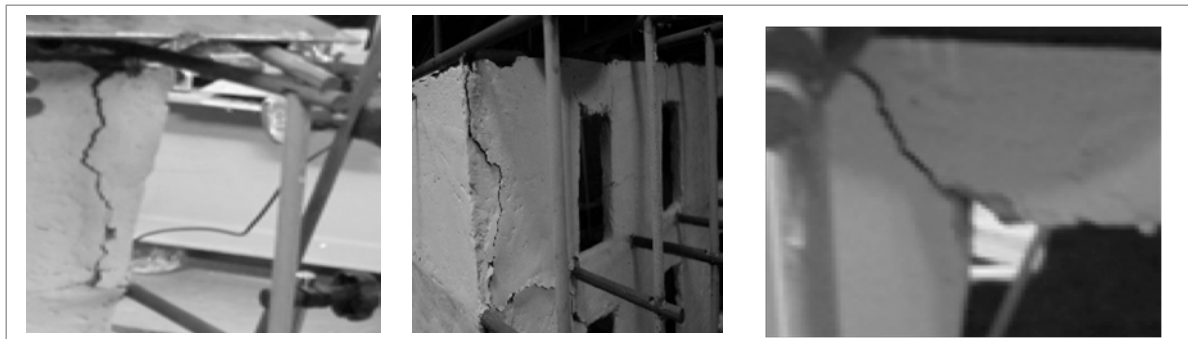
Figure 30. Cracking produced in the front by the seismic activity

In the front, cracking of the door opening occurred on the second floor between axis 1 and 2 of axis A. Moreover, the wall of the left upper side collapsed in the union of axis A – 1 and between axis A – 4. A crack was generated from the roof to the floor slab (see Figure 30).

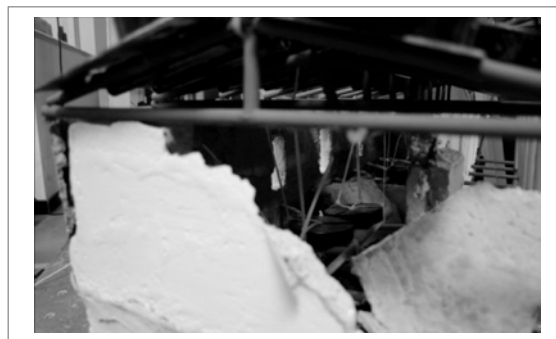
Figure 31. Collapse of the stairways on the second floor

In the stairway area, the walls of axis 2 and 3 collapsed, thereby destroying the floor slab (see Figure 31).

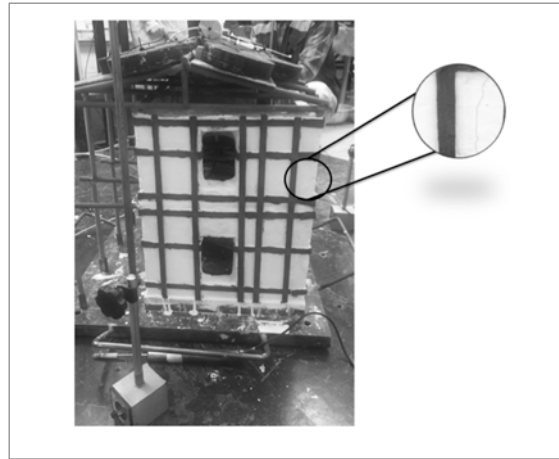
Figure 32. Left lateral side of the reinforced model

On the left lateral area, a crack was observed on the second floor on the border of the corner between axes 4 - C (see Figure 32).

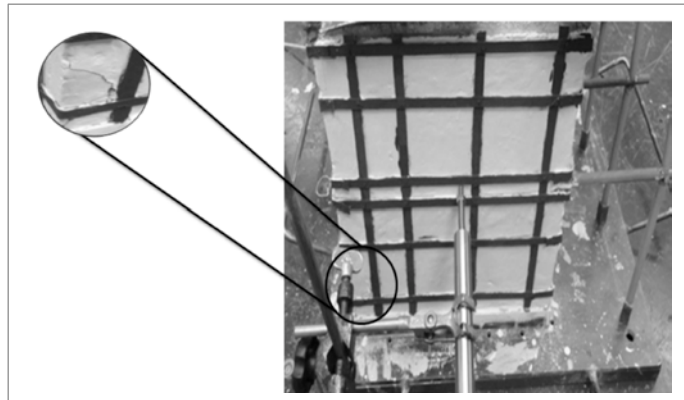
Figure 33. Right lateral side of the reinforced model

On the right lateral area, in the lower side of the wall between axes 1 - C, a diagonal crack was observed (see Figure 33).

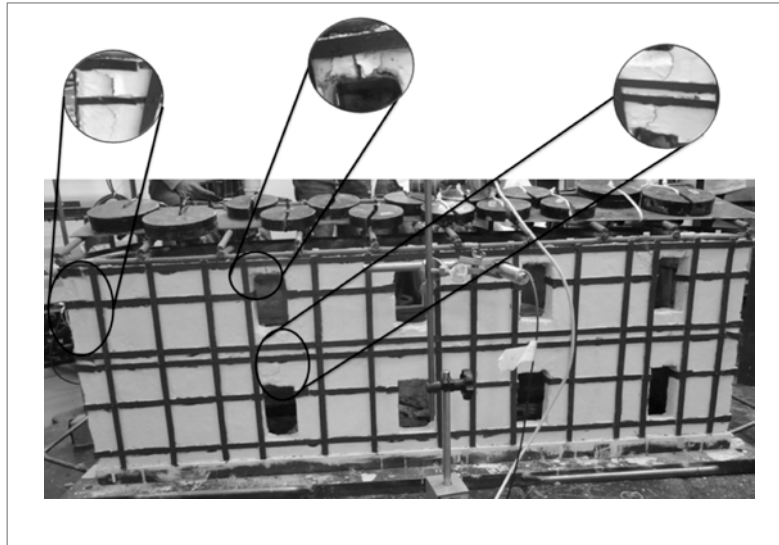
Figure 34. Back of the reinforced model

In the back, three cracks were generated: one in the corner between axes C - 4, another in the upper side of the window opening located between axes 4 and 3 over axis C, and the third between the edges of the windows located in axes 3 and 4, crossing the floor slab (see Figure 34).

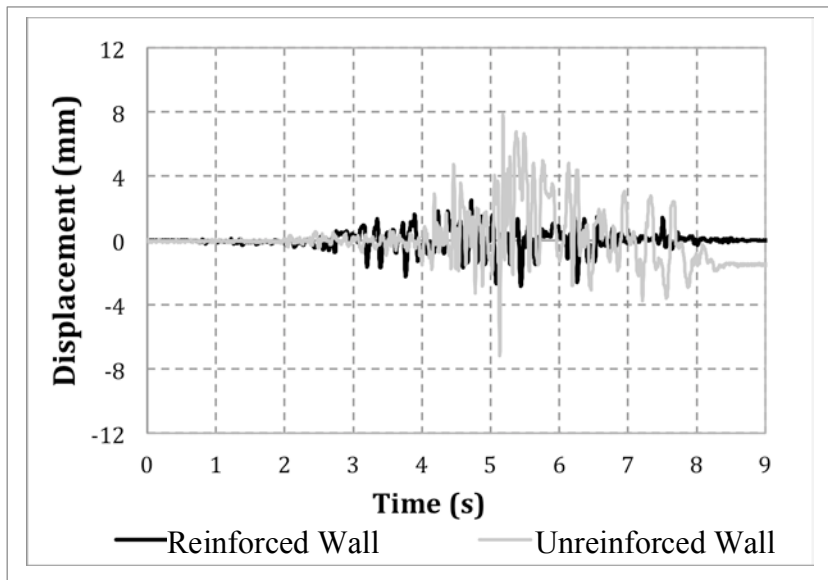
Figure 35. Displacements measured by LVDT 0 in reinforced and reinforced models for the roof

At the roof level, the LVDT 0 located in the right lateral wall registered a maximum displacement of 7.06 mm in the unreinforced model, and 2.40 mm in the reinforced model (see Figure 35). The unreinforced model registered a permanent displacement of 1.40 mm at the end of the seismic test, unlike the reinforced model where no permanent

displacements were registered. Moreover, the decrease of the displacement records for the reinforced model, compared with the unreinforced model, should be highlighted.

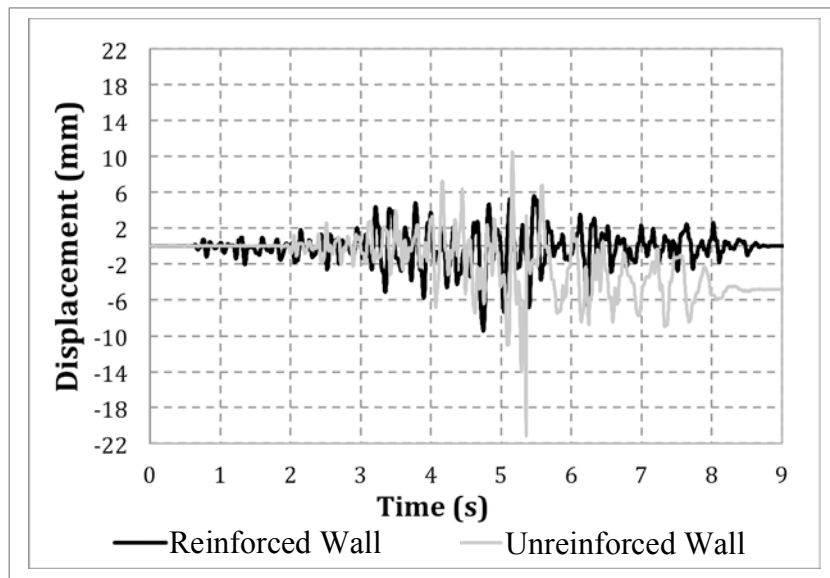
Figure 36. Displacements measured by LVDT 1 in reinforced and reinforced models for the roof

The LVDT 1 located in the back wall registered a maximum displacement of 21.15 mm in the unreinforced model, and 9.47 mm in the reinforced model (see Figure 36). The unreinforced model registered a permanent displacement of 4.90 mm at the end of the seismic test. A decrease of the displacement records for the reinforced model can also be observed with regard to the unreinforced model.

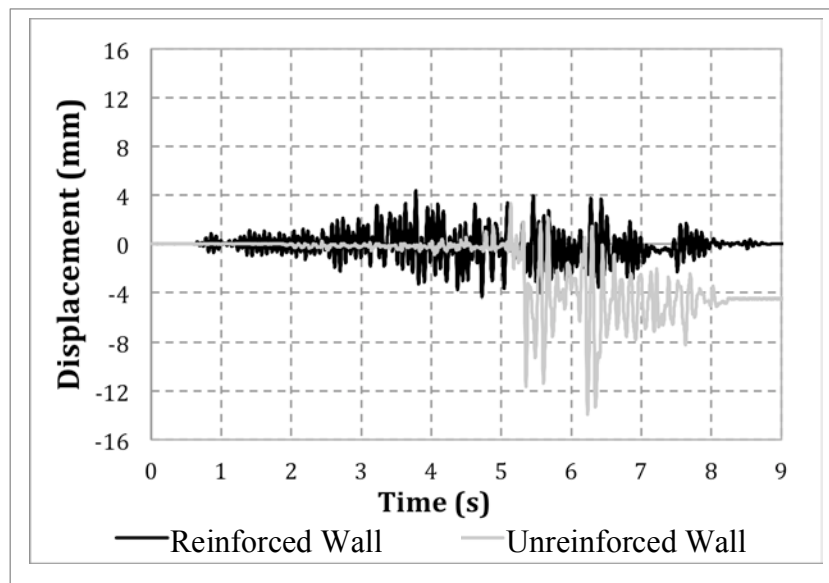
Figure 37. Displacements measured by LVDT 2 in reinforced and reinforced models for the roof

In the left lateral wall, where the LVDT 2 is located, a maximum displacement of 13.94 mm was registered in the unreinforced model, and a displacement of 4.40 mm in the reinforced model (see Figure 37). The unreinforced model registered a permanent displacement of 4.47 mm at the end of the seismic test. There is also a reduced displacement record in the reinforced model, compared with the unreinforced model.
